RIVERDALE CITY COUNCIL AGENDA-AMENDED
CIVIC CENTER - 4600 S. WEBER RIVER DR.
TUESDAY – MARCH 6, 2012

Riverdale City 2011 Flood Damage Assessment

October 13, 2011

Prepared For:
Riverdale City, Utah
Public Works department
4600 South Weber River Drive
Riverdale City, Utah 84405

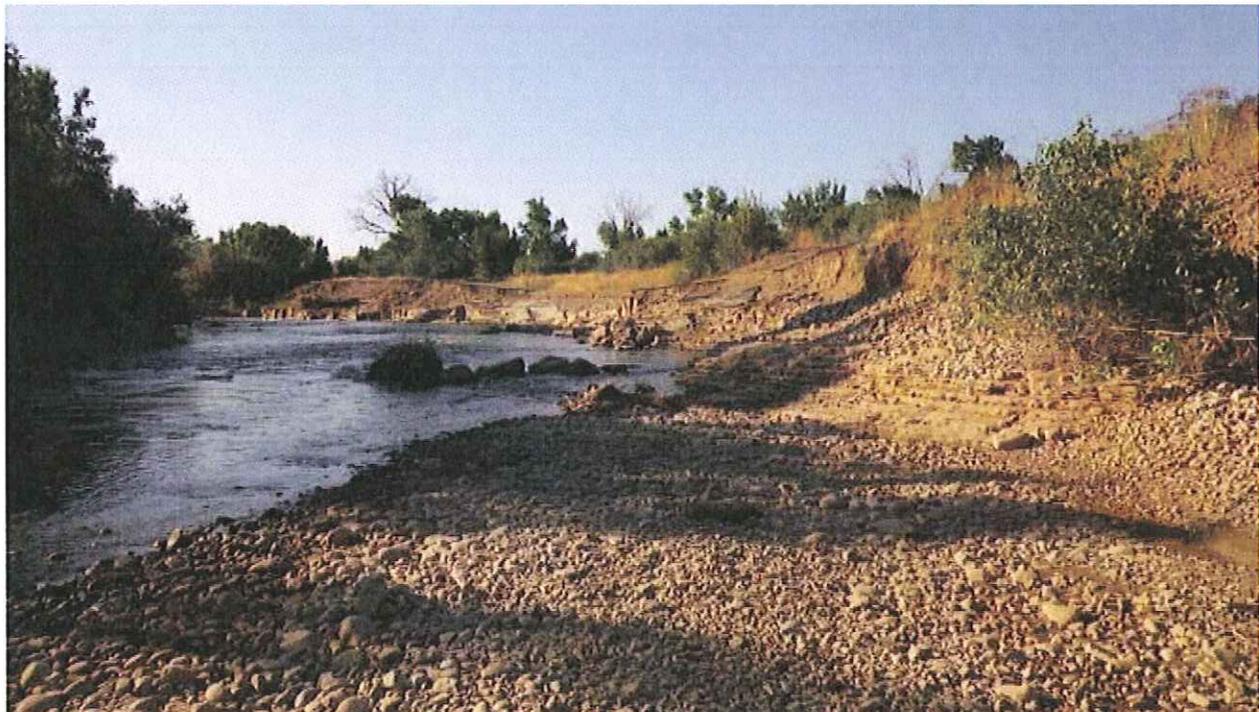
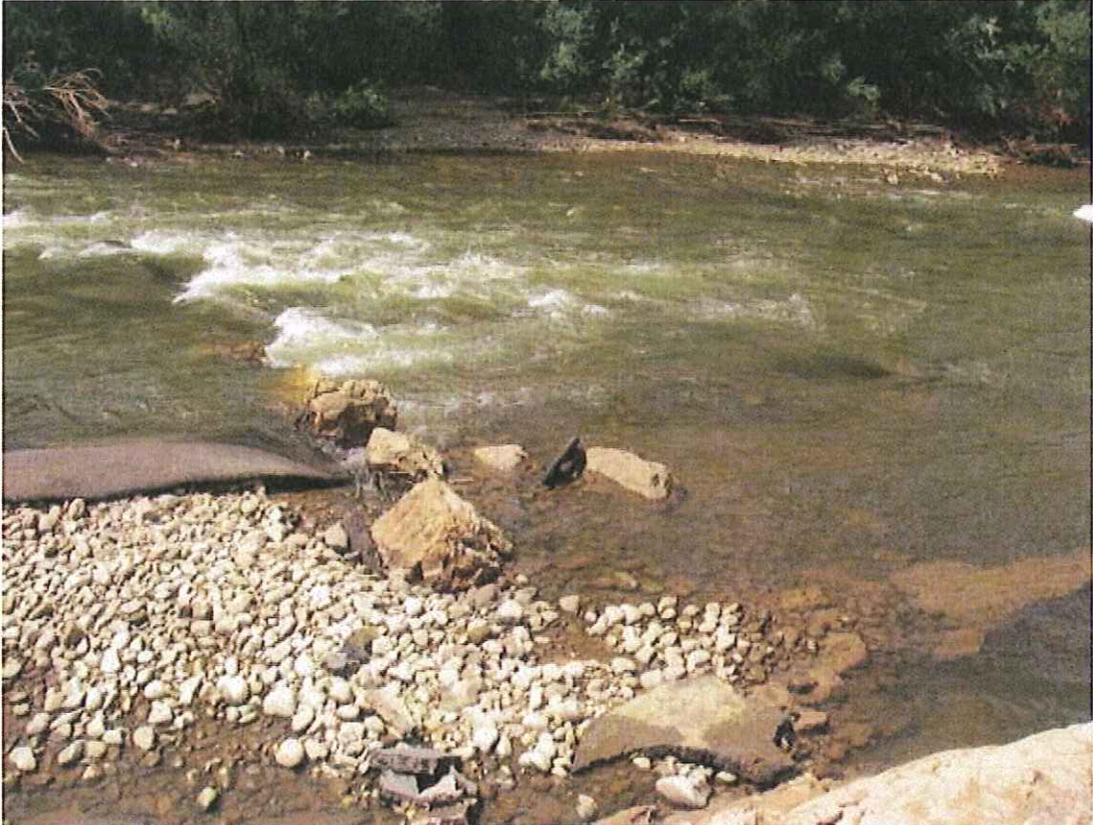
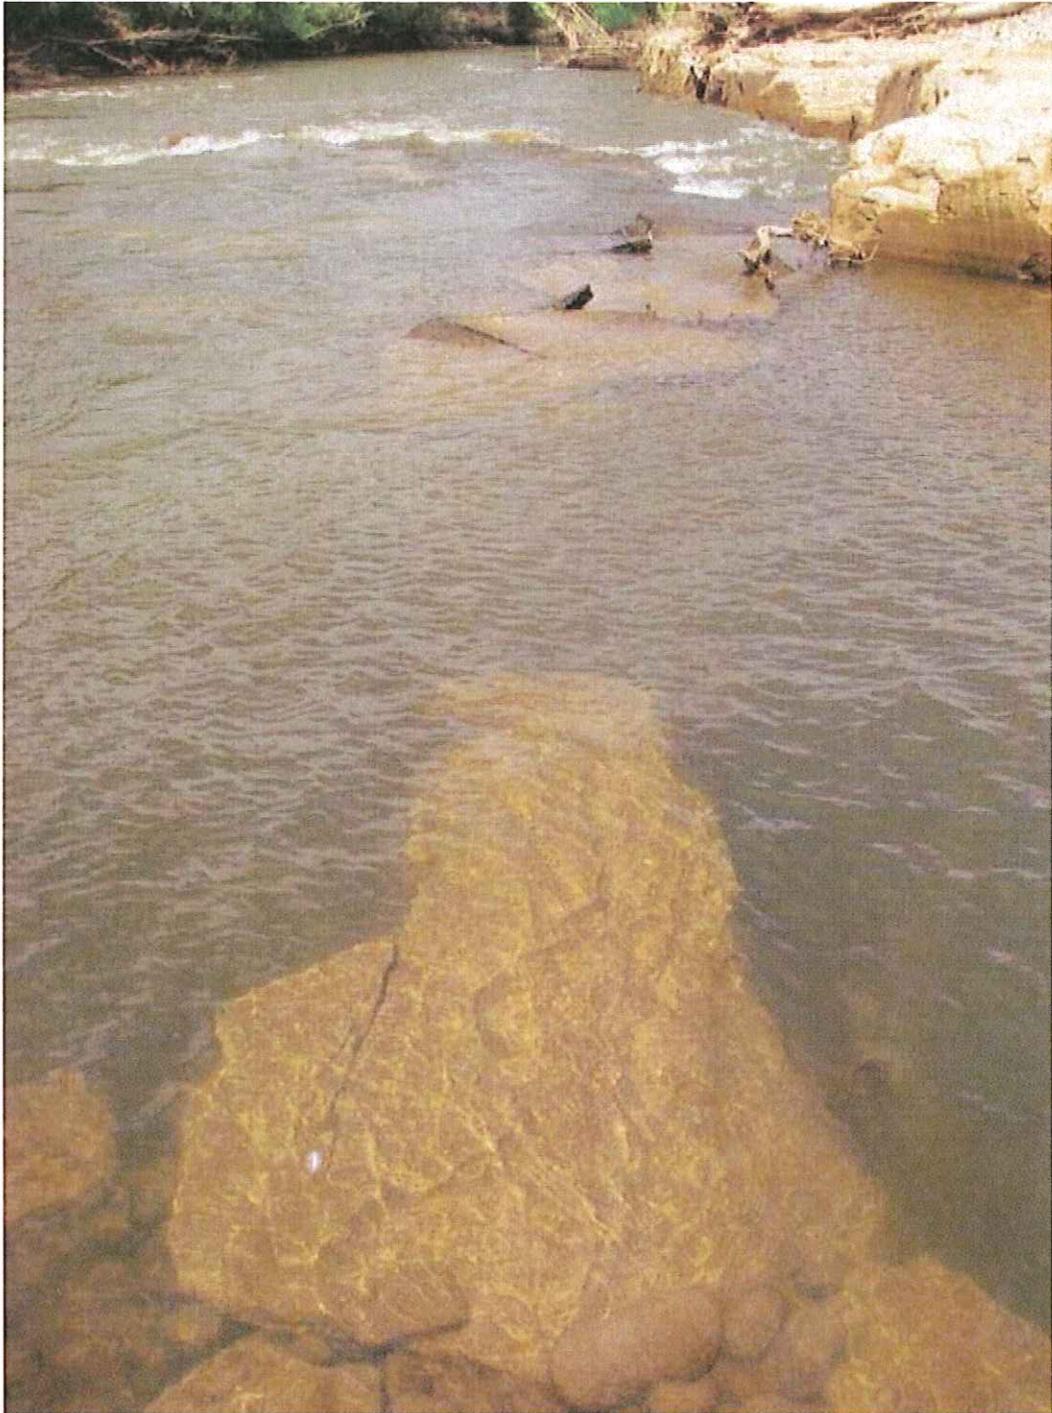
Flood Assessment Point:	#1-Weber River Parkway Collapse						
GPS Coordinates:	Waypoints RC-10 to 29						
Direction to Assessment Point:	Approximately 5260ft upstream from Weber River Dr. on bike path.						
Project Priority:	<table style="width: 100%; border: none;"> <tr> <td style="width: 33%;">High</td> <td style="width: 33%;">Moderate</td> <td style="width: 33%;">Low</td> </tr> <tr> <td style="text-align: center;">X</td> <td></td> <td></td> </tr> </table>	High	Moderate	Low	X		
High	Moderate	Low					
X							
Description of Issue:	Sever erosion of nearly 550 ft of bank resulting in collapse of 300' of asphalt pathway.						
Structures:	Bike Path						
Geomorphic Description:	<p>Aerial photographs from 1953, 1954, 1971, 1973, 1979, 1980, 1997, 2003, 2006, and 2009 were reviewed to understand the geomorphic evolution of this reach. This portion of the Weber River was channelized in the early 1970's for the construction of I-84. Prior to channelization this reach had meanders with a similar planform to the upstream DNR reach as it exists today. Aerial photography from 1953 shows that the reach length has been reduced by over 20% (7500 feet to 5800 ft). In addition to decreasing the length and a subsequent decrease in slope the construction of the highway also narrowed the effective floodplain of the river. Historic channel patterns are also evident in the 1953 photo. These patterns indicate that the Weber River may have had a meander belt width in excess of 1500ft. Aerial Photographs from 1999 and 2009 show that virtually all of the meanders have been eliminated through channelization and the riparian corridor is less than 150 ft wide. In addition to the channelization a water main crossing was placed just upstream of the failed bike path (RC-9) creating a large drop structure. The river has responded to these changes by cutting into the right bank as it attempts to adjust its flow path length. The river was cutting at this bank prior to the construction of the path in 2009. Between 1997 and 2006 the bank eroded a horizontal distance of approximately 55-60 ft. Some of this bank loss was reclaimed with the construction of the path in 2009. The 1971 photo shows a mid-channel bar formed immediately across the river from the area of the failed bike path. Portions of this bar were left unaltered during the construction of the highway. It is likely that during high flows this mid channel bar become inundated and provided extra conveyance. During the extended drought period that ended in 2008 riparian vegetation was established on this bar thus closing off any significant conveyance. The lack of overbank flooding and the establishment of mature riparian vegetation has effectively eliminated any overbank</p>

<p>conveyance through this reach. Additionally there is evidence of bank toe erosion throughout this reach, indicating that the river is down cutting. Evidence of overbank flooding at downstream end of bank failure. Large amounts of driftwood caught in overgrown understory may have decreased overbank conveyance.</p>
Habitat Considerations:	<p>Throughout this reach there is a lack of habitat diversity. Channelization has created uniform flow patterns and in portions the riparian vegetation is sparse. There is little evidence of deposition through this reach. Eroded bank material is likely transported through the reach and deposited downstream of Riverdale City.</p>
Flood Damage Repair	<ul style="list-style-type: none"> • \$250,000-\$350,000
Measures:	<ul style="list-style-type: none"> • Option 1 (Flood Damage Improved Project): <ul style="list-style-type: none"> ○ Reconstruct Bike path further northeast. ○ Biostabilize Bank ○ \$50,000-\$100,000 + Lands • Option 2 (Flood Damage Improved Project): <ul style="list-style-type: none"> ○ Reconstruct bike path in new alignment ○ Stabilize Toe ○ Lay river bank back at 3:1 and biostabilize ○ Thin out overgrown riparian vegetation on river left to open up flood conveyance channels. ○ \$200,000 to \$300,000 + Lands

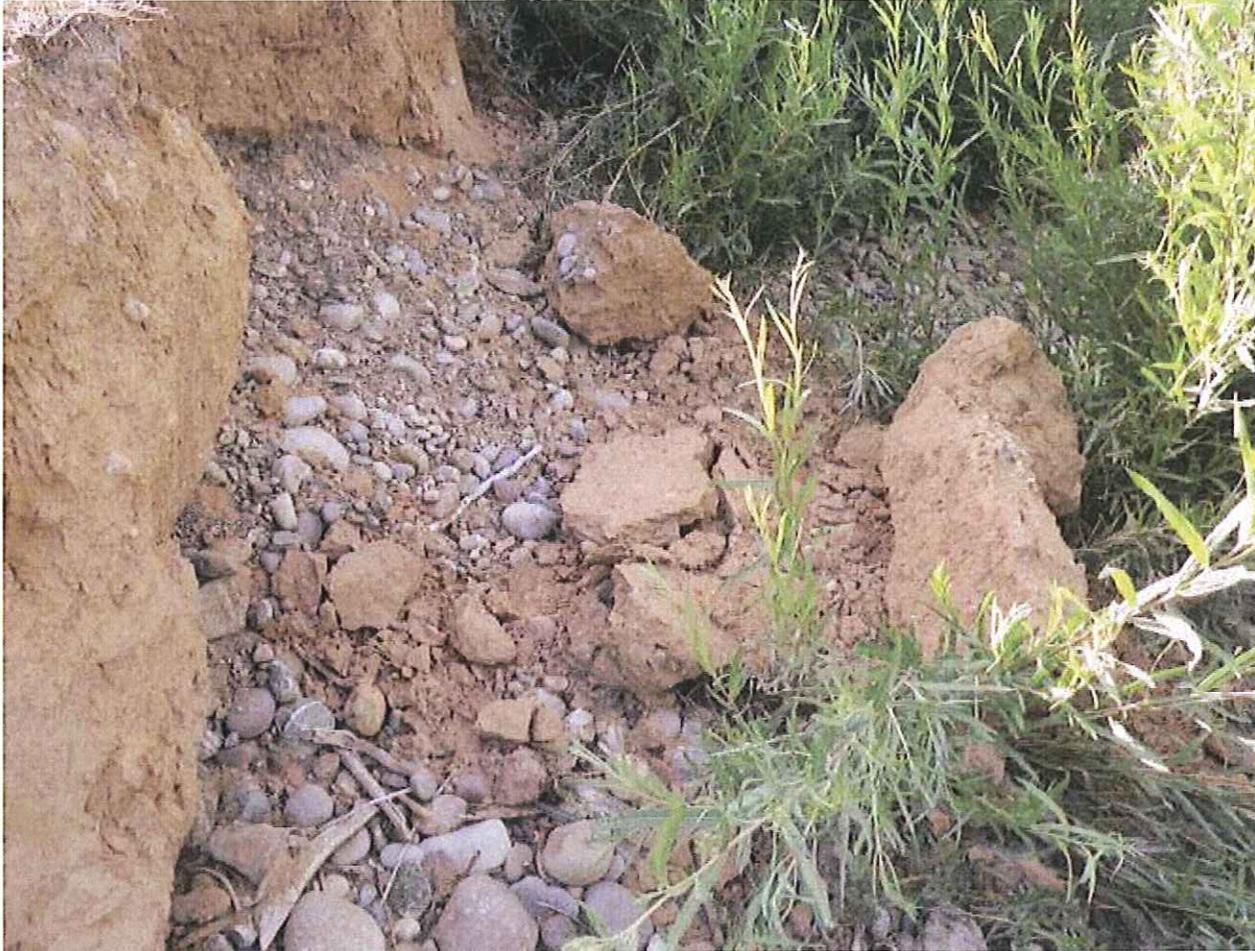
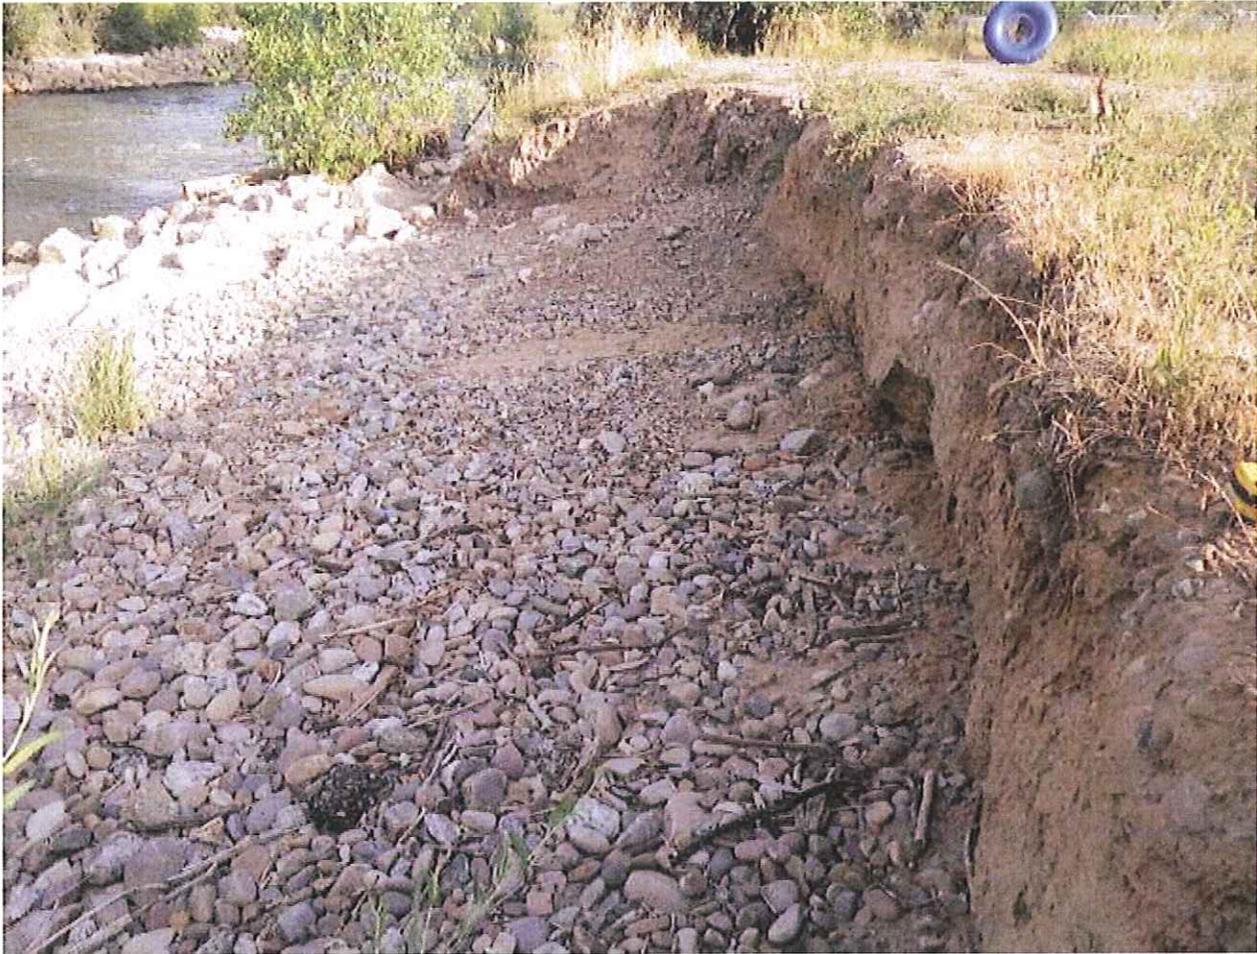
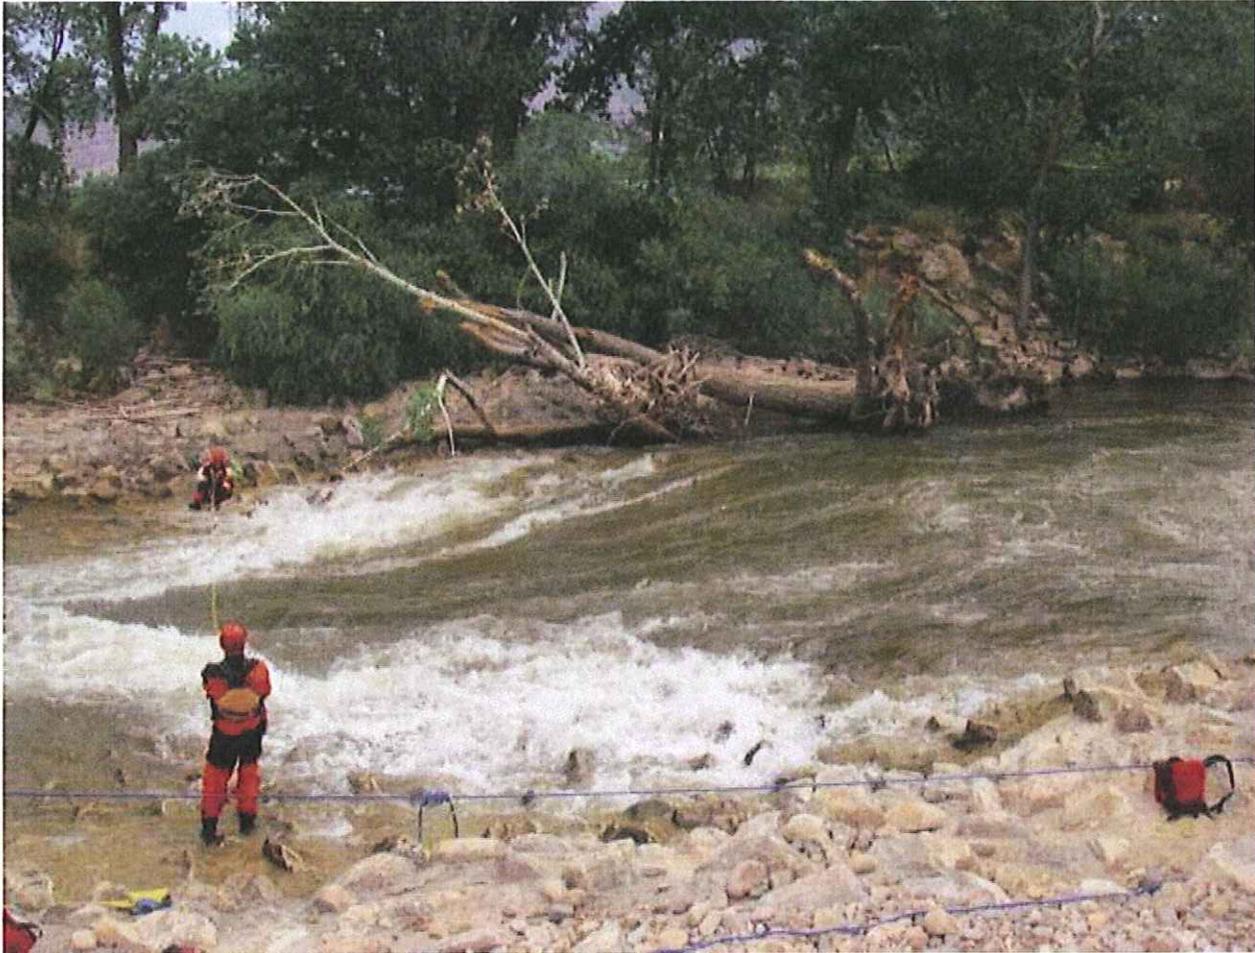
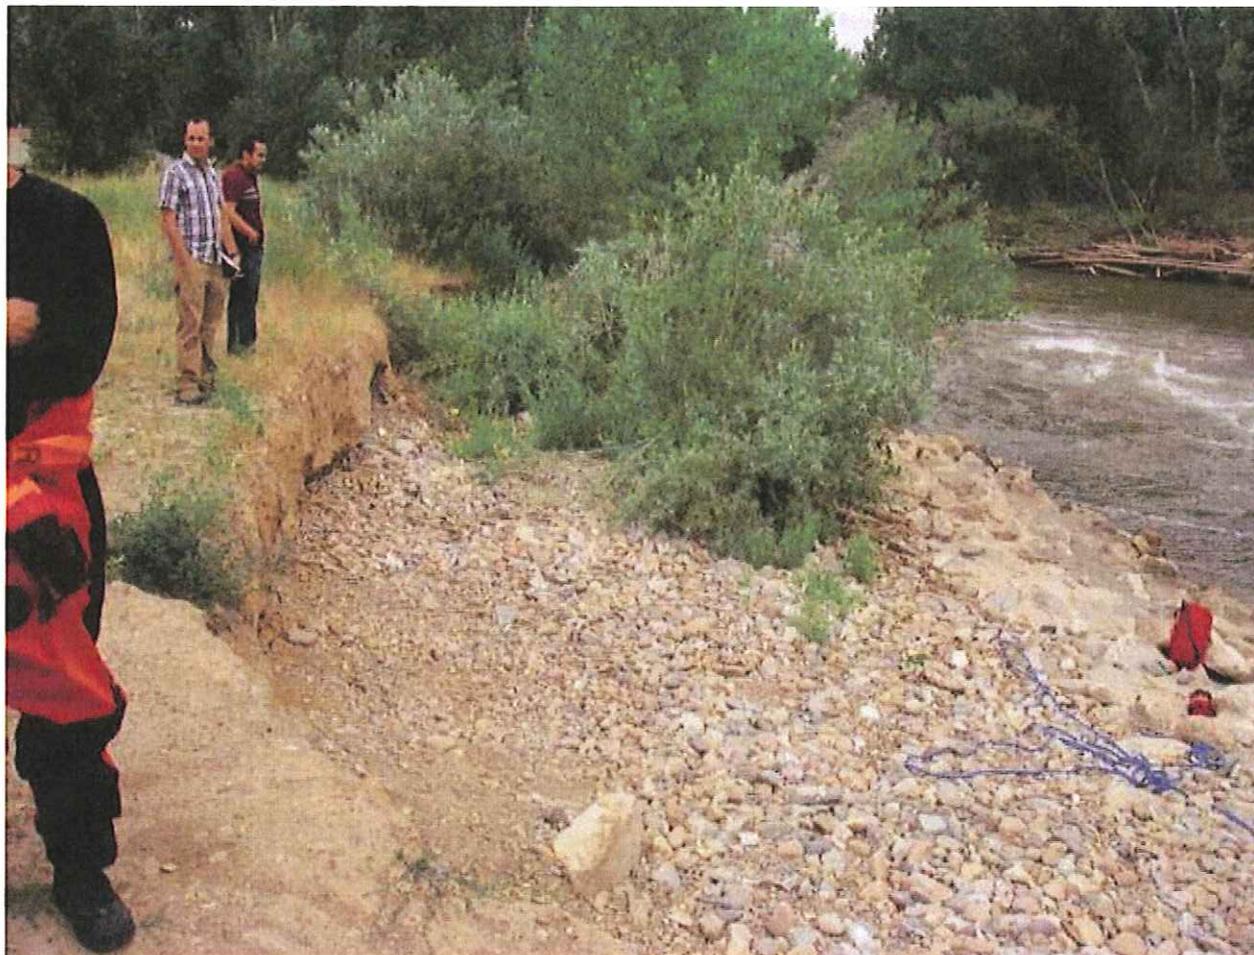
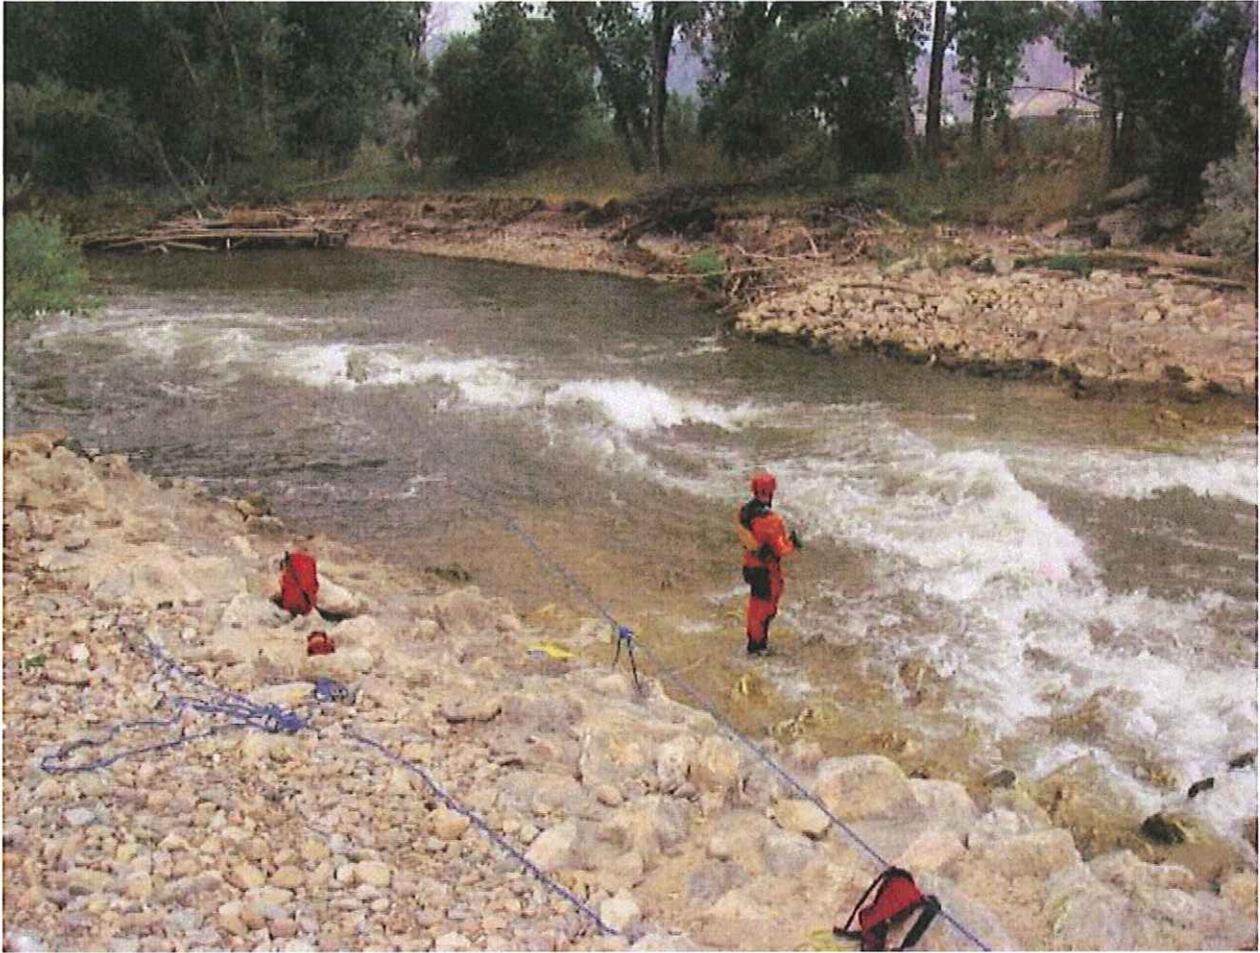
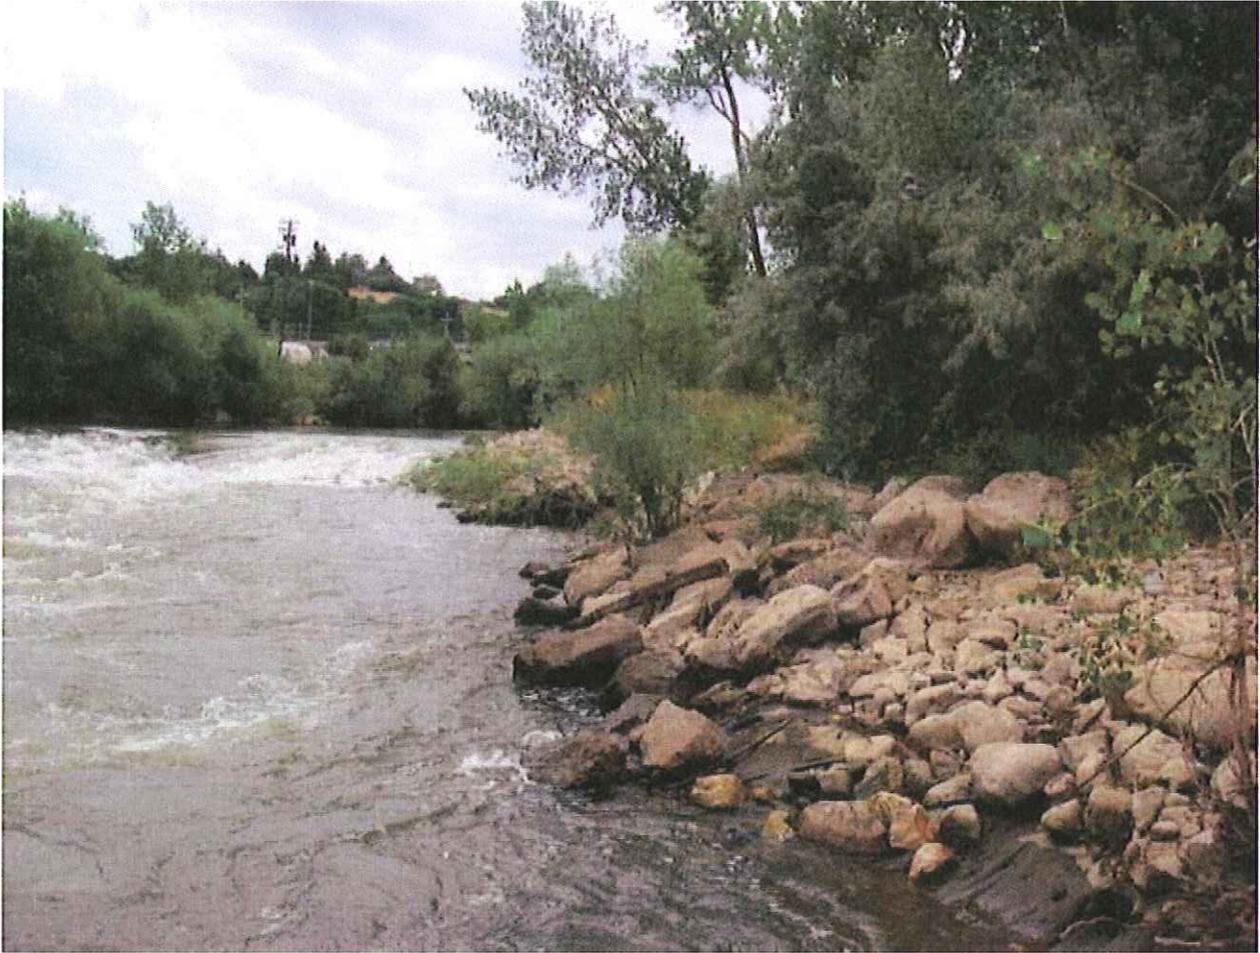
Photographs:	<ul style="list-style-type: none"> • IMGP0159 • IMGP0160 • IMGP0161 • IMGP 2796

Flood Assessment Point:	#4-Riverdale Play Park, Grade control and Riprap Failure
GPS Coordinates:	8-16-11: Pts 9 & 10
Direction to Assessment Point:	Approximately 600 ft downstream on the bike path from the South Weber River Dr. trailhead.
Project Priority:	High Moderate Low X
Description of Issue:	Grouted Riprap appears to be failing and as a result the whitewater wave no longer functions. Probing indicates 8’ deep hole upstream of the grouted grade control and an 8’ deep hole downstream of the structure. Design drawings indicate that the cutoff wall above the lower drop is only 5’ deep; it is likely that the grouted riprap has been undercut. Additionally the grouted grade control on the left bank between the two structures has also failed and there is significant erosion in the viewing area on the left bank at the lower drop. This erosion extend downstream over 350 ft. This is a High Priority project for a number of reasons: 1) the Riverdale Whitewater Park is a world class whitewater feature that brings tourism \$ into Riverdale, 2) <u>Potential significant entrapment hazard to boaters/swimmers (There is a popular rope swing just upstream of the lower structure)</u>

Structures:	Sewer Line, Kayak Wave, Bike Path
Geomorphic Description:	<p>This grouted grouted grade control structure was constructed in 2005. The primary goal of this structure is to protect the sewer line crossing. The structure was also designed to create a whitewater wave. Based on design drawings there is a 5’ concrete cutoff wall upstream of the lower drop structure.</p> <p>Like much of the Weber River through Riverdale City, this reach has been channelized during the urbanization of Riverdale in the 1970s. Historically, this reach of the river was more similar to the upstream reaches that pass through the DNR property; it was a dynamic, aggrading system. The modified channel has a greater sediment transport capacity and is capable of transporting most of the alluvium supplied by the upstream reaches. As a result of this excess transport capacity the Weber river is degrading through much of Riverdale City. This is evidenced by bank toe erosion and little evidence of sediment deposition throughout the Riverdale reach. While it is difficult to assess the condition of the structure due to high flows, the presence of 8’ deep holes upstream and downstream of the structure indicate that the 2011 flood flows were sufficiently large, and of a sufficient duration that they may have undercut the 5 foot cutoff wall and eroded under the grouted grade control. It is</p>

not uncommon for grouted grade control structures to be undercut. Additionally, the downstream hydraulics have caused significant bank erosion on the right bank of the river. General channel degradation is likely downstream of the grade control structure. Due to the excessive channel scour the structure no longer functions as designed.
Habitat Considerations:	This structure provides better fish passage than the upstream drop structures.
Flood Damage Repair:	<ul style="list-style-type: none"> • \$250,000-\$350,000
Measures:	<ul style="list-style-type: none"> • Option 1 (Flood Damage Lower Structure Improved Project) <ul style="list-style-type: none"> ○ Re-Grout riprap ○ Fill voids under structure with Flowable Fill ○ Replace Cutoff Wall (sheet pile) ○ Biostablize Left Bank ○ Repair downstream grade control ○ \$200,000-\$300,000 • Option 2- (Replace Lower Structure, Alternate Project) <ul style="list-style-type: none"> ○ Remove grouted rip-rip ○ Construct new structure out of large boulders embedded below scour depth ○ Install pre-cast “Wave Blocks” to create play wave ○ Install Sheet pile cutoff. ○ Protect viewing area with boulder and flagstone ○ \$350,000-\$650,000

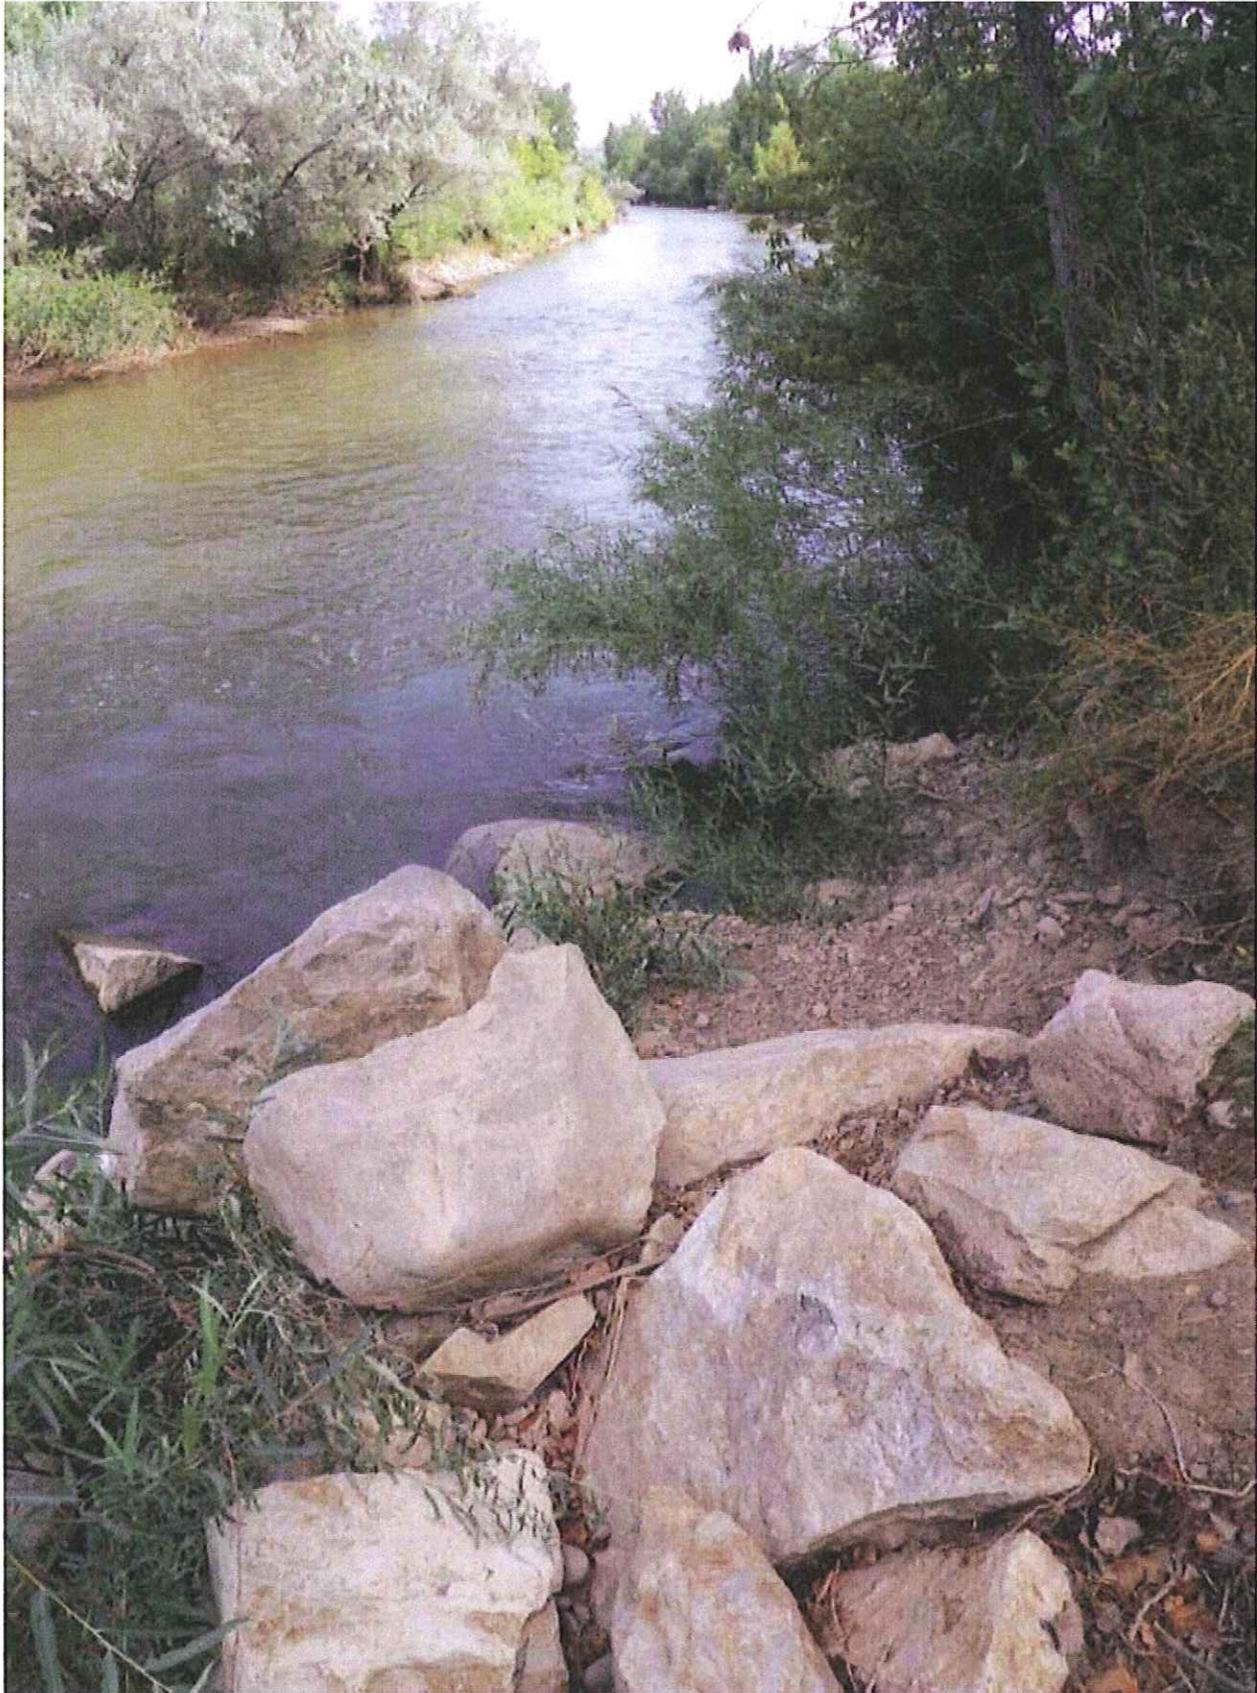
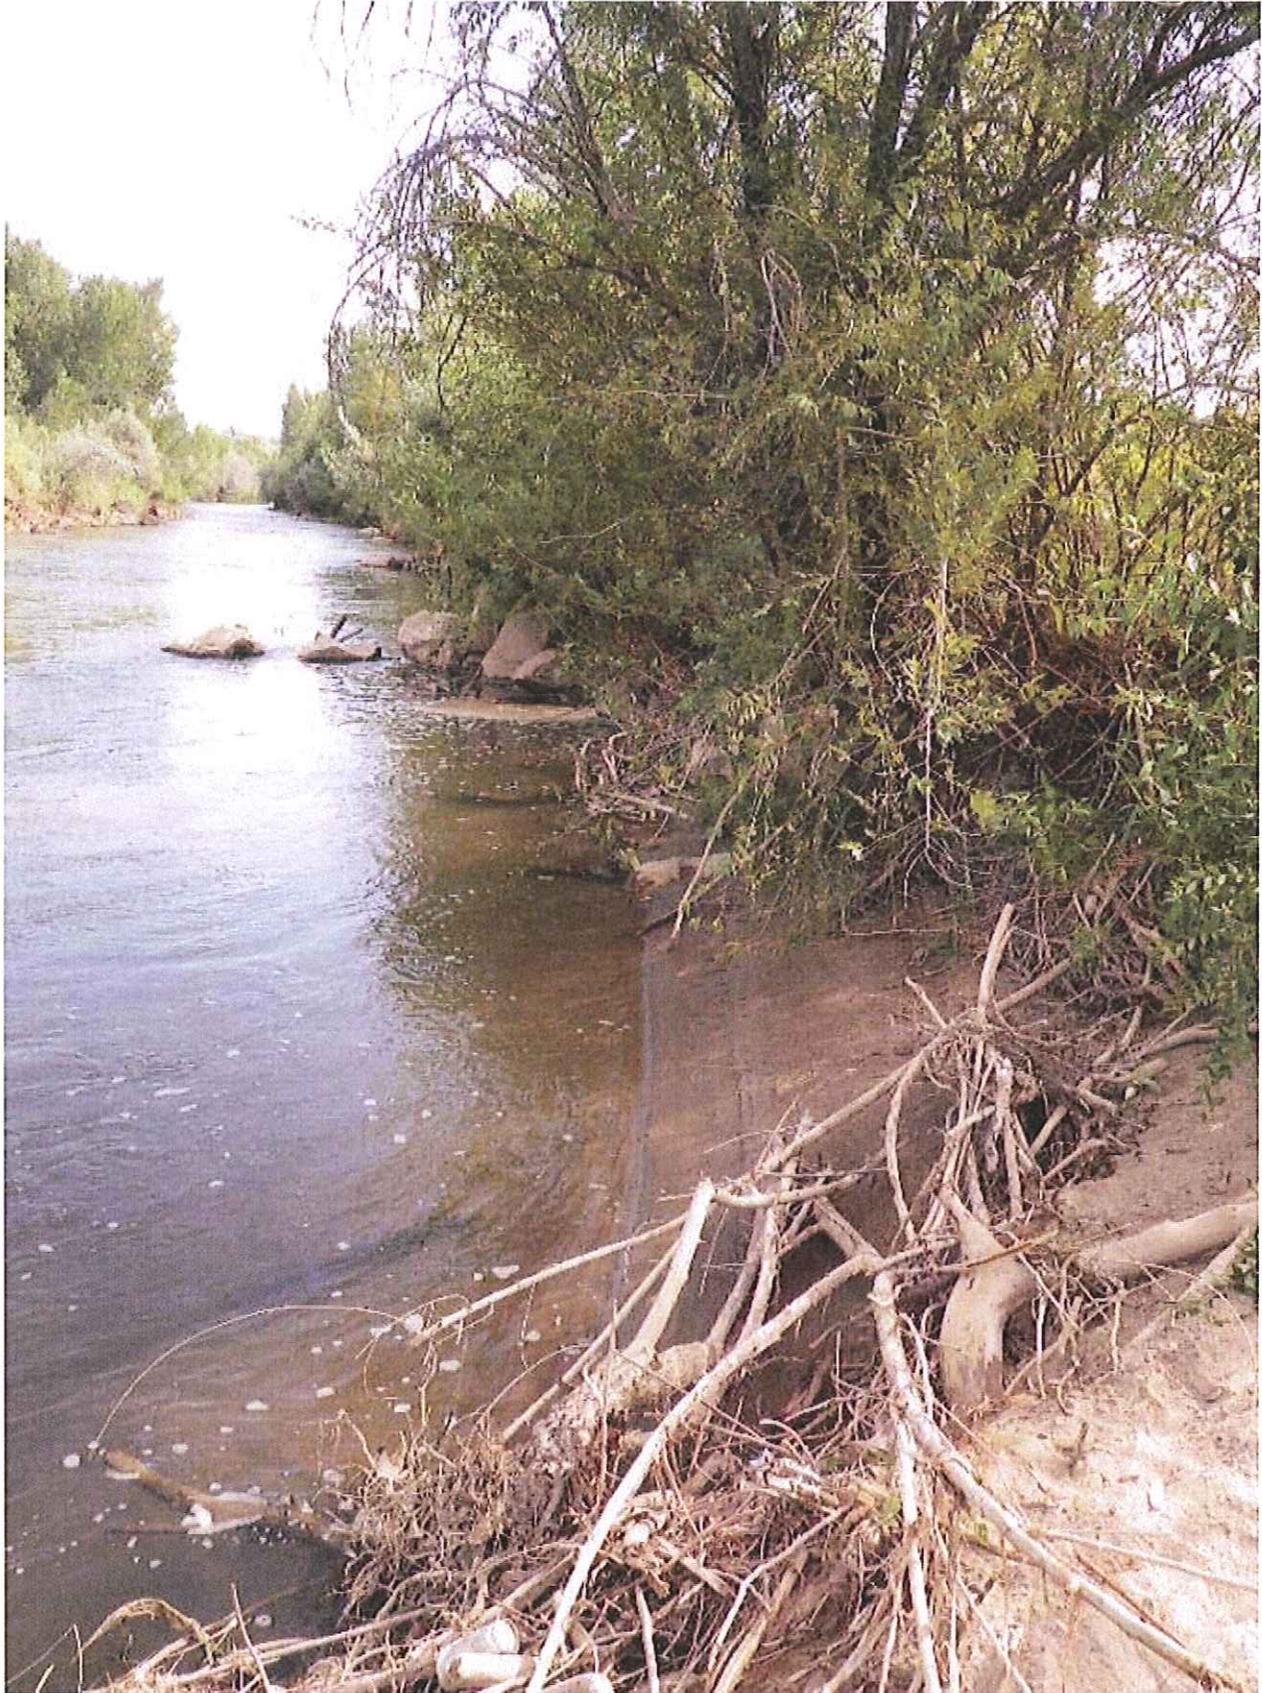
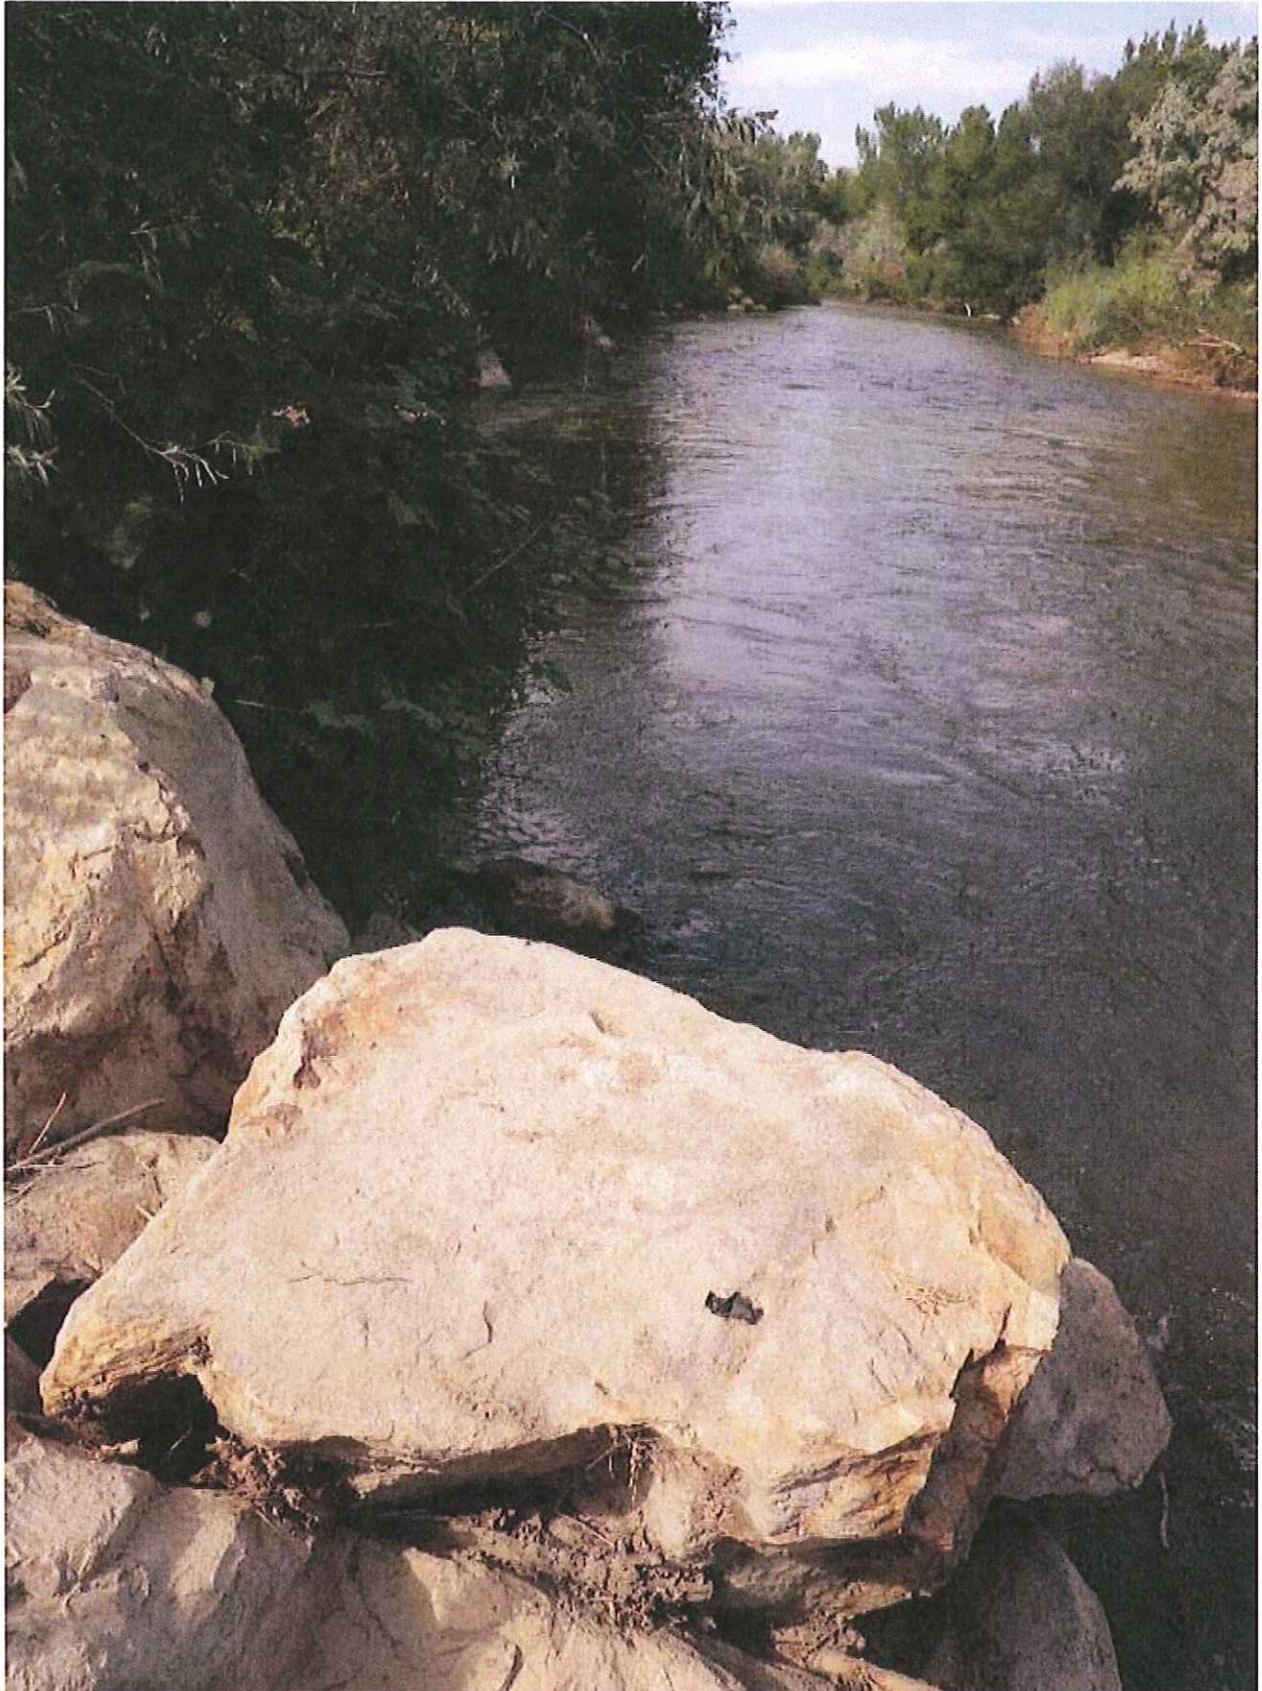
Flood Assessment Point:	#10-Failed Bank Stabilization
GPS Coordinates:	8-16-11 Points 46
Direction to Assessment Point:	This specific location is at the Junction of the Hunter Creek Trail and the Weber Parkway See also Failed J-Hooks Point 50 (8-16-11)
Project Priority:	High Moderate Low X
Description of Damage:	Non systemically planned constructed J-hooks and localized erosion
Structures:	J-hooks, Path
Geomorphic Description:	Similar to other location along the Weber River, these structure were placed to prevent bank erosion and the subsequent migration of the river channel. Installed in the 1980s or early 1990, these structures may have been intended to reduce shear stress on the bank by forcing the flow towards the centerline of the channel. Many of these structures were designed without consideration of systemic response. Other stabilization methods may be more appropriate for this location

Habitat Considerations:	j-hooks cause erosion which contributes to non-point source sediment pollution.
Flood Damage Repair:	<ul style="list-style-type: none"> • \$20,000-\$40,000
Measures:	<ul style="list-style-type: none"> • Option 1 (Flood Damage Replacement Project) <ul style="list-style-type: none"> ○ Remove J-hook structures ○ Use boulders for toe protection/Stabilization ○ Biostabilize bank ○ Toe Stability ○ \$35,000 - \$64,000
Photographs:	<ul style="list-style-type: none"> • IMGP0203 • IMGP0205 • IMGP0206
