RIVERDALE CITY COUNCIL AGENDA-AMENDED
CIVIC CENTER - 4600 S. WEBER RIVER DR.
TUESDAY – MARCH 6, 2012

Riverdale City 2011 Flood Damage Assessment

October 13, 2011

Prepared For:
Riverdale City, Utah
Public Works department
4600 South Weber River Drive
Riverdale City, Utah 84405

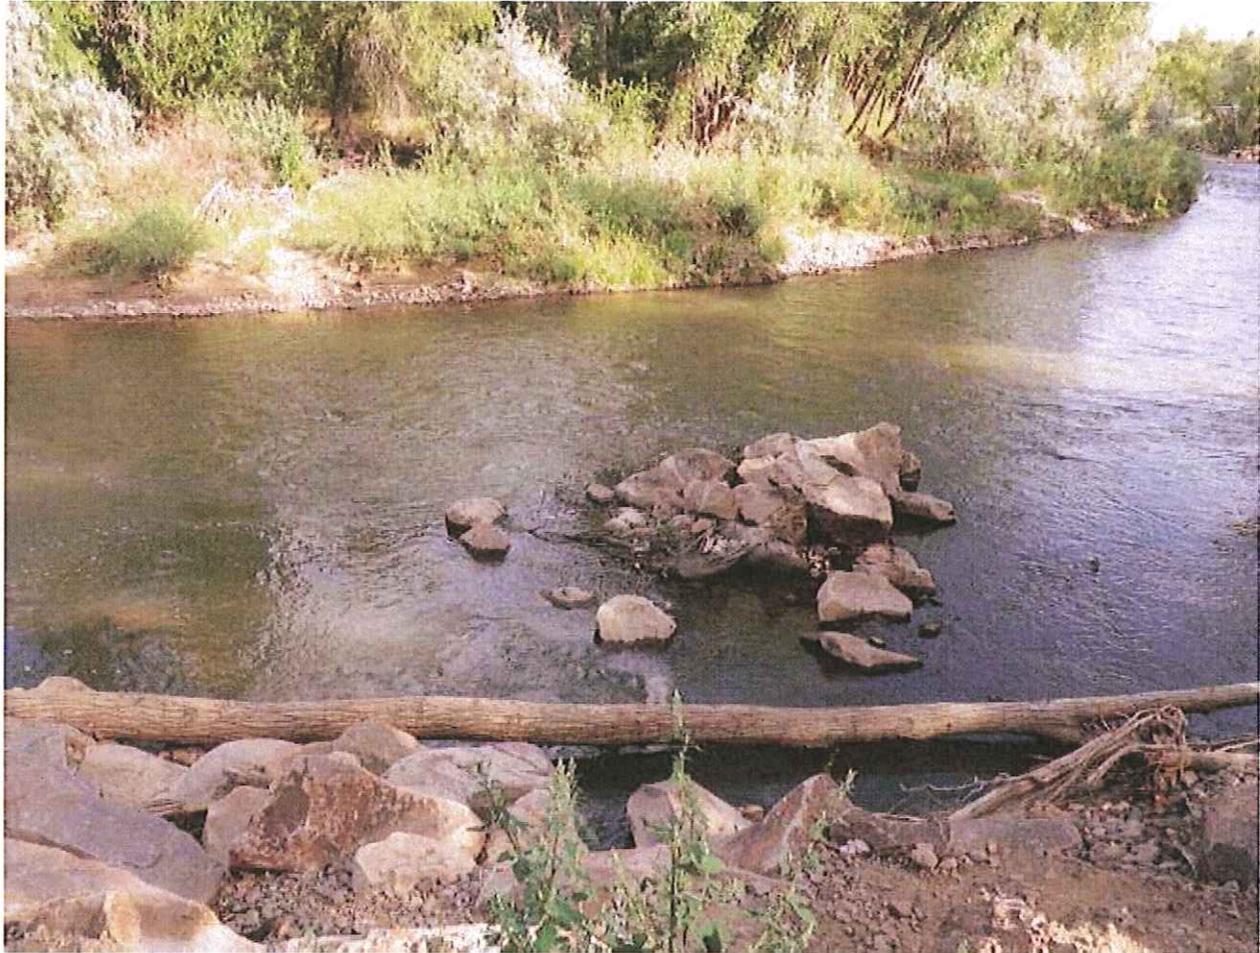
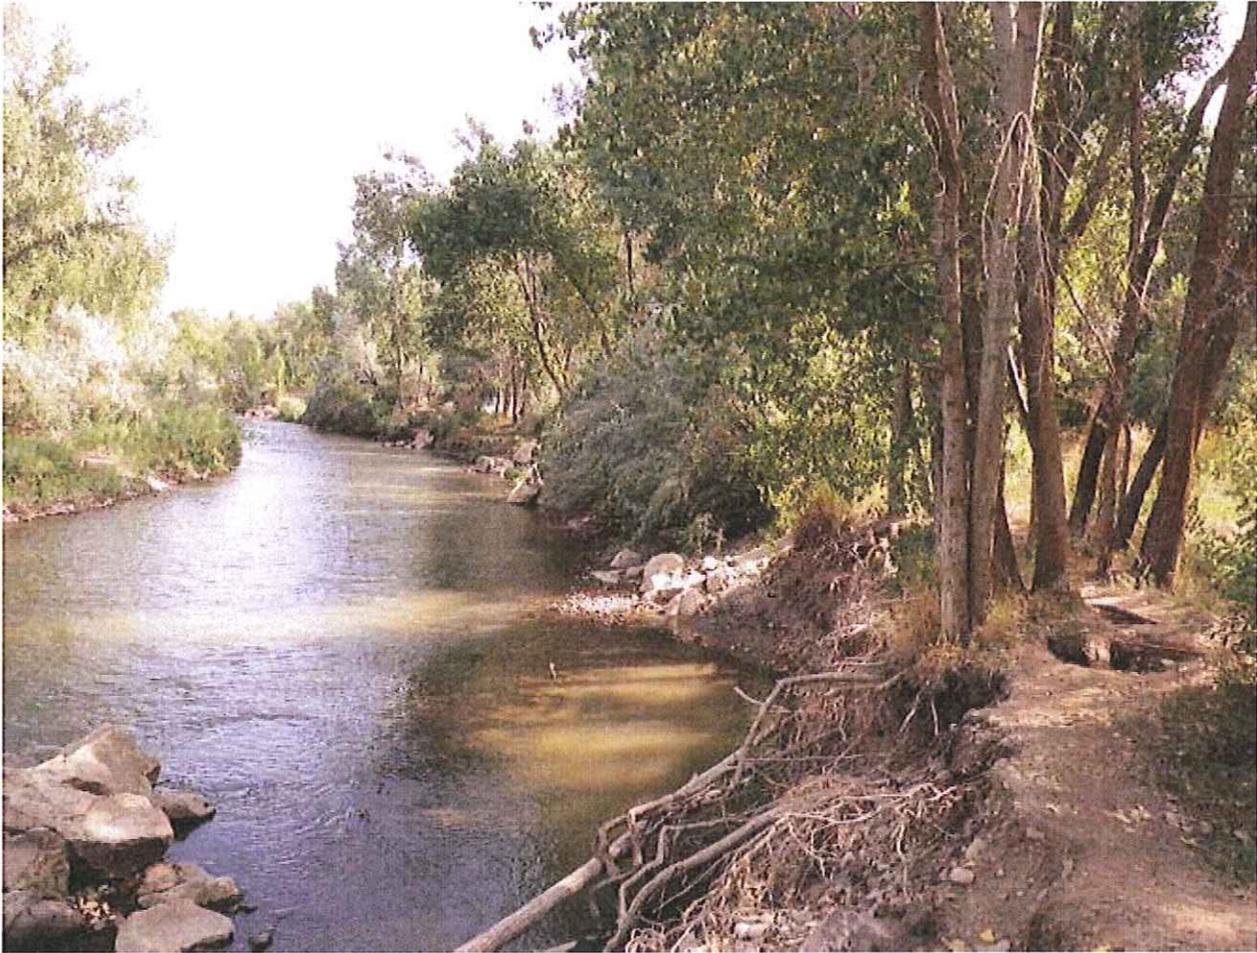
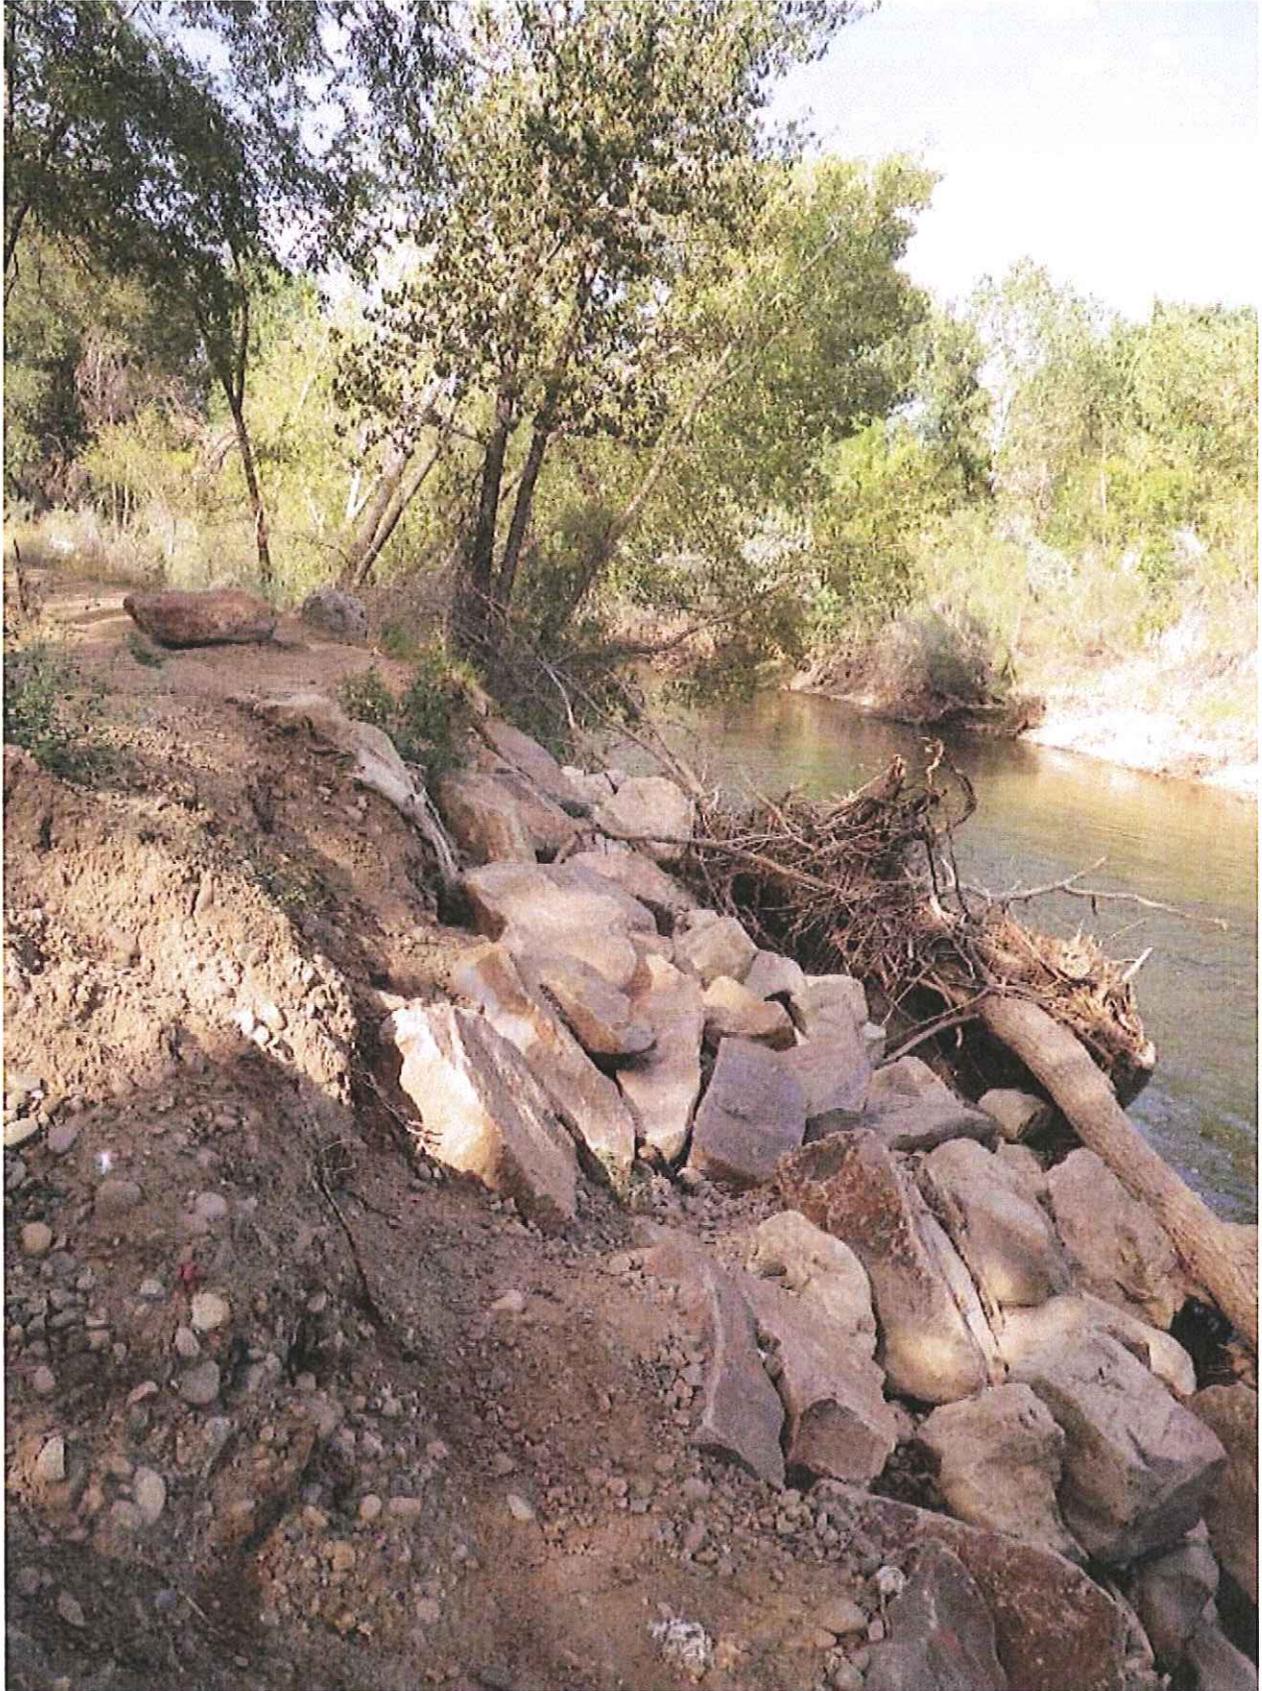
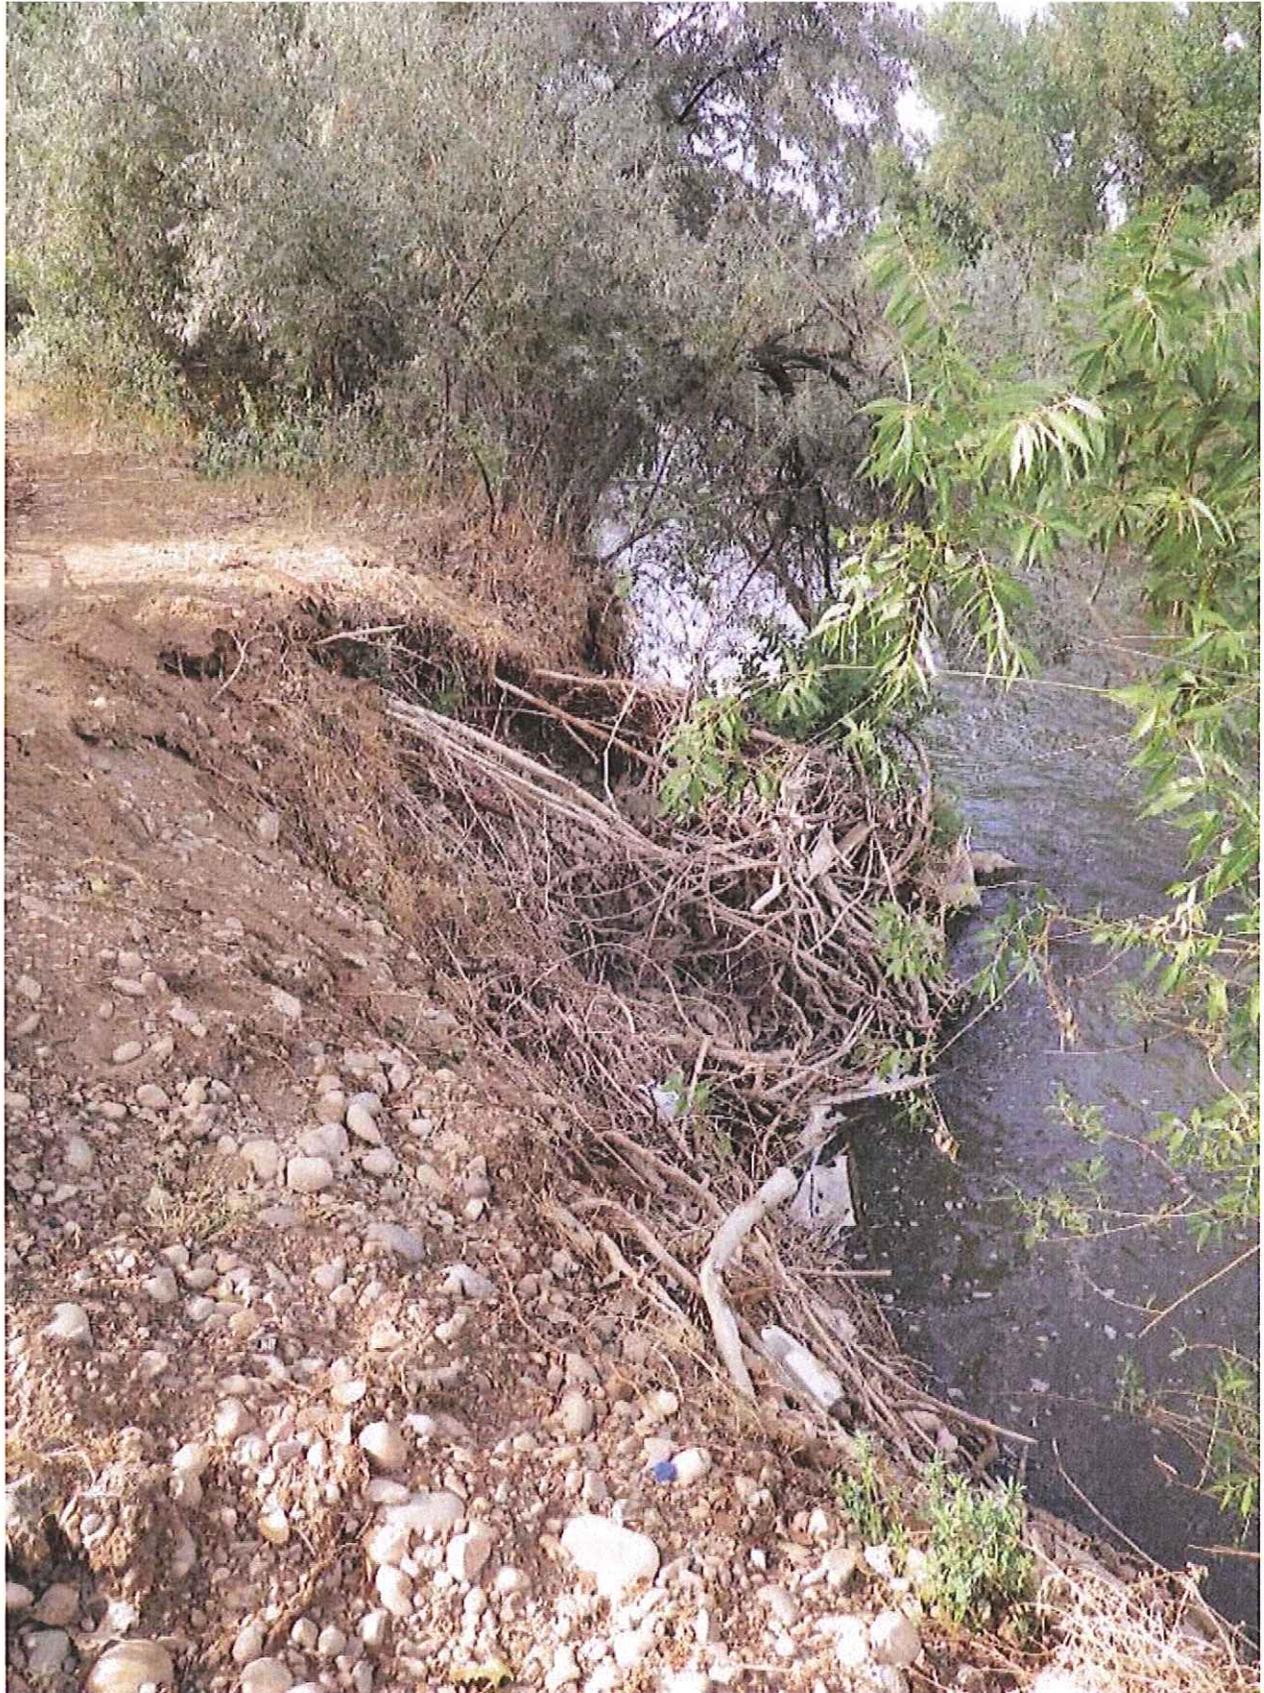
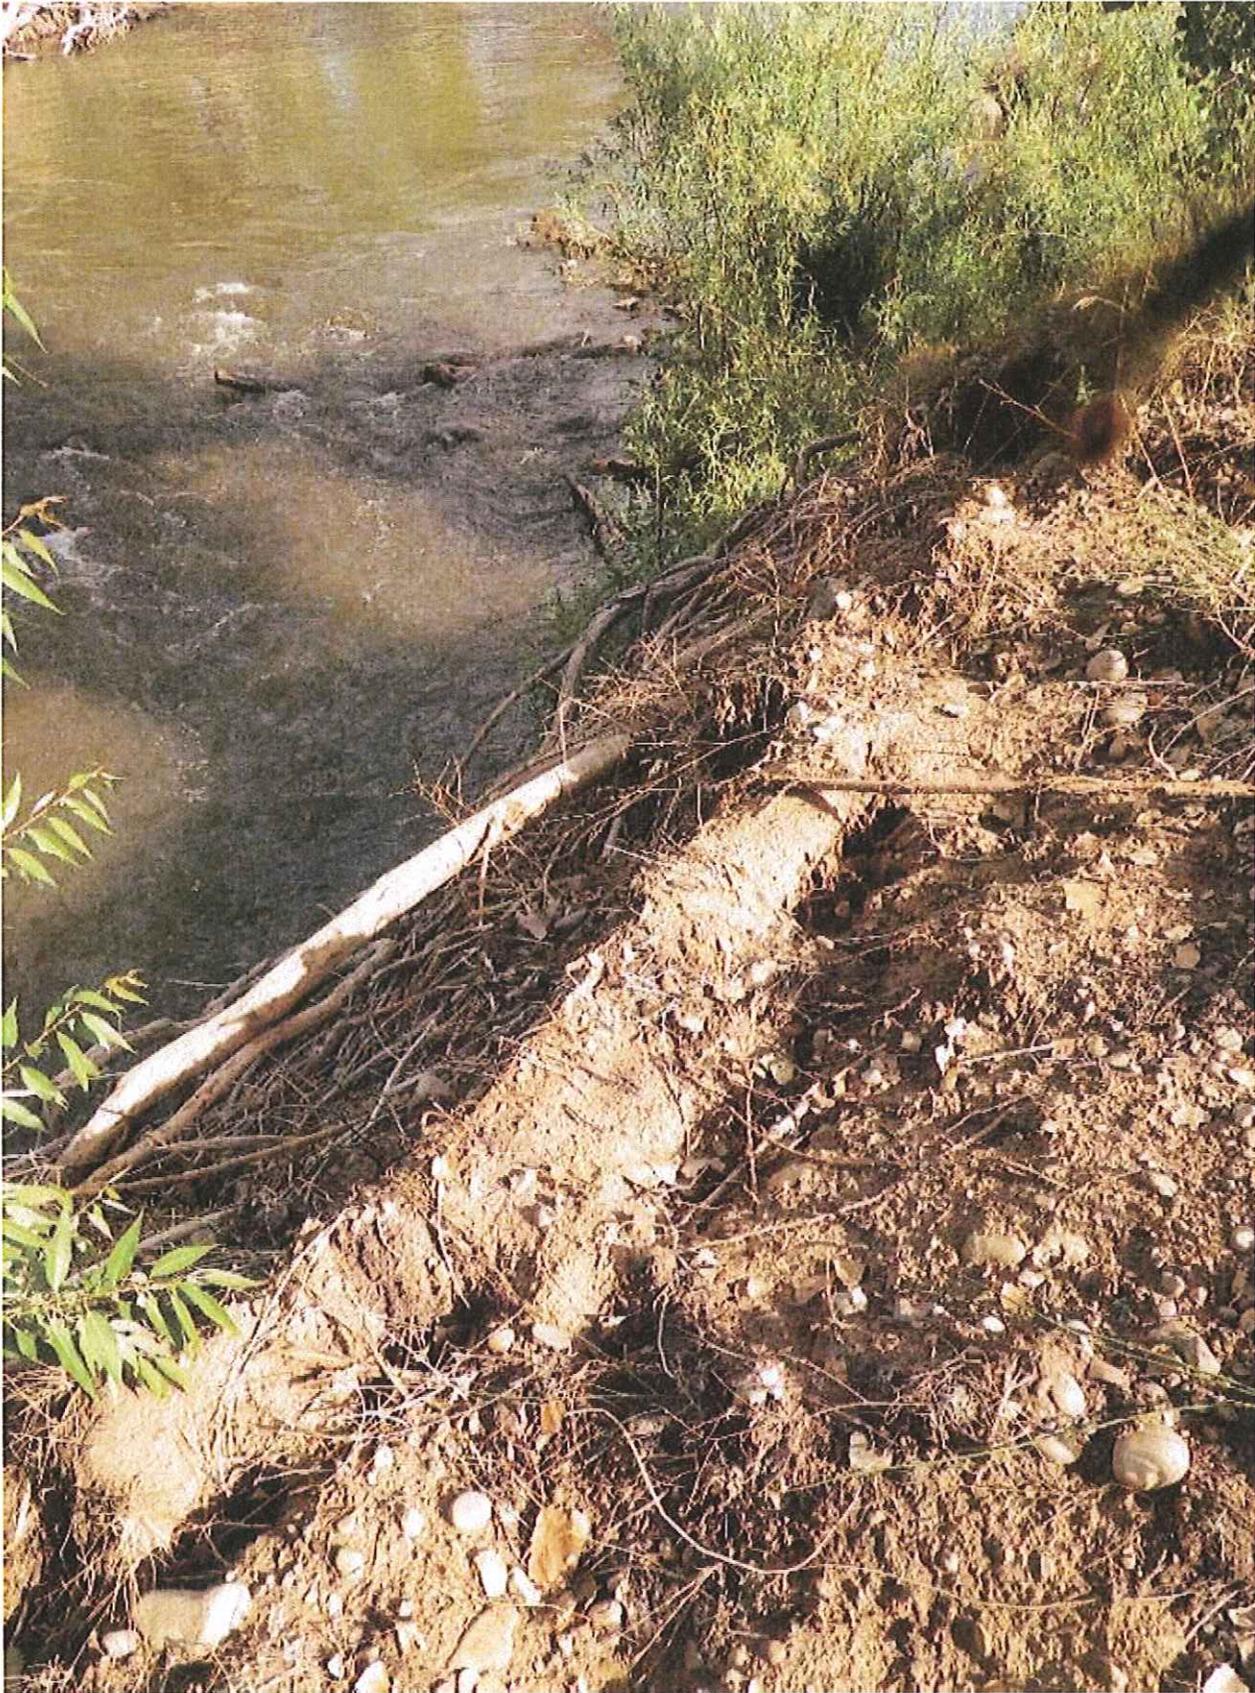
Photographs:	<ul style="list-style-type: none"> • IMG0211

Flood Assessment Point:	#11-Failed Bank Stabilization
GPS Coordinates:	8-16-11 Points 50, 51
Direction to Assessment Point:	Upstream end is approximately 330ft downstream of the Riverdale Kayak Park on the Pathway
Project Priority:	High Moderate Low X
Description of Damage:	Numerous failed J-hook structures, failed rip-rap and eroded banks and resulted bank failure is approximately 700' long and 10' high.
Structures:	Path, Homes, Land
Geomorphic Description:	These structures (rip-rap and J-hooks) were installed in response to the rivers channelized flow path to protect land and the Parkway. The residential areas to the west of this location were constructed in the late 1970s and early 1980s. Aerial photography from the 1950s shows that the location of the River Valley Subdivision was a historic flow path for the Weber River. Prior to the subdivision development the Weber Rivers geomorphically active floodplain was more than 1000ft wide. The historic photos also show a large oxbow flood channel located in the exact location of 4300 S (A.K.A. Oxbow Dr.) and River Valley Dr. Presently the River is constrained to a corridor that is 100 to 150 ft wide.

Habitat Considerations:	Source of non-point source sediment pollution.
Flood Damage Repair	<ul style="list-style-type: none"> • \$100,000-\$200,000
Measures:	<ul style="list-style-type: none"> • Option 1-(Flood Damage Replacement) <ul style="list-style-type: none"> ○ 700 ft of bank stabilization ○ Remove J-Hooks and use boulders for toe protection ○ Import material to protect bank. ○ \$200,000-\$350,000 • Option 2-(Flood Improvement, Improved Project) <ul style="list-style-type: none"> ○ Remove upper bank boulders and riprap and place 150' D.S. to connect left bank levee (100' Long) ○ Improving D.S. flood overflow channel. ○ \$64,000 • Options 3-(Flood Mitigation Project) <ul style="list-style-type: none"> ○ Remove upper bank boulders and riprap and place 150' D.S. to connect left bank levee (100' Long) ○ Improving D.S. flood overflow channel. ○ Realign Bike Path away from River. ○ Biostabilize Left Bank ○ \$85,000-\$120,000

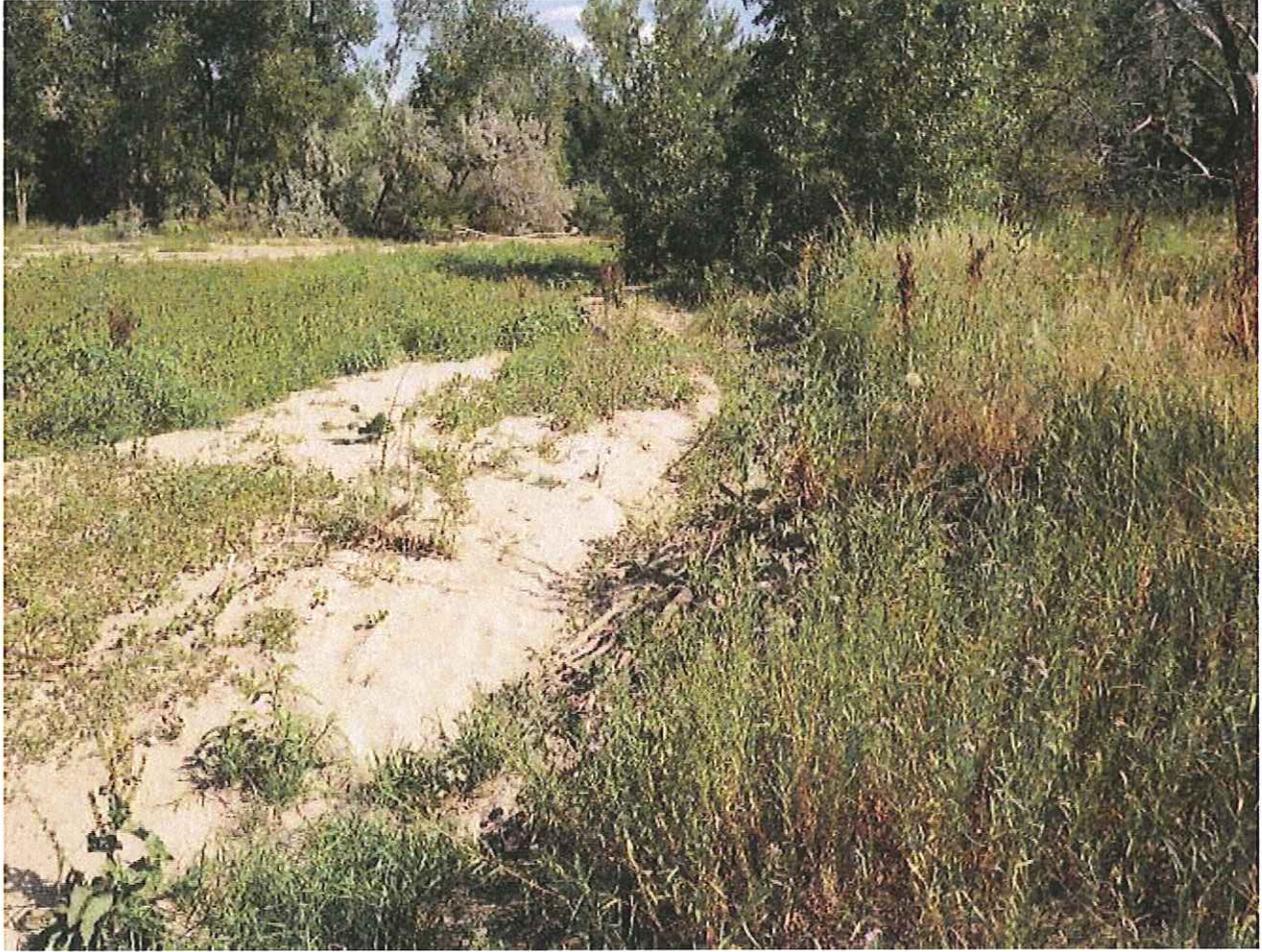
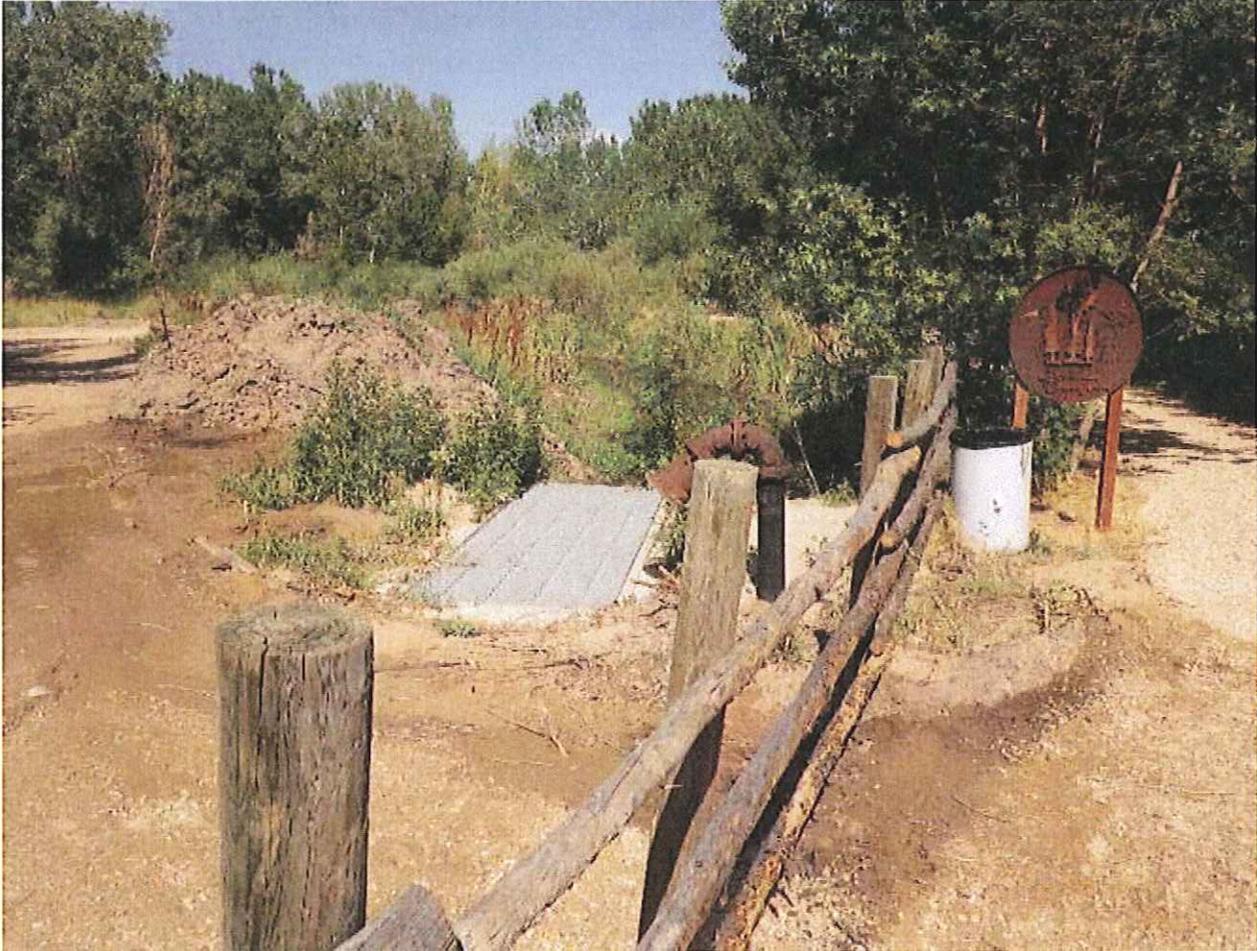
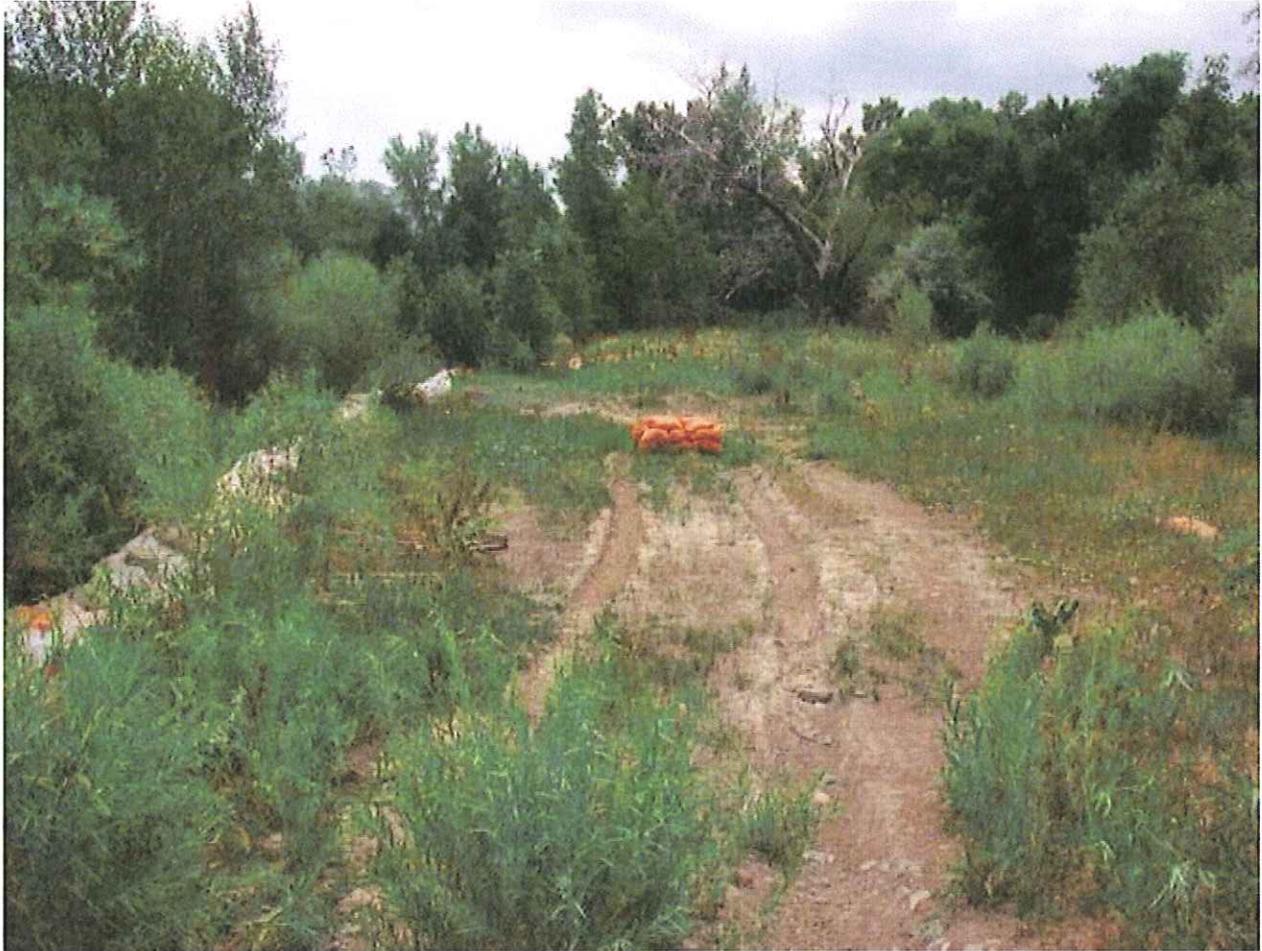
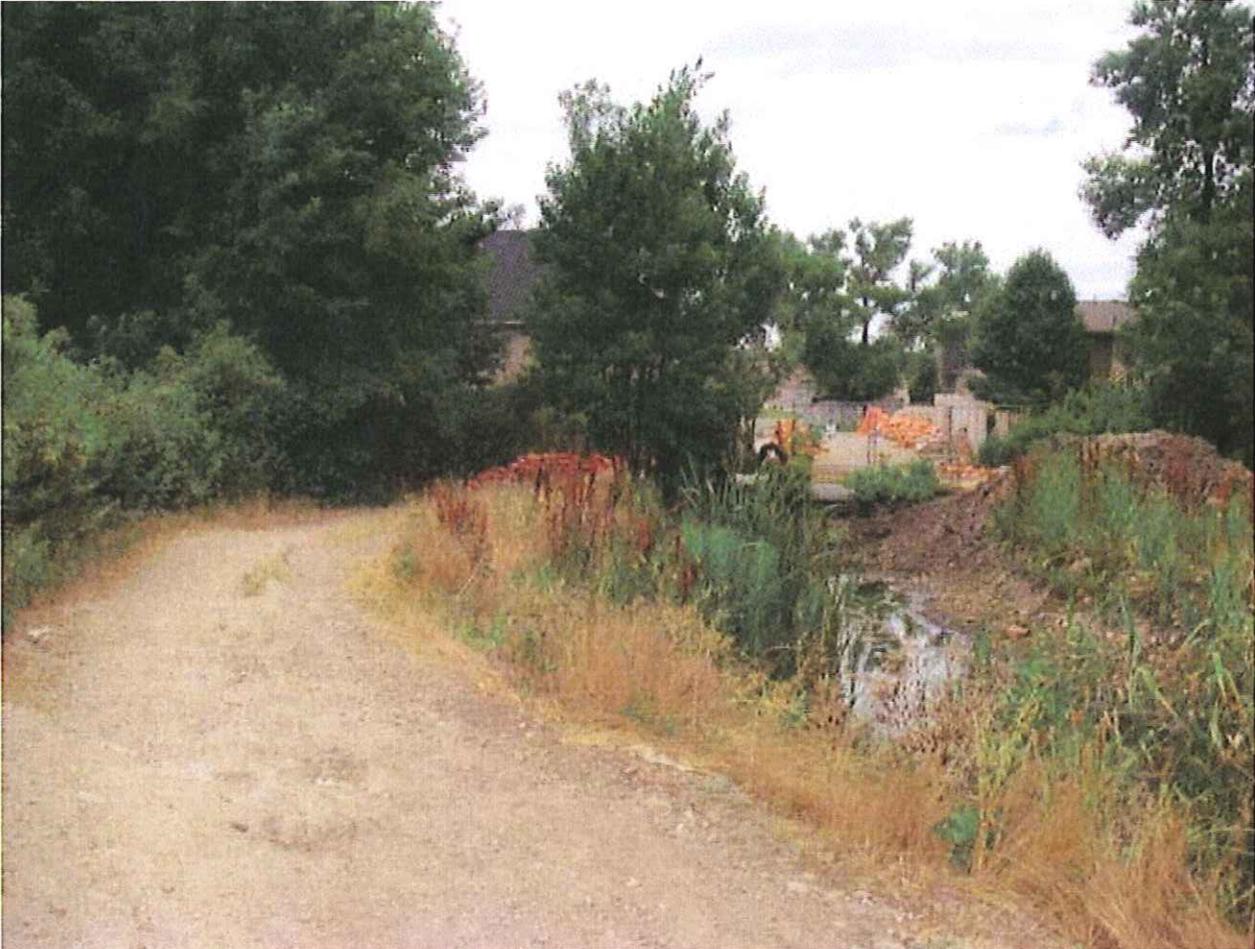
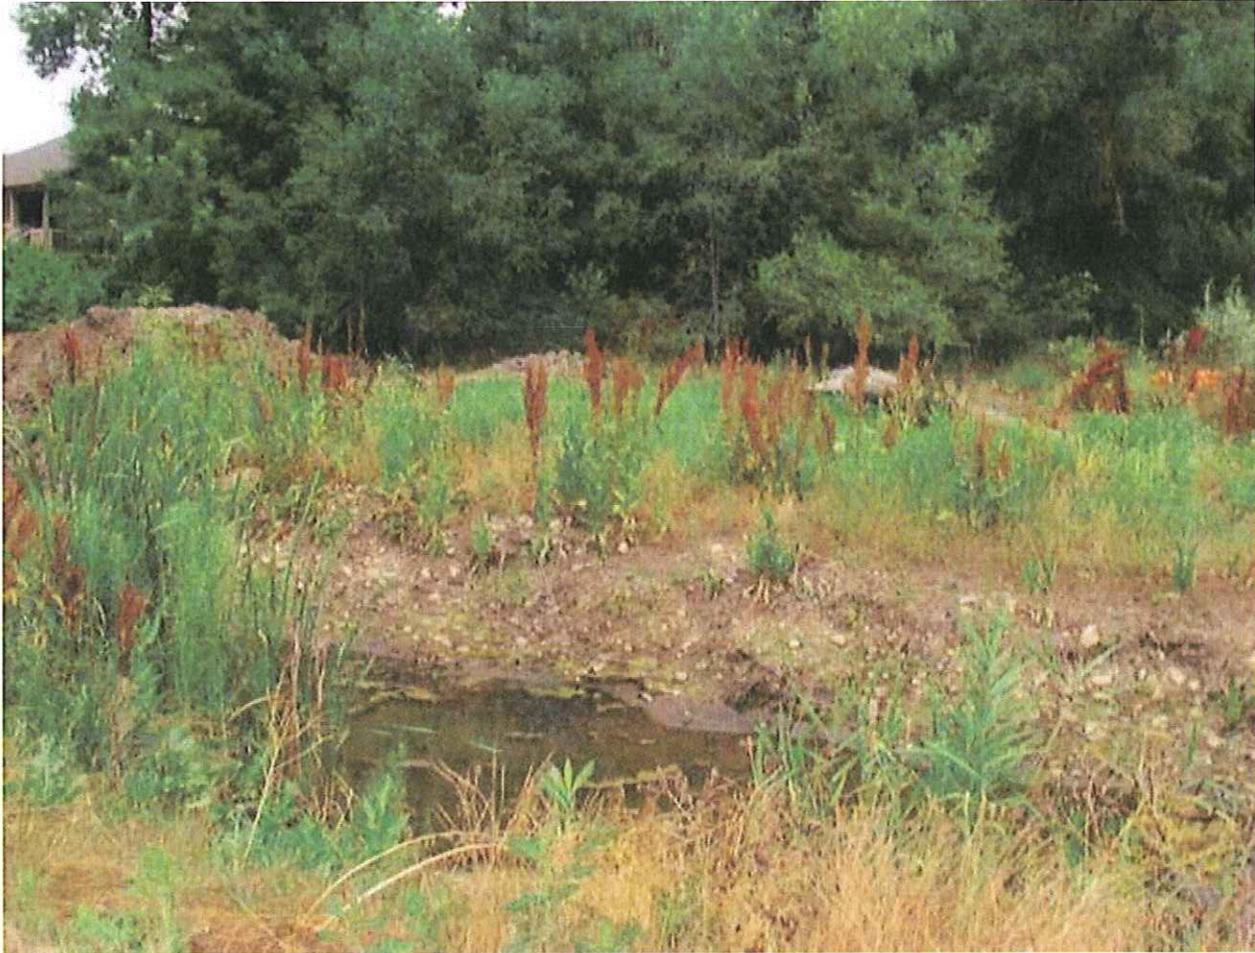
Flood Assessment Point:	#9 & #13-Creekside Trailhead Path Erosion @ River Glen Subdivision
GPS Coordinates:	8-16-11 Point 39, 40, 41, 42
Direction to Assessment Point:	At the junction of the Creekside trail and the Weber River Pathway. Approximately 1000ft on the bike path upstream from north trail head.
Project Priority:	High Moderate Low X
Description of Damage:	The path that leads from the River Bend Subdivision was completely eroded by overbank flooding. This path was reconstructed immediately after the 2011 flood event. 275 ft of split rail fence destroyed, 275 ft path destroyed. There are also issues with the stormwater conveyance at this location. There is a drainage channel that discharges at the west end of the Creekside trail. During high flow events this structure backs up, causing flooding in the River Bend subdivision.
Structures:	Path, Fence, stormwater return channel, homes.
Geomorphic Description:	<p>This portion of the Weber River Floodplain has historically been very active. Historic aerial photos from prior to 1971 show that the active channel of the Weber River flowed through this area. The historic channel passed directly across the junction of the two paths, continued northwest directly through what is now Wildcat Storage and the trailhead facility. The construction of I-15 and Parker Drive has encroached on the active channel at this point, forcing the river east, into its current, channelized location. The river overbanks approximately 500 ft south of the trail junction on the Pathway. FEMA mapping indicates that the trail junction is in ZONE AE and the majority of the Creekside Trail is in the 500 year floodplain. During 2011 runoff this area was inundated by a 10-year flood, indicating that the FEMA information May need updating.</p> <p><u><i>It's important to note that the DFIRM identifies most of this area as 100-year and 500-year floodplain. This was a ten year event; this area should be remapped.</i></u></p> <p>Also we may want to separate this into two damage sites.</p>

Habitat Considerations:	None
Flood Damage Repair:	<ul style="list-style-type: none"> • \$5,000-\$15,000

<p>Measures:</p>	<ul style="list-style-type: none"> • Option 1(Flood Damage Replacement) <ul style="list-style-type: none"> ○ Repair path ○ Repair fence ○ Biostabilize left bank at location of overbank. ○ \$30,000-\$64,000 • Option 2 (Flood Mitigation Project) <ul style="list-style-type: none"> ○ Rebuild path to handle overbank flows ○ Remove fence to facilitate overbank flows ○ Create overbank flow path between Weber Parkway and Riverbend Subdivision ○ Reconstruct Weber Pathway to have boardwalk to allow overbank flows ○ Biostabilze overbank area ○ Construct return flow channel upstream of North trailhead and downstream of trail junction. ○ Build offset levee along property lines ○ Install pump station at trailhead to pump stormwater against floodflow head, discharge downstream in Weber River. ○ \$250,000-\$500,000
<p>Photographs:</p>	<ul style="list-style-type: none"> • IMG0192 Trailhead • IMG0193 Looking upstream flood channel • IMG0195 Bank failure at overbank area • IMG0196 Looking downstream at overbank area, flood flow path.

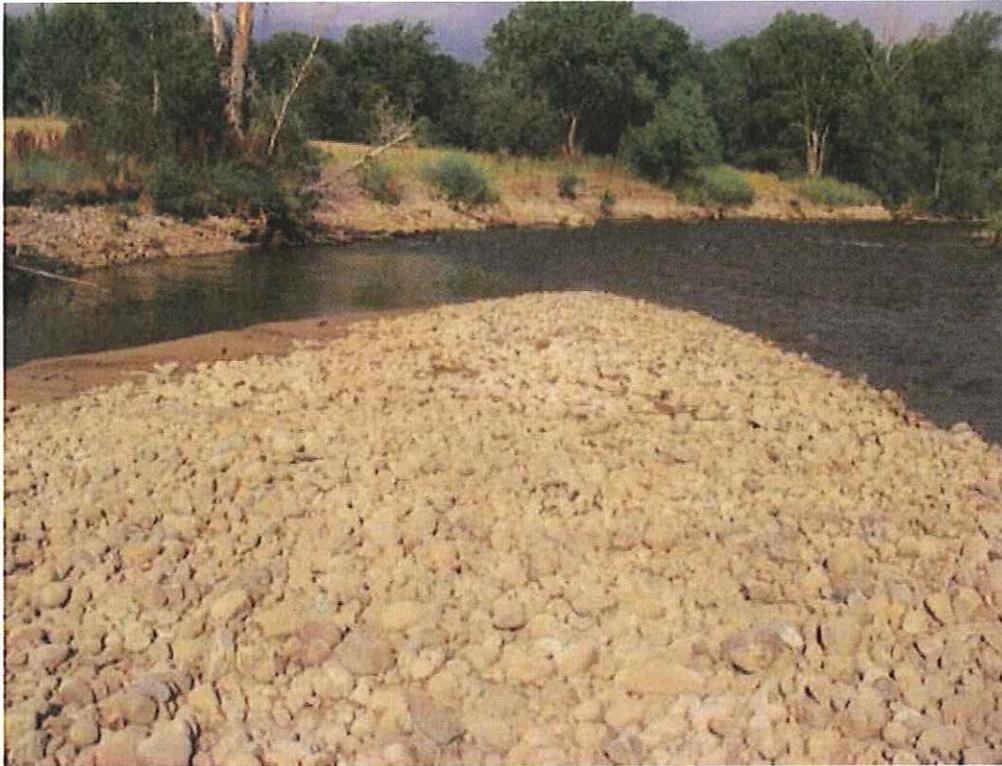
Figure 1-Example of large alluvial deposits upstream of Riverdale City.

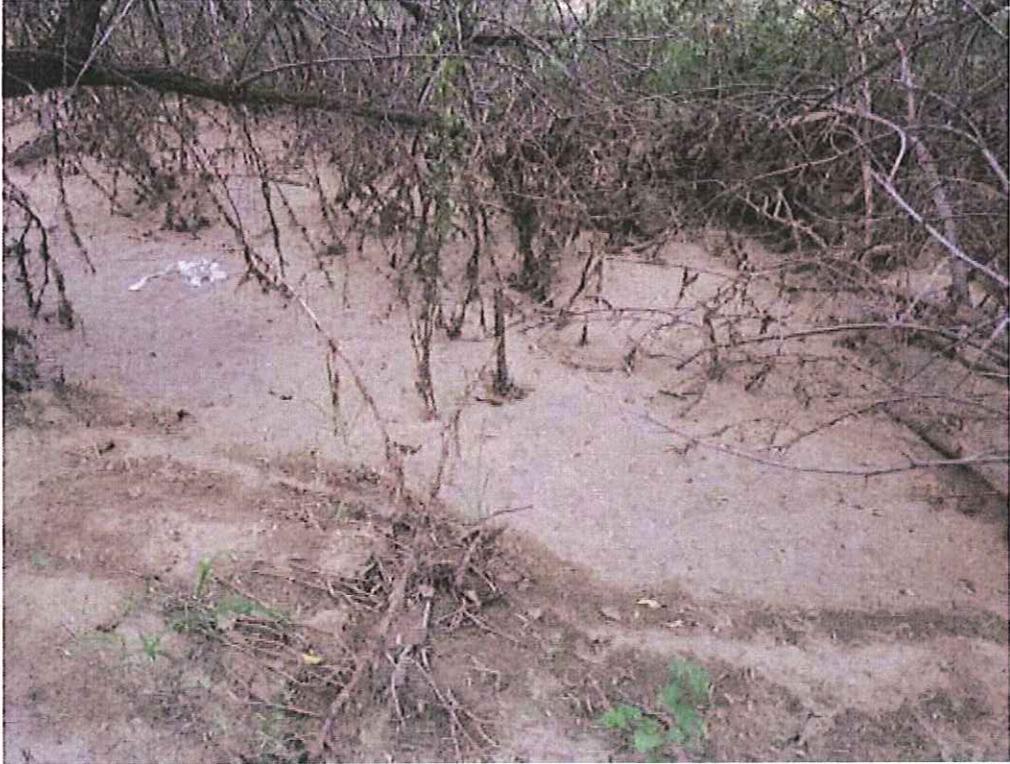
Figure 7-Fine sediment deposition resulting from decreased overbank velocities.

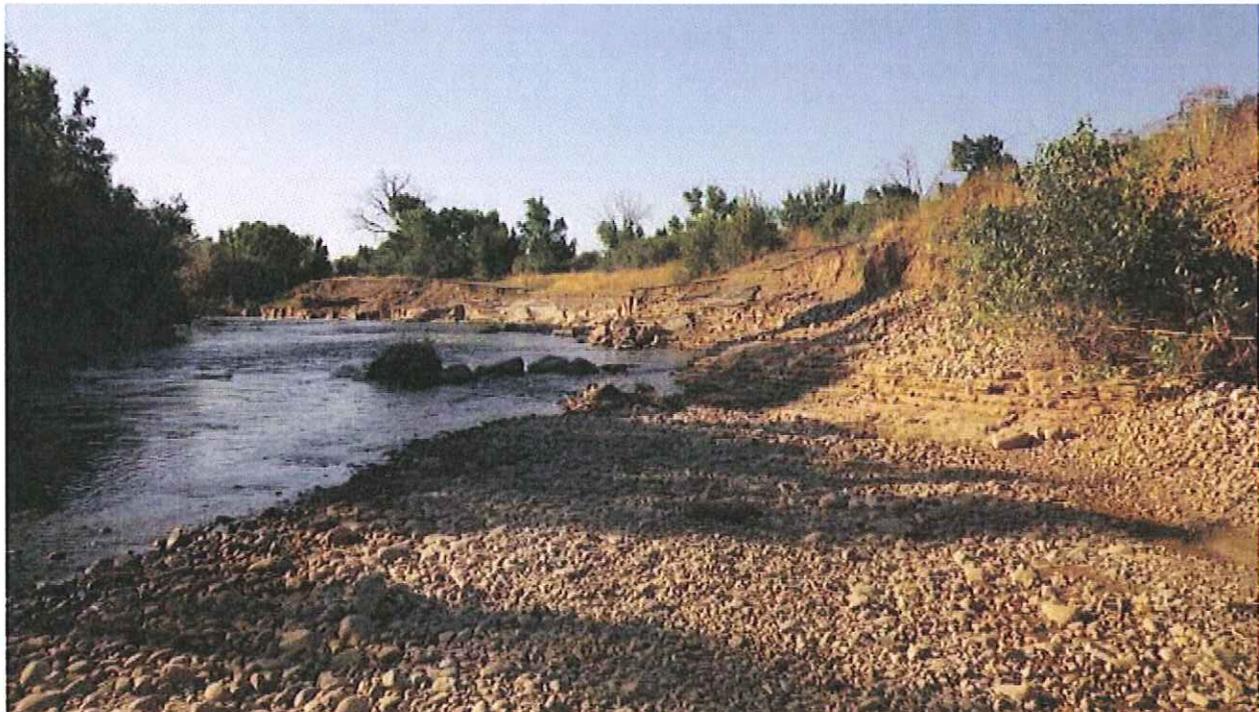
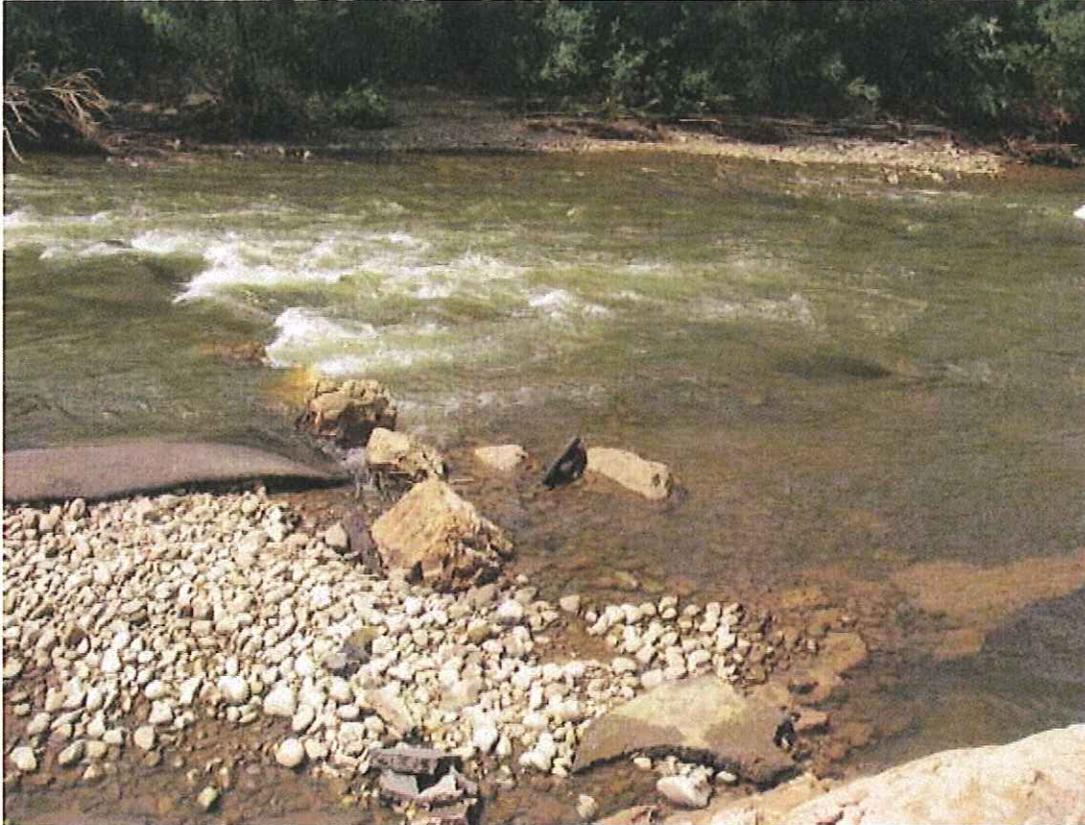
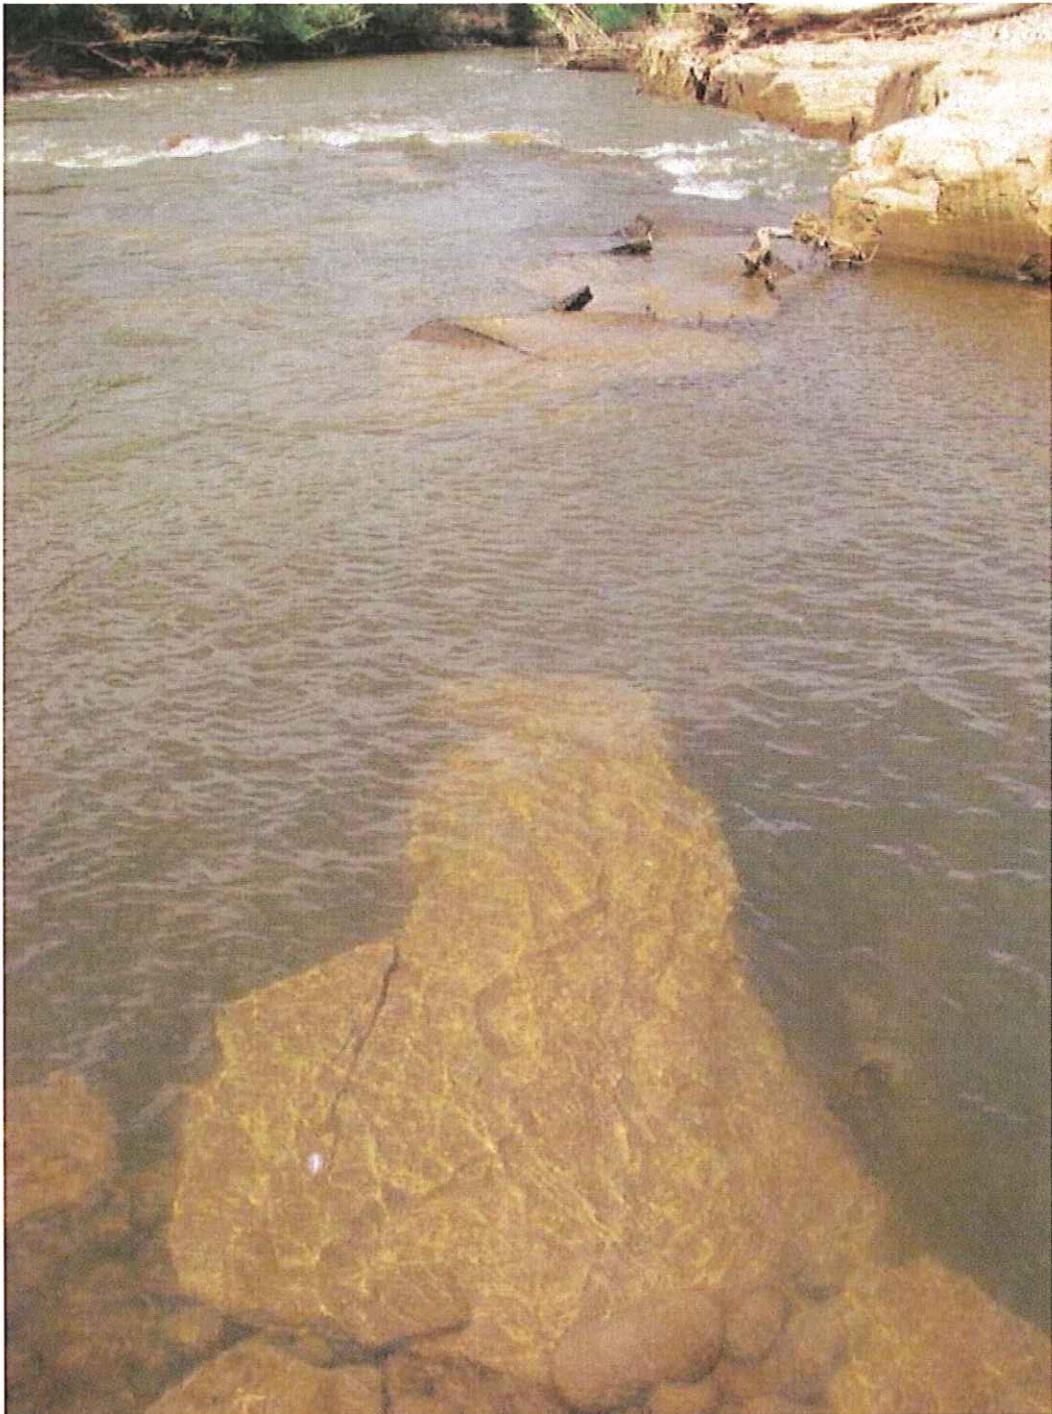
<p>conveyance through this reach. Additionally there is evidence of bank toe erosion throughout this reach, indicating that the river is down cutting. Evidence of overbank flooding at downstream end of bank failure. Large amounts of driftwood caught in overgrown understory may have decreased overbank conveyance.</p>
Habitat Considerations:	<p>Throughout this reach there is a lack of habitat diversity. Channelization has created uniform flow patterns and in portions the riparian vegetation is sparse. There is little evidence of deposition through this reach. Eroded bank material is likely transported through the reach and deposited downstream of Riverdale City.</p>
Flood Damage Repair	<ul style="list-style-type: none"> • \$250,000-\$350,000
Measures:	<ul style="list-style-type: none"> • Option 1 (Flood Damage Improved Project): <ul style="list-style-type: none"> ○ Reconstruct Bike path further northeast. ○ Biostabilize Bank ○ \$50,000-\$100,000 + Lands • Option 2 (Flood Damage Improved Project): <ul style="list-style-type: none"> ○ Reconstruct bike path in new alignment ○ Stabilize Toe ○ Lay river bank back at 3:1 and biostabilize ○ Thin out overgrown riparian vegetation on river left to open up flood conveyance channels. ○ \$200,000 to \$300,000 + Lands
