RIVERDALE CITY COUNCIL AGENDA-AMENDED
CIVIC CENTER - 4600 S. WEBER RIVER DR.
TUESDAY – MARCH 6, 2012

Riverdale City 2011 Flood Damage Assessment

October 13, 2011

Prepared For:
Riverdale City, Utah
Public Works department
4600 South Weber River Drive
Riverdale City, Utah 84405

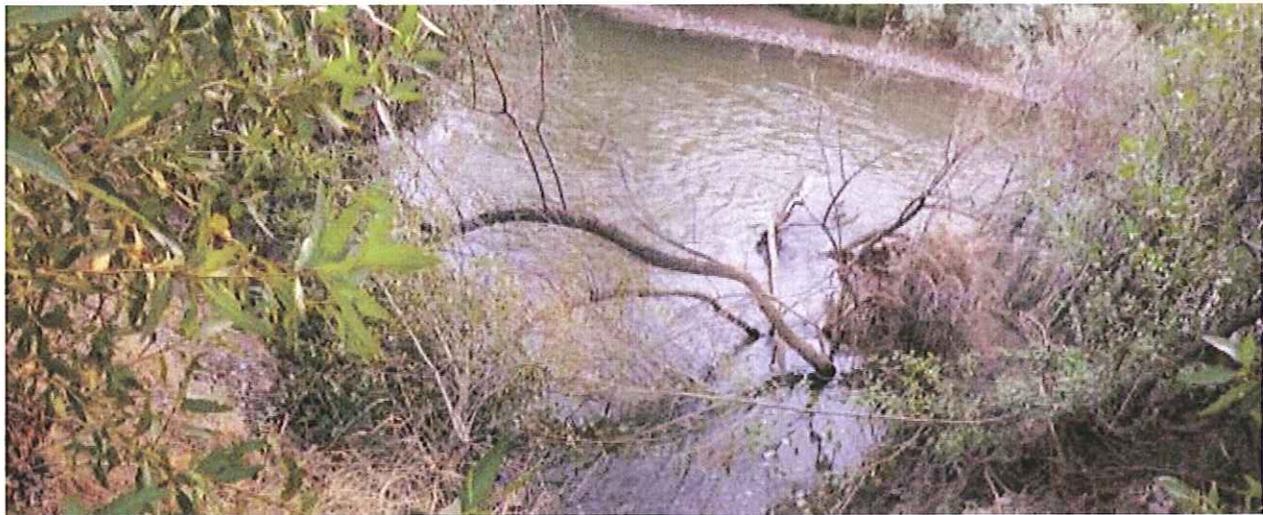
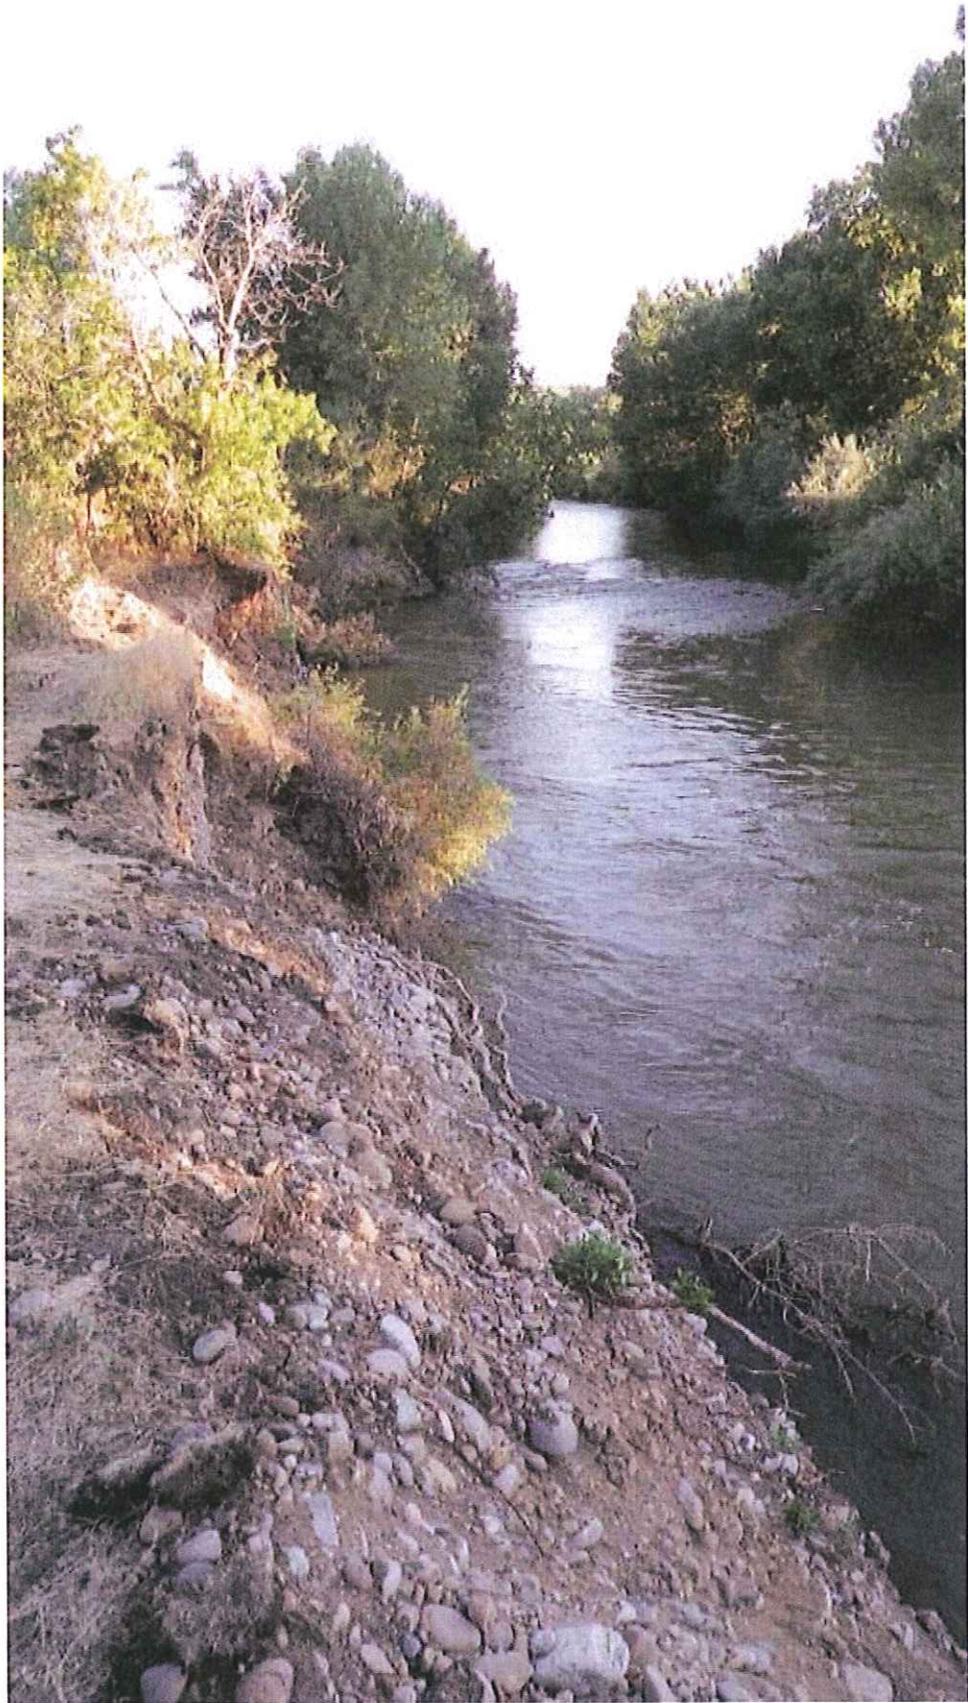
evidence of deposition through this reach. Eroded bank material is likely transported through the reach and deposited downstream of Riverdale City.
Flood Damage Repair	<ul style="list-style-type: none"> • \$30,000-\$64,000
Measures:	<ul style="list-style-type: none"> • Option 1 (Flood Damage Improved Project) <ul style="list-style-type: none"> ○ Lay back right bank ○ Offset Bike path and allow some bank erosion ○ \$50,000-\$100,000
Photographs:	<ul style="list-style-type: none"> • IMG0096 • IMG0098

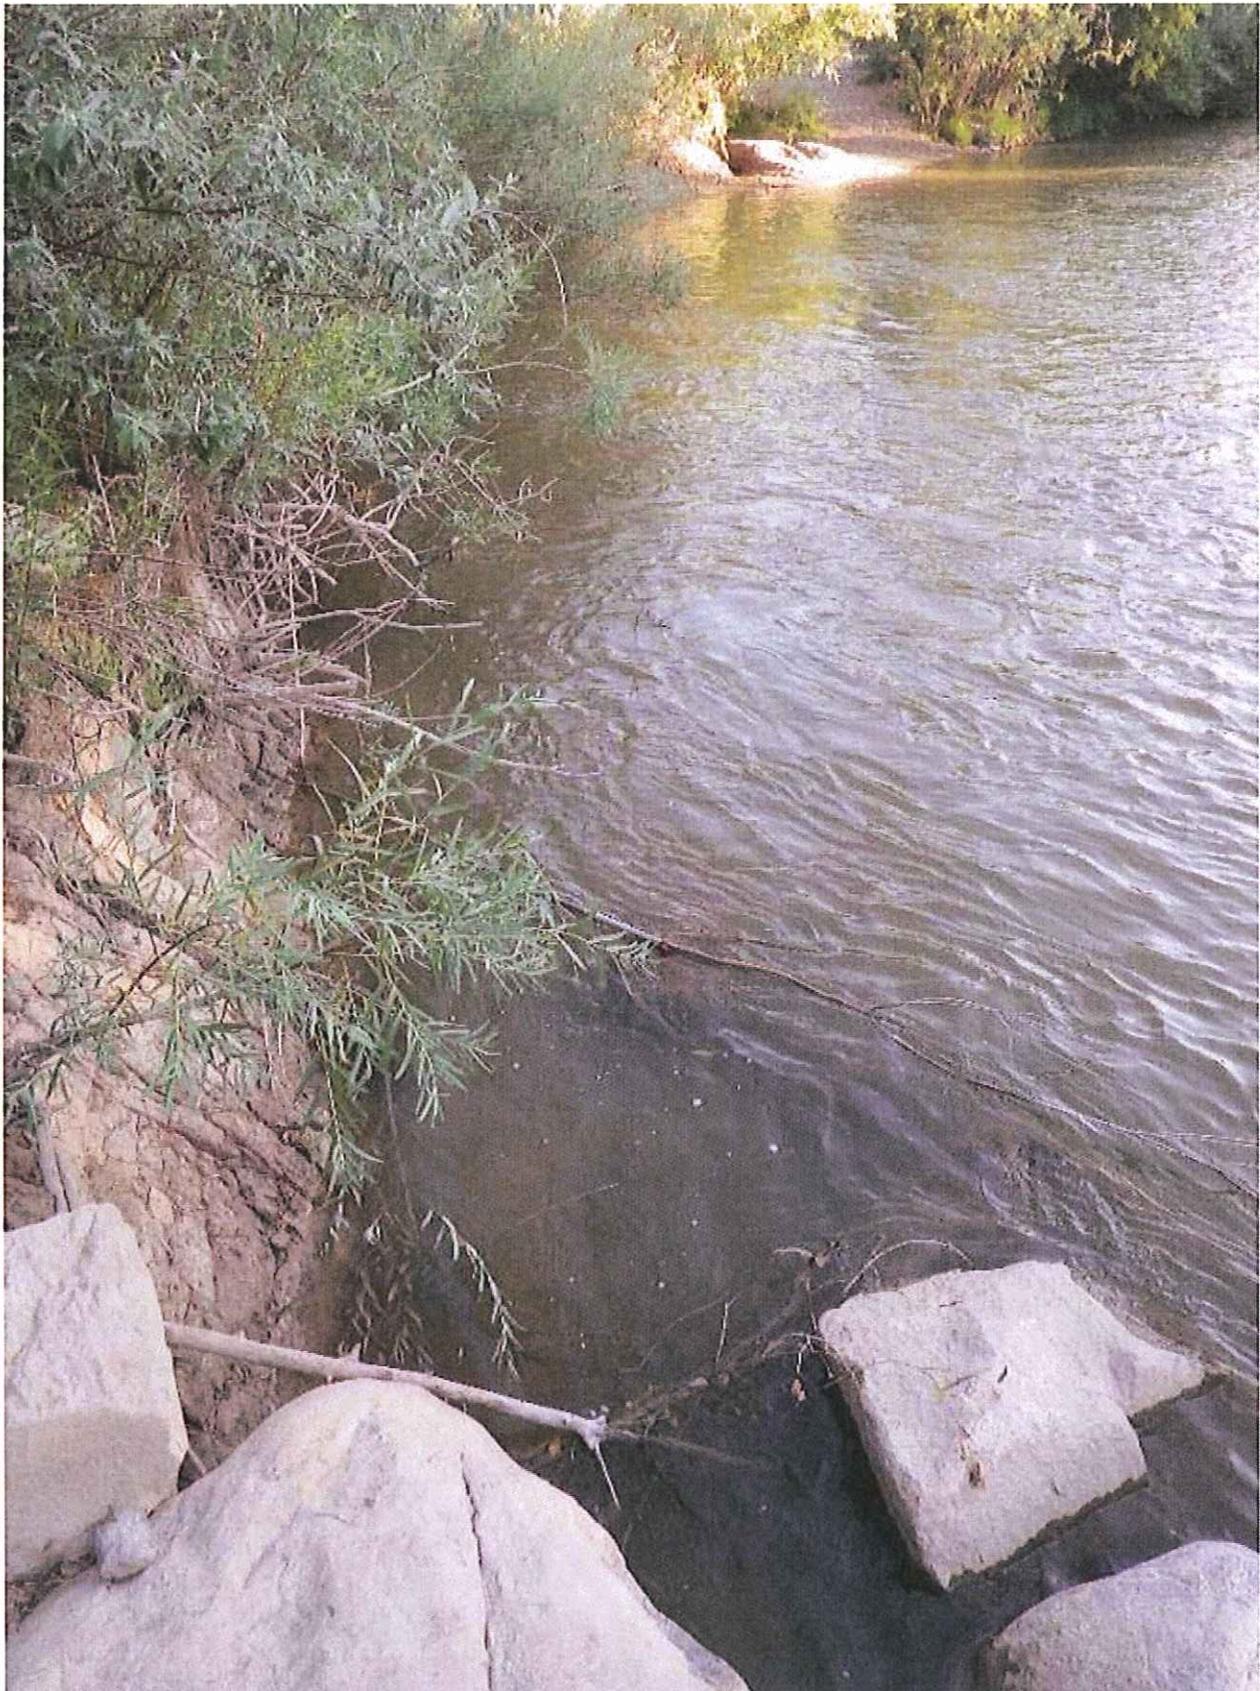
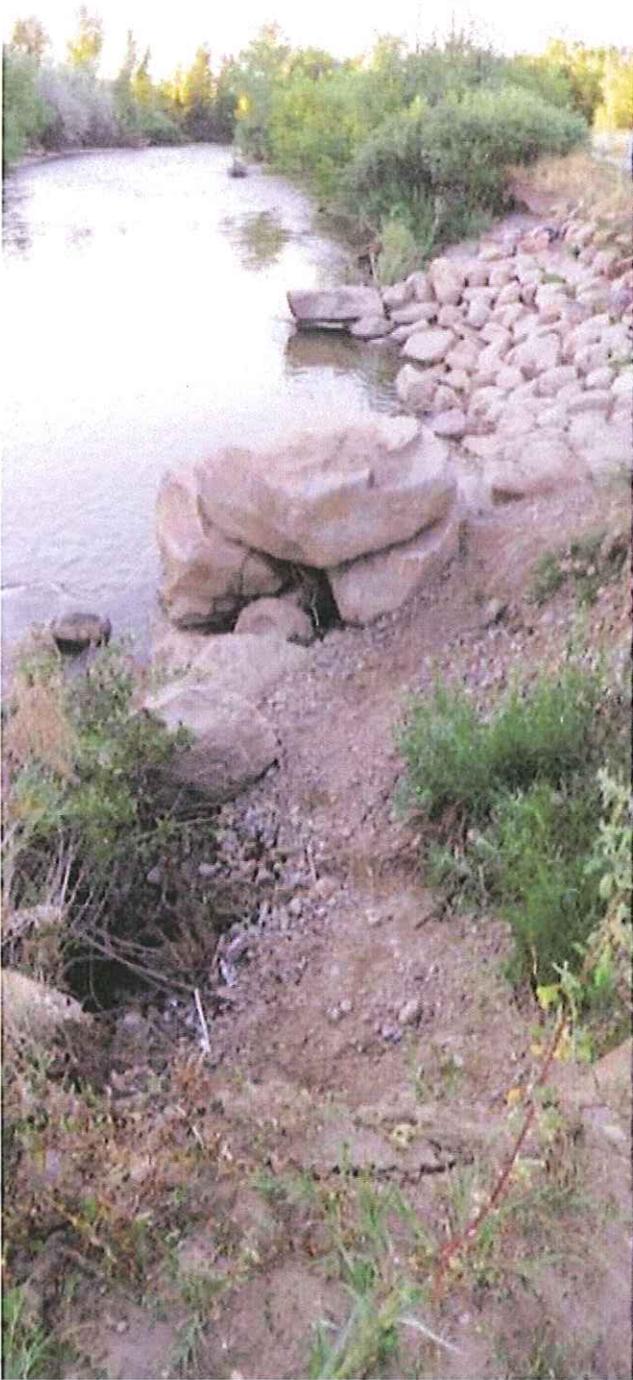
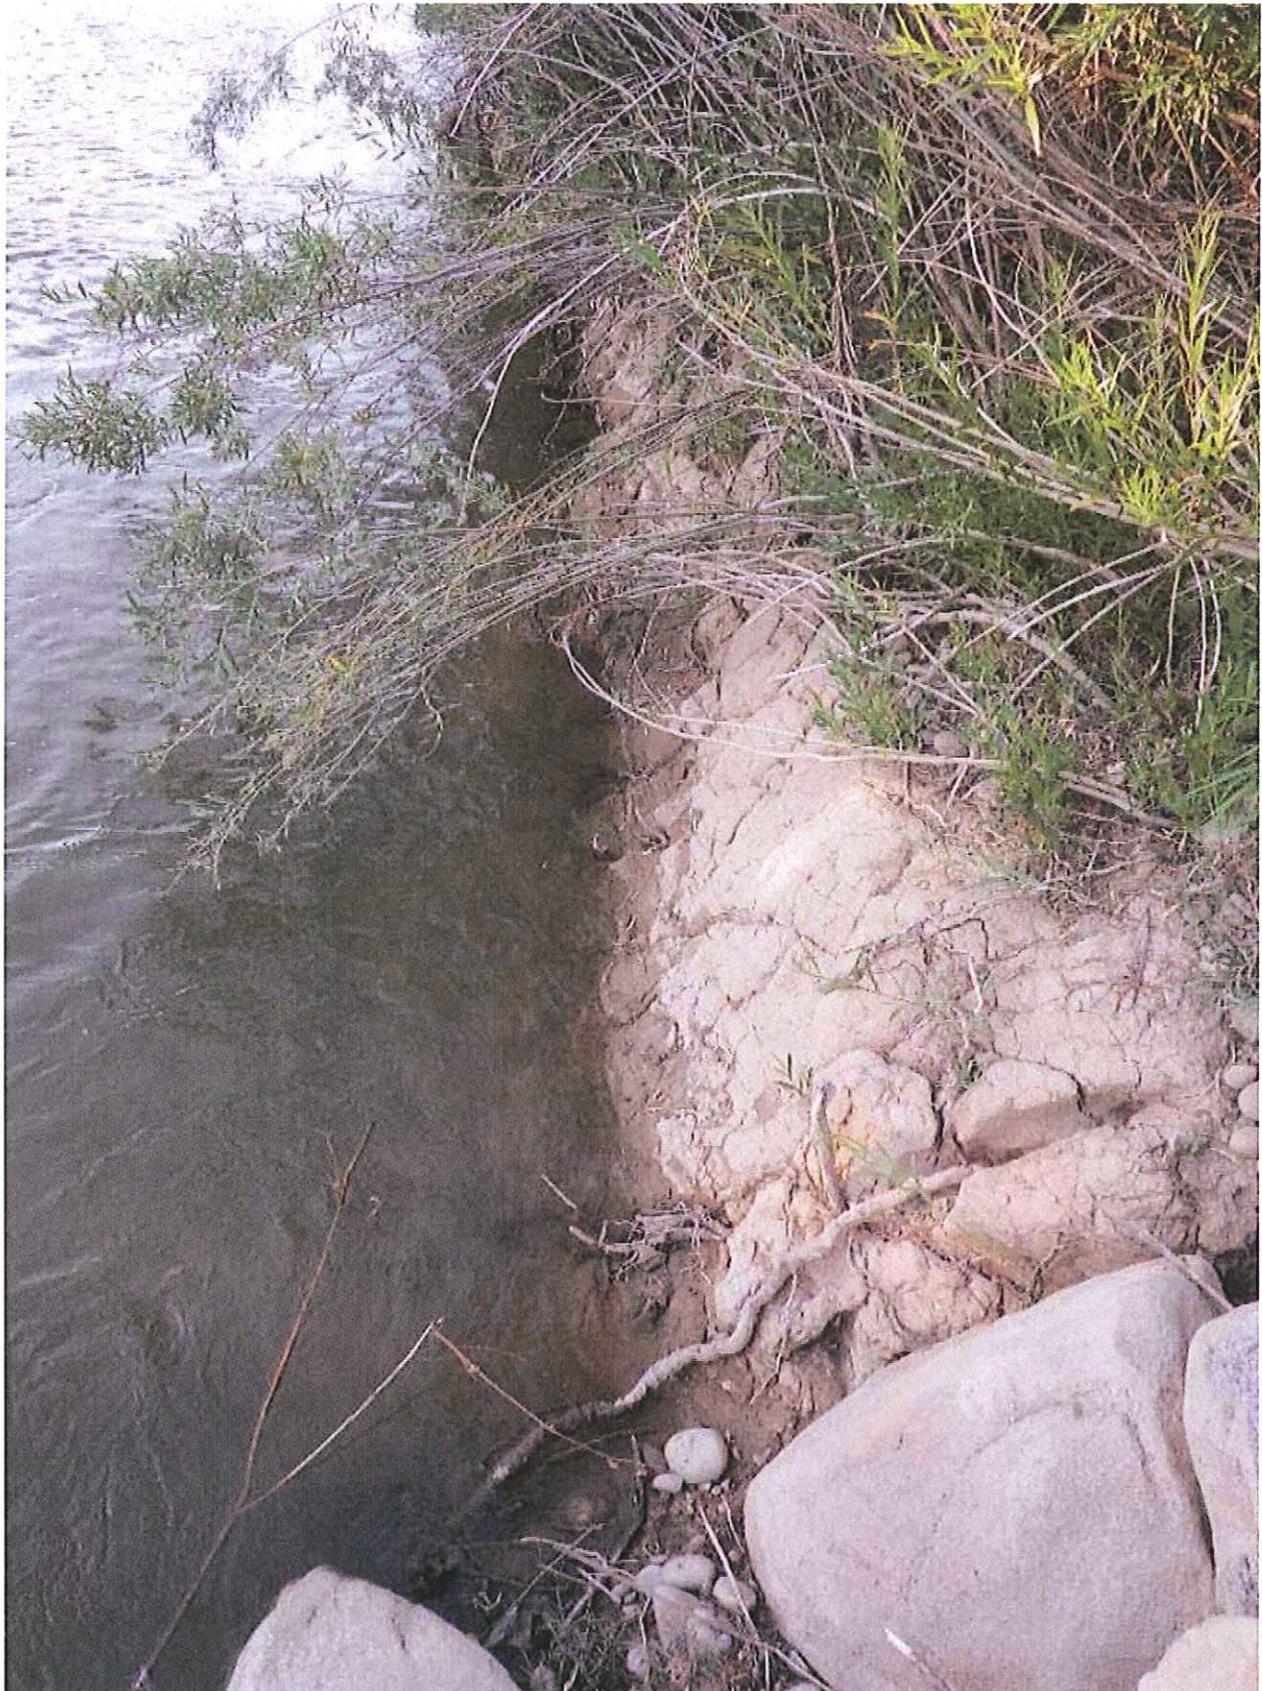
<p>Aerial photographs show evidence of historic flow paths in the floodplains on either side of the current alignment. The open field just to the east of this rip-rap failure appears to contain one of these old river alignments. These alignments are visible because they have differing vegetation and stand out. The difference in vegetation is due to the different soils that the river deposits as it alters its alignment. Often these old channel alignments contain deposits of gravel and small cobbles that are easily mobilized during flood events.</p> <p>Just downstream of this rip-rap failure a mid channel bar has become vegetated, the J-hooks have caused aggradation around this bar decreasing capacity on the right of the vegetated bar. At low flows this mid channel bar becomes connected to the right bank and functions as a large vegetated point bar. A riffle has formed at the head of this point bar, just downstream of the failed riprap. These morphologic changes have altered the local hydraulics and put greater stress on the right bank. Lastly there is less riparian vegetation along this portion of the river. The increased bank stress combined with the adverse hydraulics created by the non systemically planned J-hooks, the lack of bank stabilizing vegetation and the easily erodible channel deposit resulted in the bank failing between 2006 and 2010. The riprap was placed between two of the J-hooks to prevent further damage of the bank. It's likely that while the rip-rap failed it succeeded in preventing further damage to the path. However, the rip-rap installation was not extensive enough to truly address this situation. An engineered riprap design for this location could extend over 300 ft.</p>

<p>Habitat Considerations:</p>	<p>Throughout this reach there is a lack of habitat diversity. Channelization has created uniform flow patterns. There is some evidence of deposition in this reach. Eroded bank material is likely transported through the reach and deposited downstream of Riverdale City.</p>
<p>Flood Damage Repair:</p>	<ul style="list-style-type: none"> • \$25,000-\$50,000
<p>Measures:</p>	<ul style="list-style-type: none"> • Option 1(Flood Damage Replacement Project) <ul style="list-style-type: none"> ○ Move Path to East (City Owned Land) ○ Lay back right bank ○ Bio stabilize right bank. ○ Remove J-hooks. Use as Toe Boulders ○ Place Excess J-hook boulders in River as habitat/squirt boat features. ○ Construct overbank relief channel ○ \$50,000-\$100,000
<p>Photographs:</p>	<ul style="list-style-type: none"> • IMGP0099 • IMGP0221 • IMGP0222

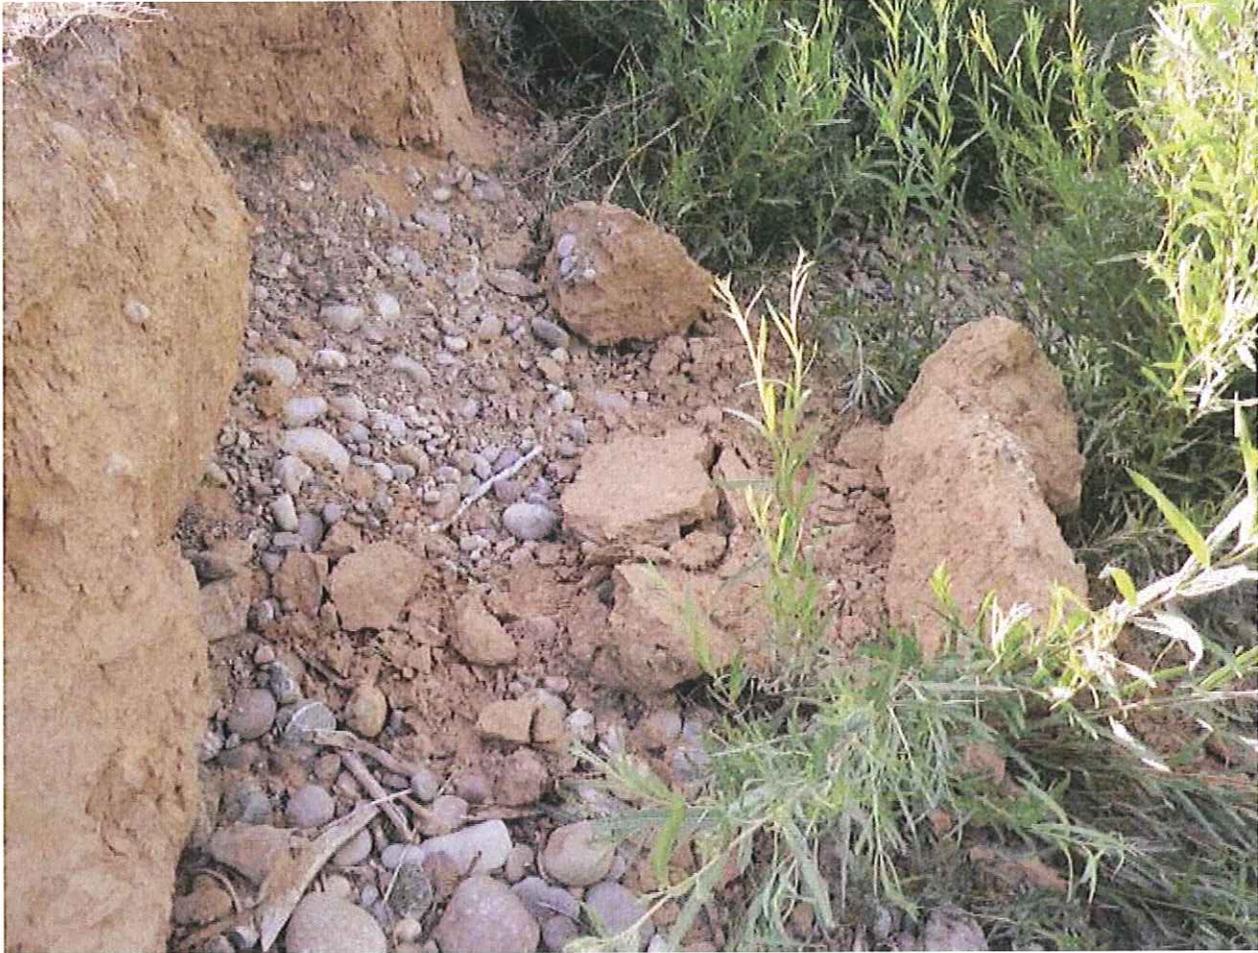
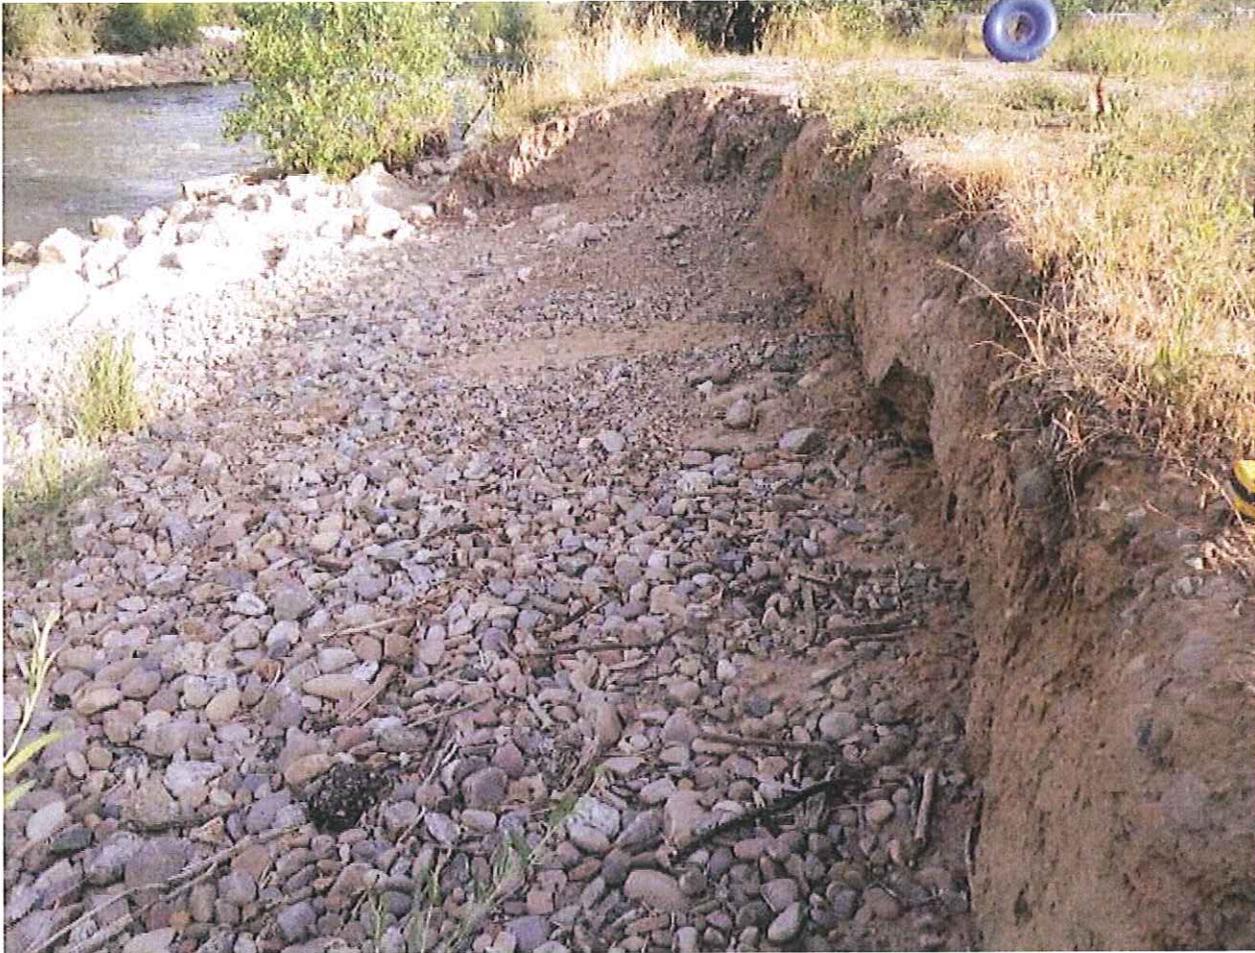
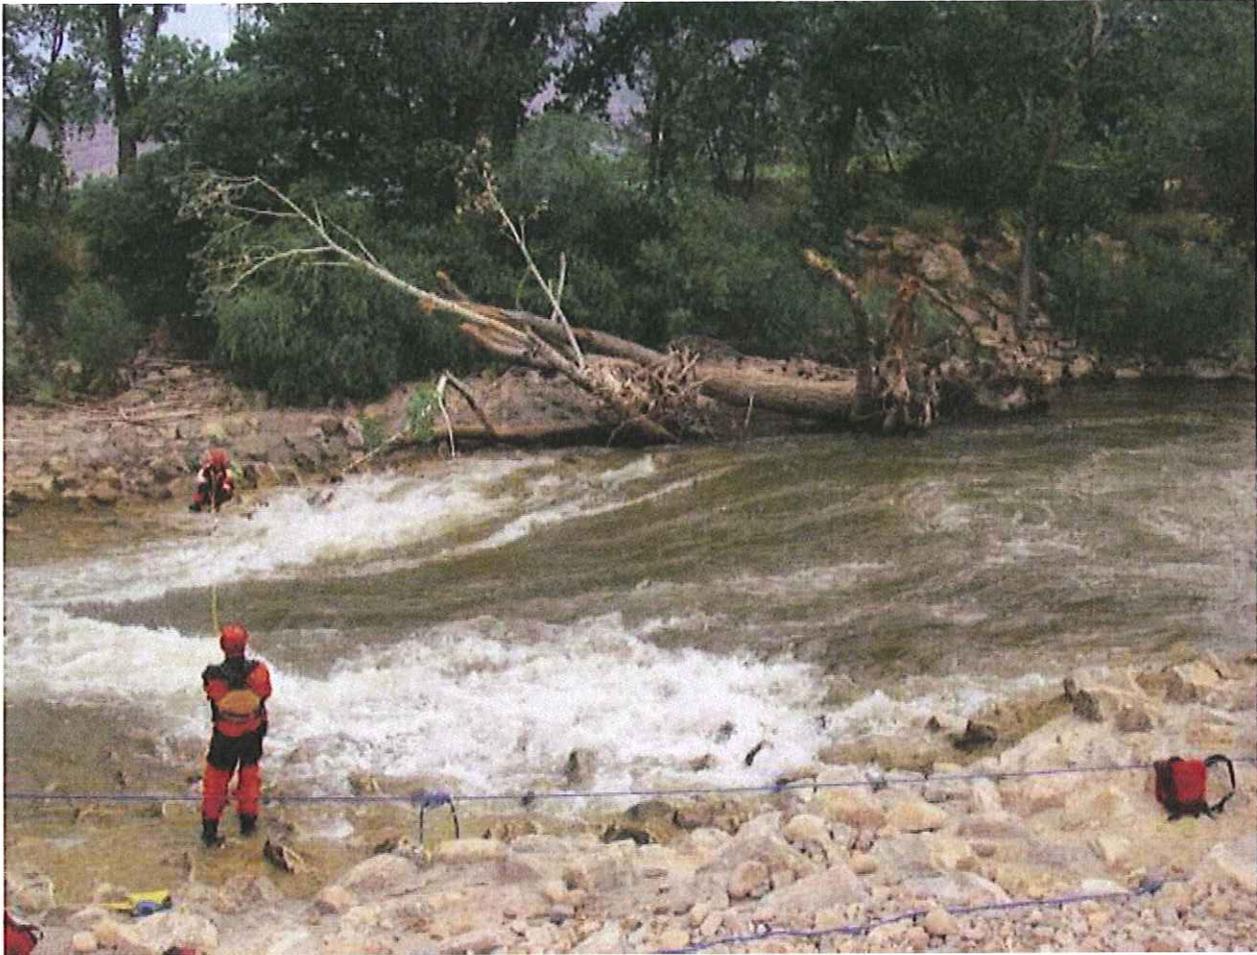
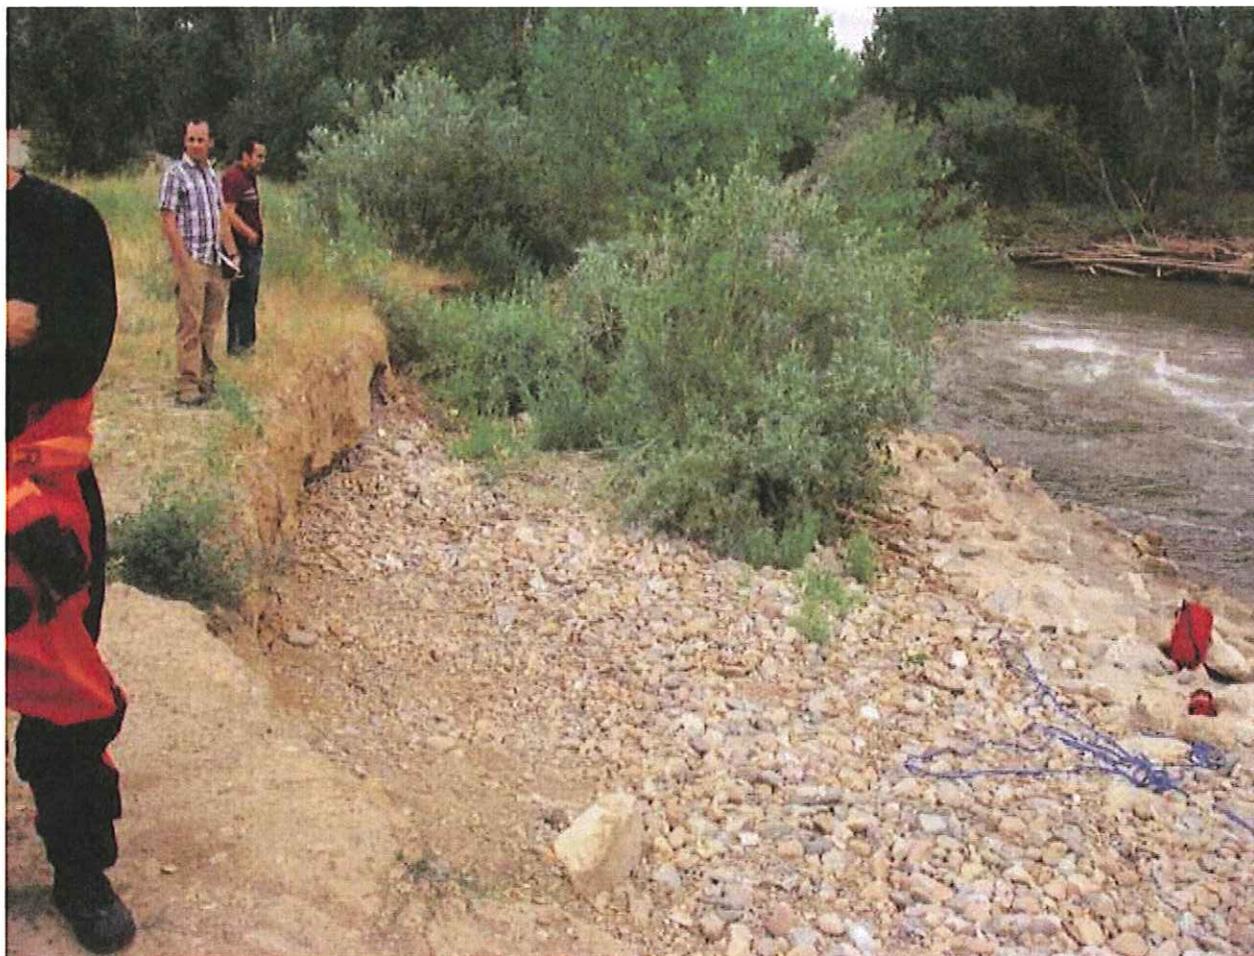
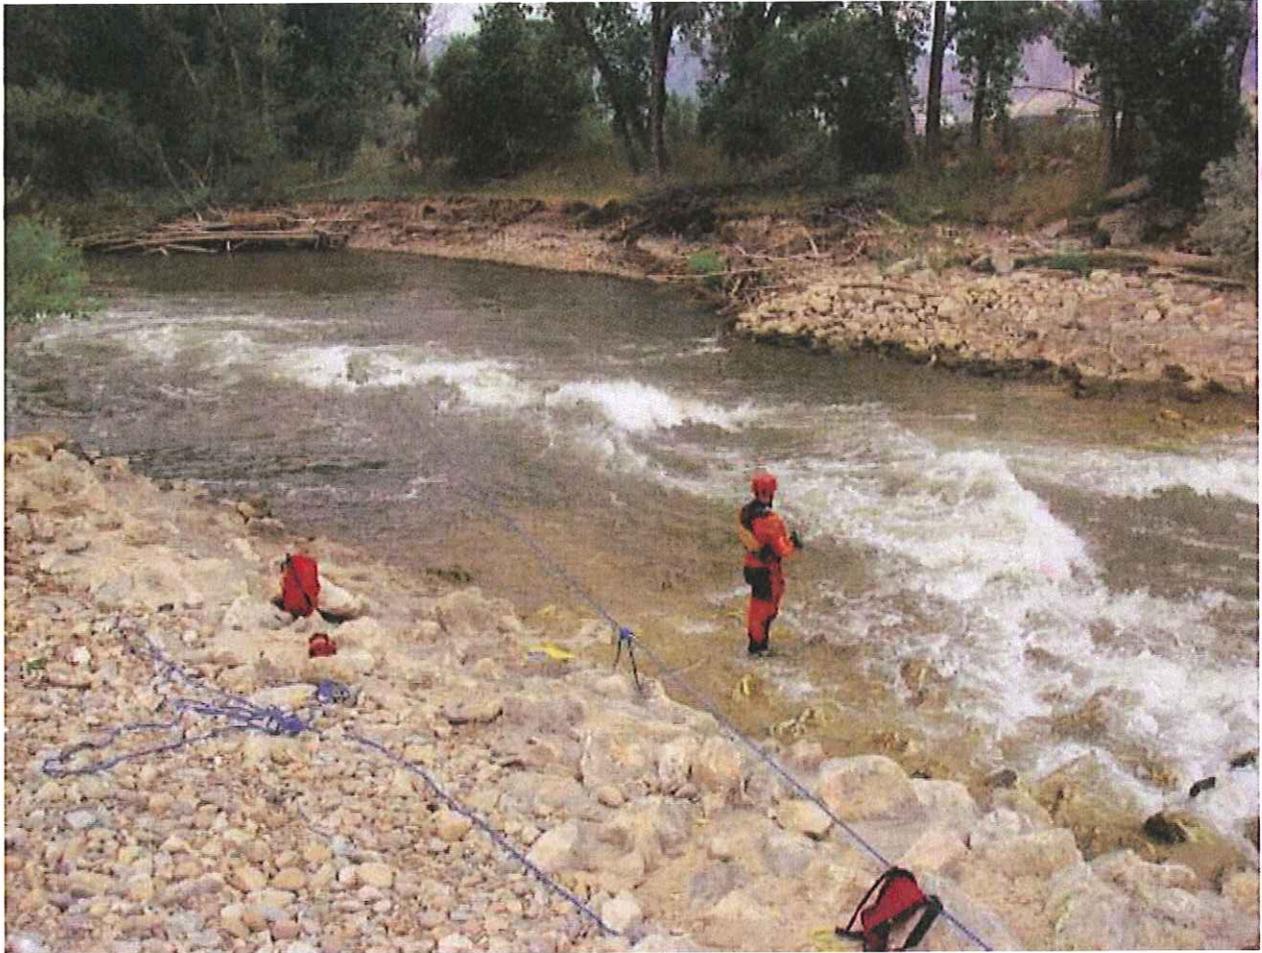
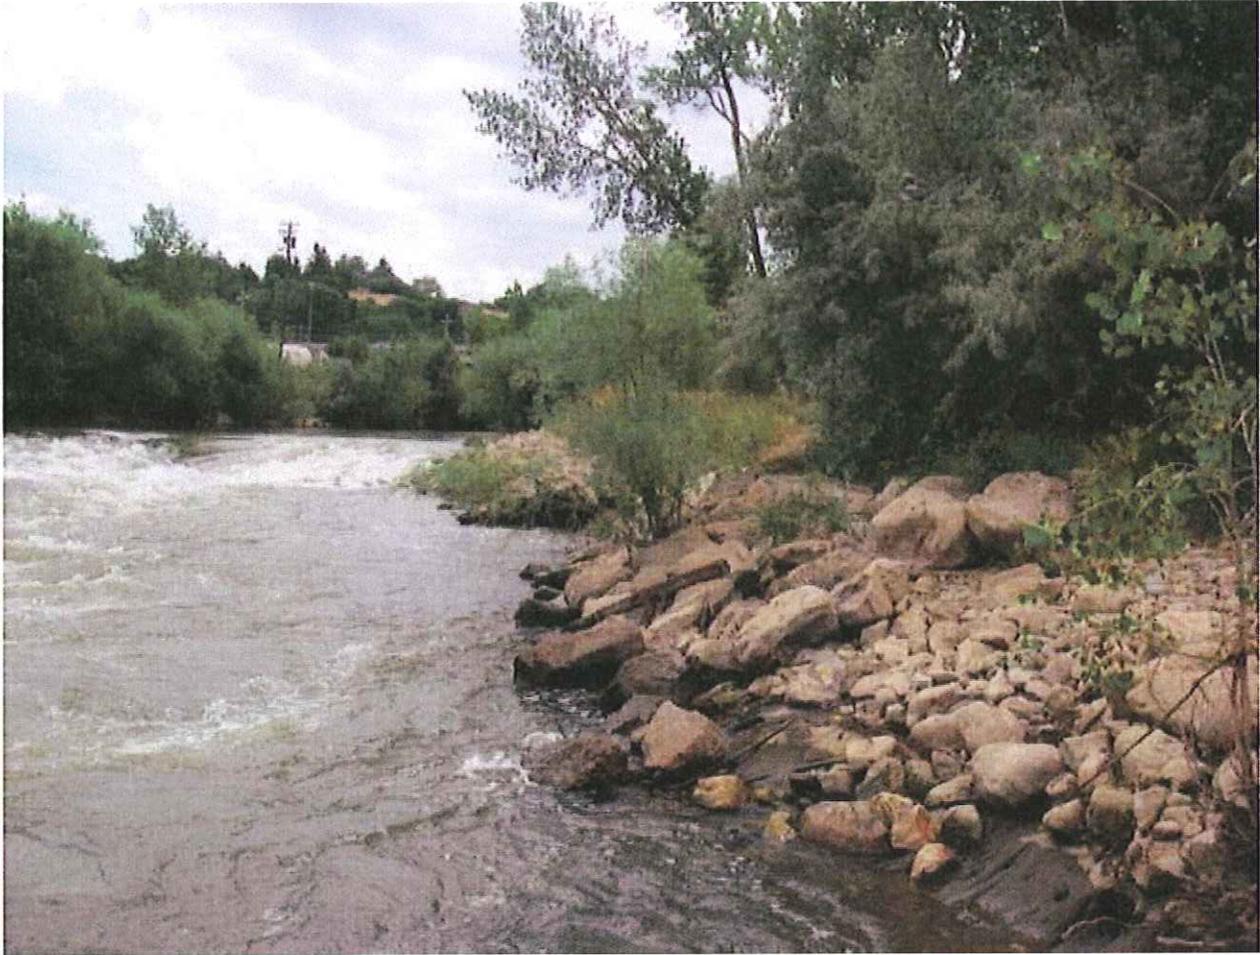
Photographs:	<ul style="list-style-type: none"> • IMGP0159 • IMGP0160 • IMGP0161 • IMGP 2796

Flood Assessment Point:	#4-Riverdale Play Park, Grade control and Riprap Failure
GPS Coordinates:	8-16-11: Pts 9 & 10
Direction to Assessment Point:	Approximately 600 ft downstream on the bike path from the South Weber River Dr. trailhead.
Project Priority:	High Moderate Low X
Description of Issue:	Grouted Riprap appears to be failing and as a result the whitewater wave no longer functions. Probing indicates 8’ deep hole upstream of the grouted grade control and an 8’ deep hole downstream of the structure. Design drawings indicate that the cutoff wall above the lower drop is only 5’ deep; it is likely that the grouted riprap has been undercut. Additionally the grouted grade control on the left bank between the two structures has also failed and there is significant erosion in the viewing area on the left bank at the lower drop. This erosion extend downstream over 350 ft. This is a High Priority project for a number of reasons: 1) the Riverdale Whitewater Park is a world class whitewater feature that brings tourism \$ into Riverdale, 2) <u>Potential significant entrapment hazard to boaters/swimmers (There is a popular rope swing just upstream of the lower structure)</u>

Structures:	Sewer Line, Kayak Wave, Bike Path
Geomorphic Description:	<p>This grouted grouted grade control structure was constructed in 2005. The primary goal of this structure is to protect the sewer line crossing. The structure was also designed to create a whitewater wave. Based on design drawings there is a 5’ concrete cutoff wall upstream of the lower drop structure.</p> <p>Like much of the Weber River through Riverdale City, this reach has been channelized during the urbanization of Riverdale in the 1970s. Historically, this reach of the river was more similar to the upstream reaches that pass through the DNR property; it was a dynamic, aggrading system. The modified channel has a greater sediment transport capacity and is capable of transporting most of the alluvium supplied by the upstream reaches. As a result of this excess transport capacity the Weber river is degrading through much of Riverdale City. This is evidenced by bank toe erosion and little evidence of sediment deposition throughout the Riverdale reach. While it is difficult to assess the condition of the structure due to high flows, the presence of 8’ deep holes upstream and downstream of the structure indicate that the 2011 flood flows were sufficiently large, and of a sufficient duration that they may have undercut the 5 foot cutoff wall and eroded under the grouted grade control. It is</p>

not uncommon for grouted grade control structures to be undercut. Additionally, the downstream hydraulics have caused significant bank erosion on the right bank of the river. General channel degradation is likely downstream of the grade control structure. Due to the excessive channel scour the structure no longer functions as designed.
Habitat Considerations:	This structure provides better fish passage than the upstream drop structures.
Flood Damage Repair:	<ul style="list-style-type: none"> • \$250,000-\$350,000
Measures:	<ul style="list-style-type: none"> • Option 1 (Flood Damage Lower Structure Improved Project) <ul style="list-style-type: none"> ○ Re-Grout riprap ○ Fill voids under structure with Flowable Fill ○ Replace Cutoff Wall (sheet pile) ○ Biostablize Left Bank ○ Repair downstream grade control ○ \$200,000-\$300,000 • Option 2- (Replace Lower Structure, Alternate Project) <ul style="list-style-type: none"> ○ Remove grouted rip-rip ○ Construct new structure out of large boulders embedded below scour depth ○ Install pre-cast “Wave Blocks” to create play wave ○ Install Sheet pile cutoff. ○ Protect viewing area with boulder and flagstone ○ \$350,000-\$650,000

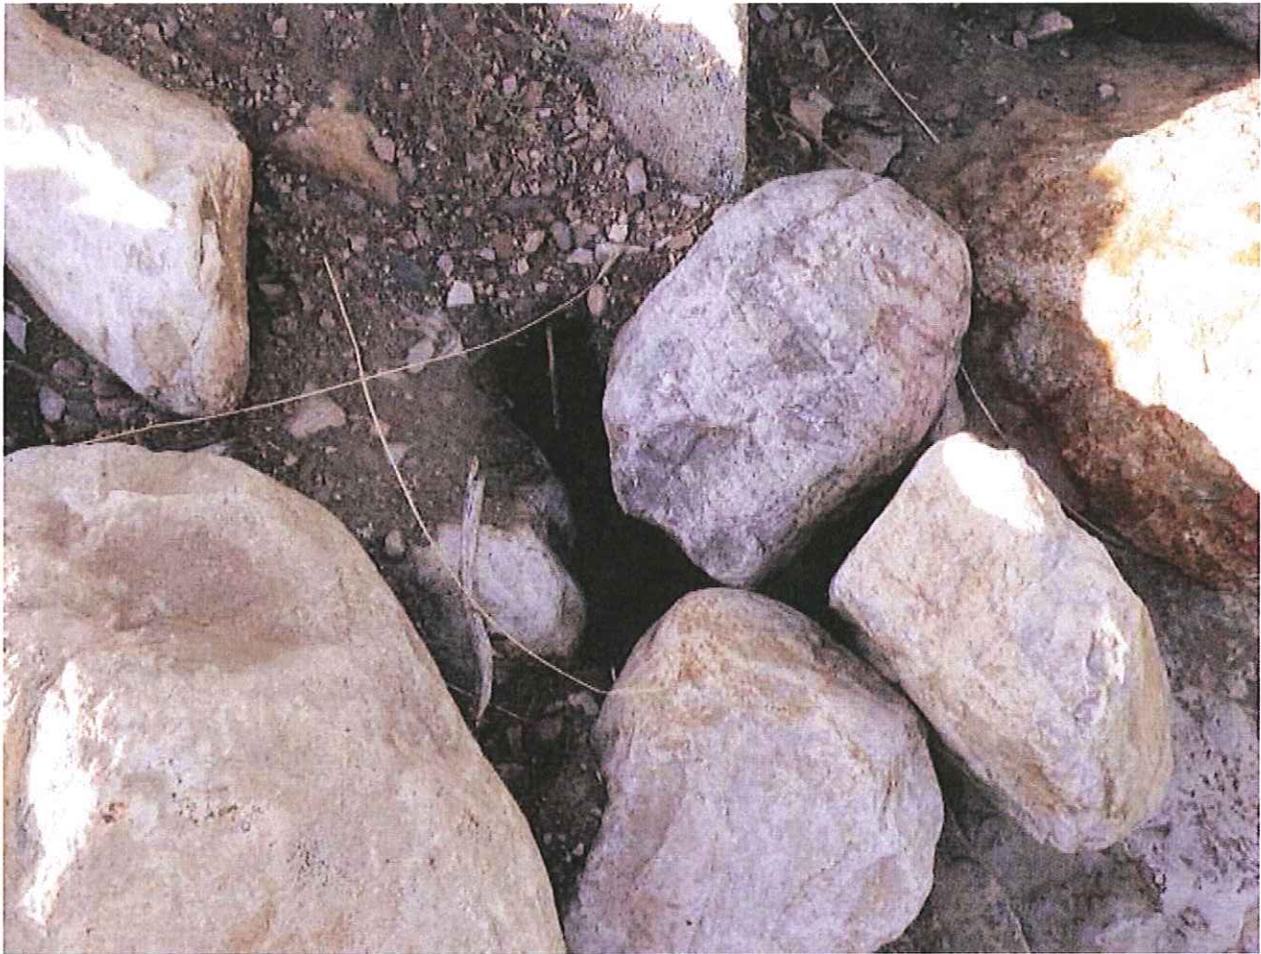
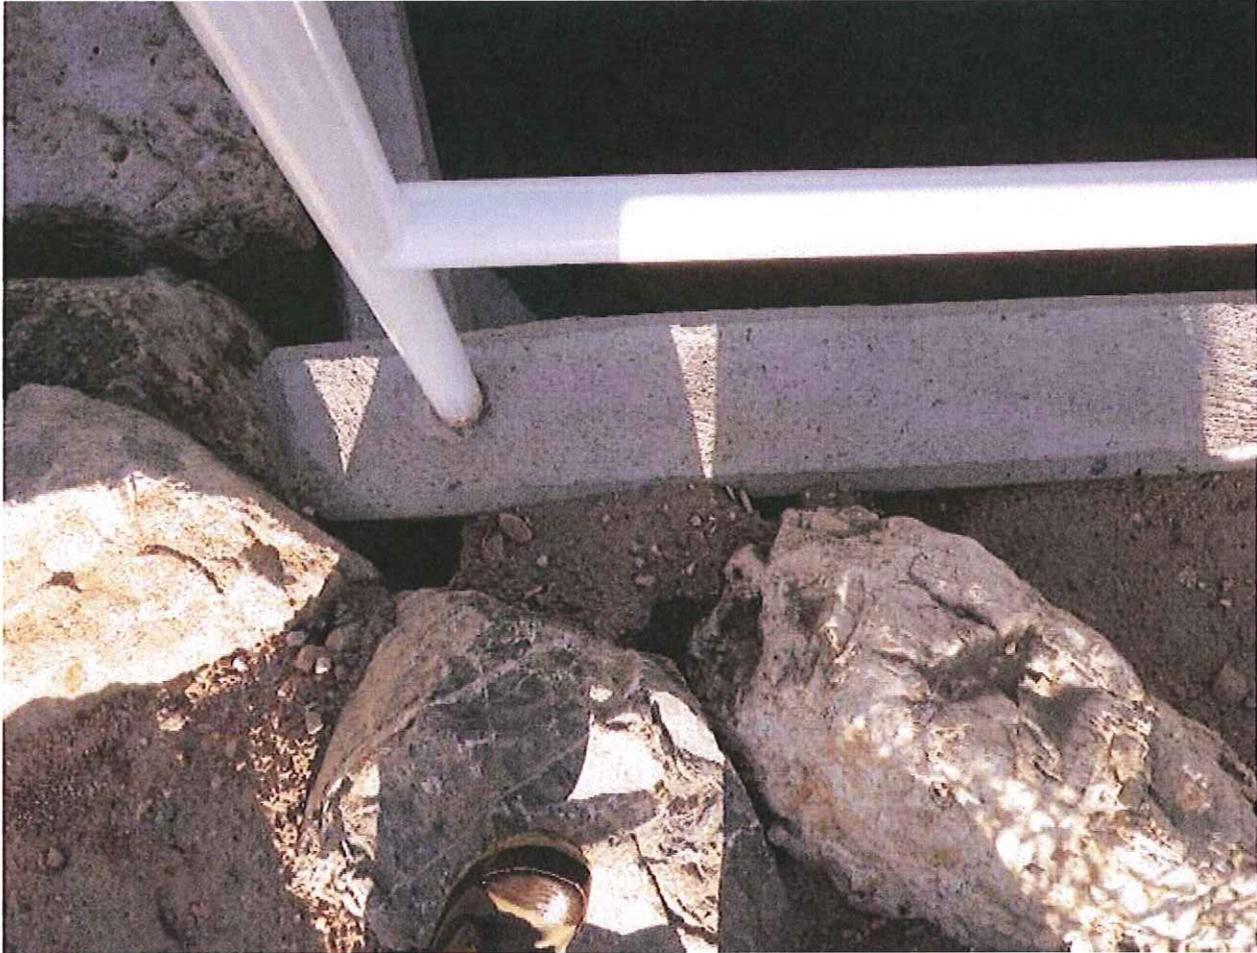
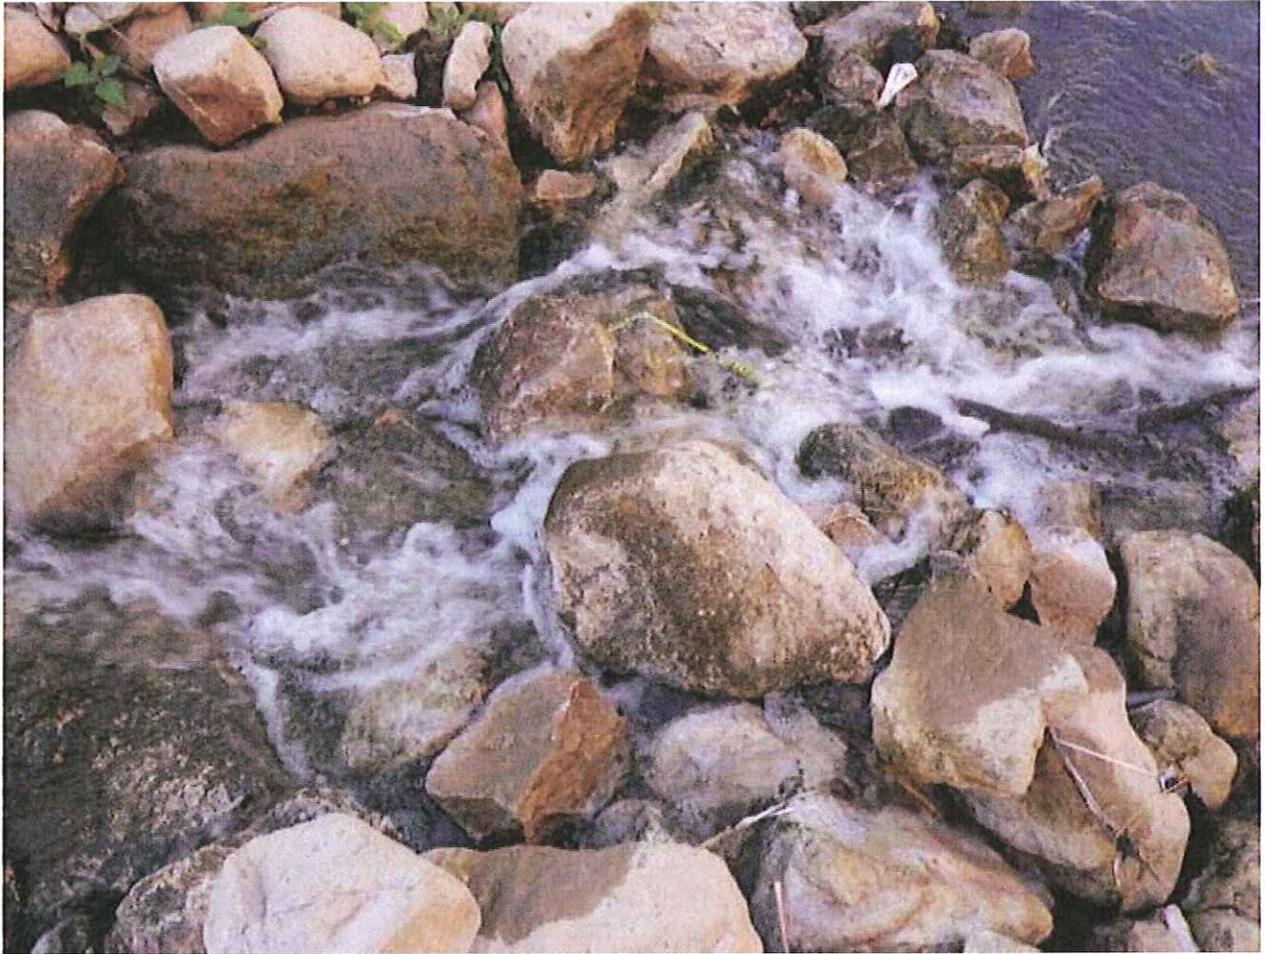
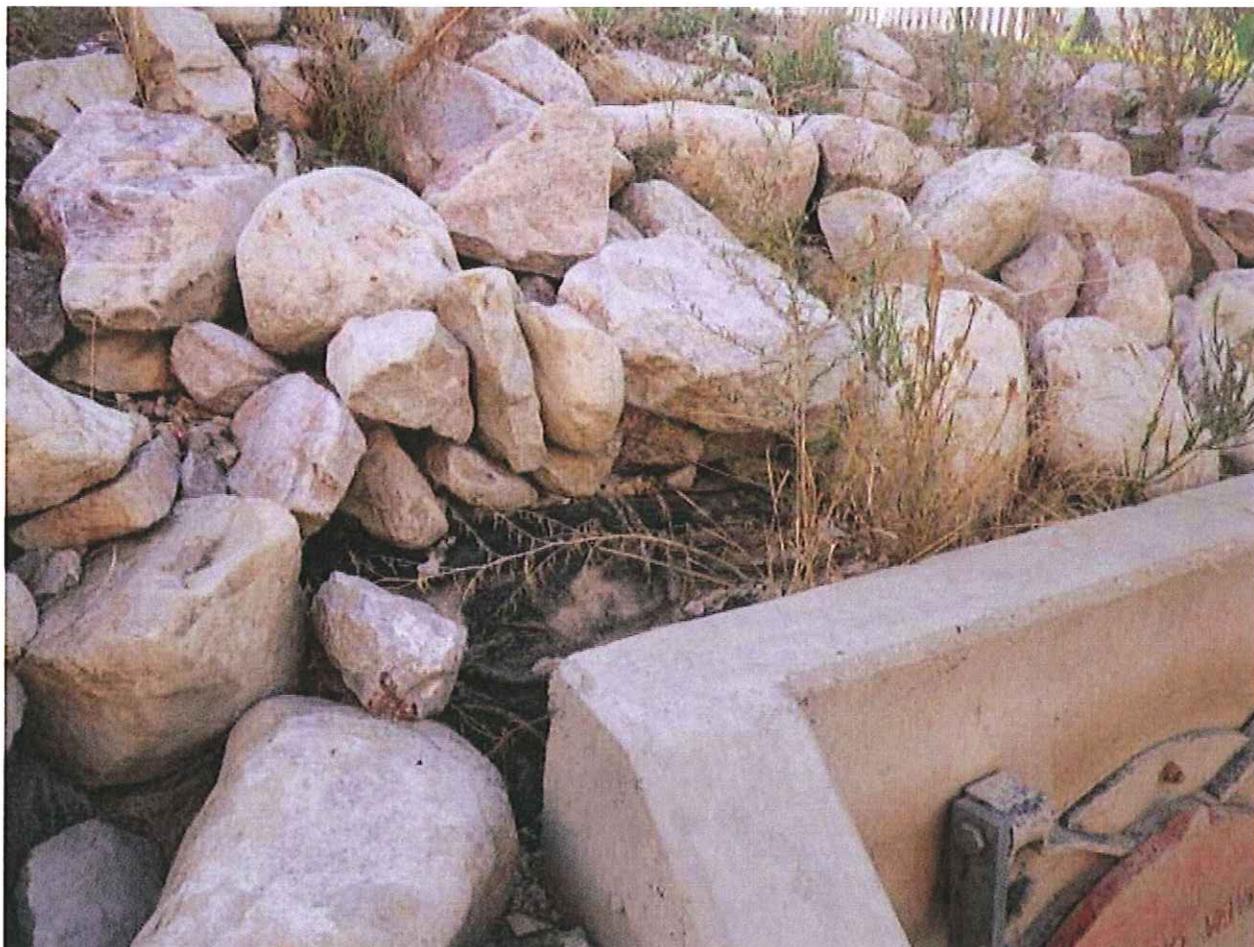
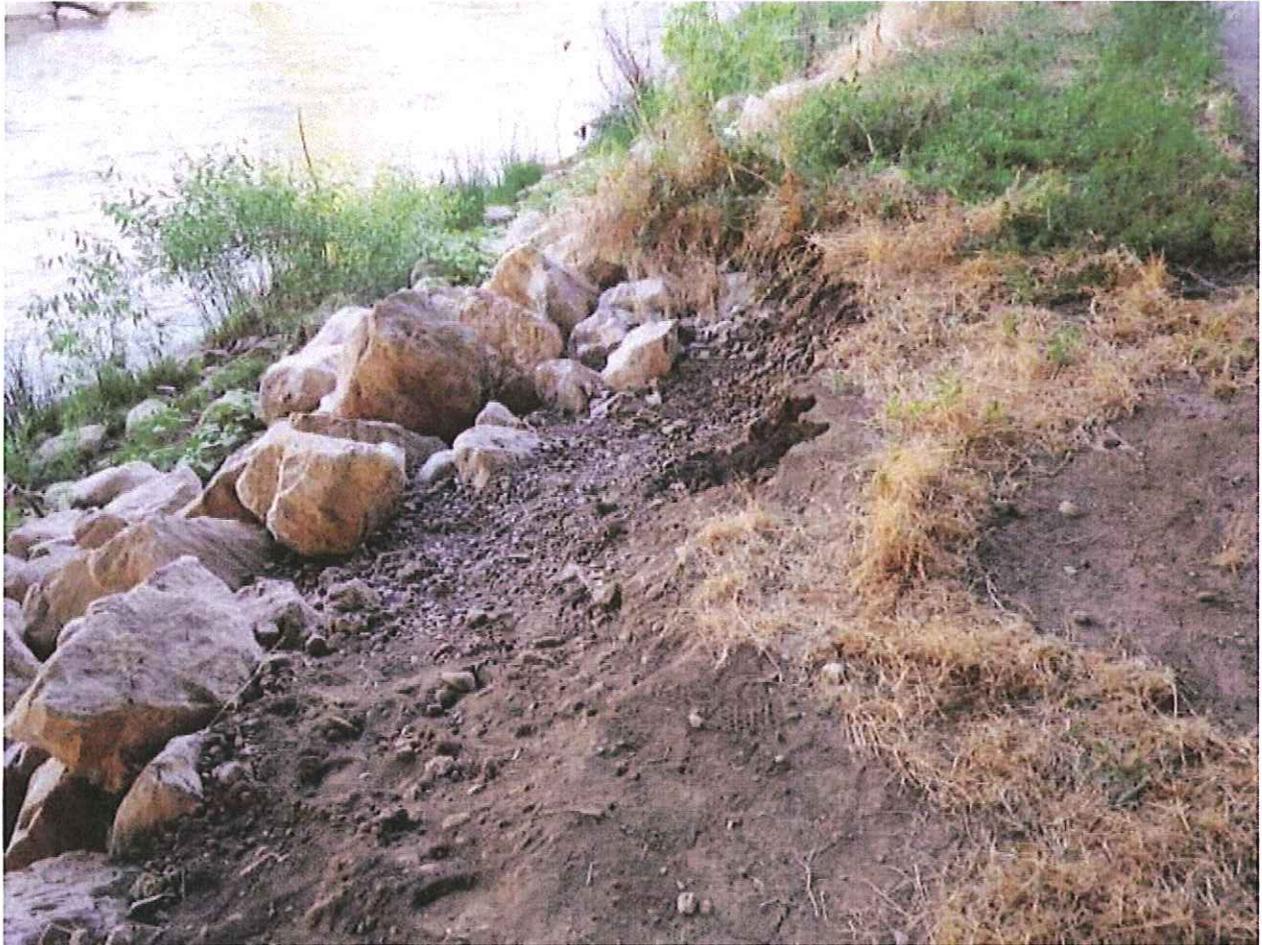
Photographs:	<ul style="list-style-type: none"> • IMG0165 • IMG0166

Flood Assessment Point:	#5-54" RCP outfall @ W4400S & S Weber River Dr.
GPS Coordinates:	8-16-11 Point 20
Direction to Assessment Point:	On left bank at east end of W4400S @ S Weber River Dr. left turn
Project Priority:	High Moderate Low X
Description of Issue:	Rip-Rap around outfall is failing. Evidence of piping around headwall.
Structures:	Stormwater Outfall.
Geomorphic Description:	The riprap has been compromised by the high flows of 2011. The rip-rap has insufficient depth, toe stability and does not appear to have any filter material.
Habitat Considerations:	Sediment source.
Damage Assessment	<ul style="list-style-type: none"> • \$15,000-\$35,000
Measures:	<ul style="list-style-type: none"> • Option 1 (Flood Damage Replacement Project) <ul style="list-style-type: none"> ○ Repair rip-rap with sufficient blanket depth and filter material ○ Opportunity to create stormwater treatment wetland? ○ Stabilize toe ○ \$30,000-\$64,000
