RIVERDALE CITY COUNCIL AGENDA-AMENDED
CIVIC CENTER - 4600 S. WEBER RIVER DR.
TUESDAY – MARCH 6, 2012

Riverdale City 2011 Flood Damage Assessment

October 13, 2011

Prepared For:
Riverdale City, Utah
Public Works department
4600 South Weber River Drive
Riverdale City, Utah 84405

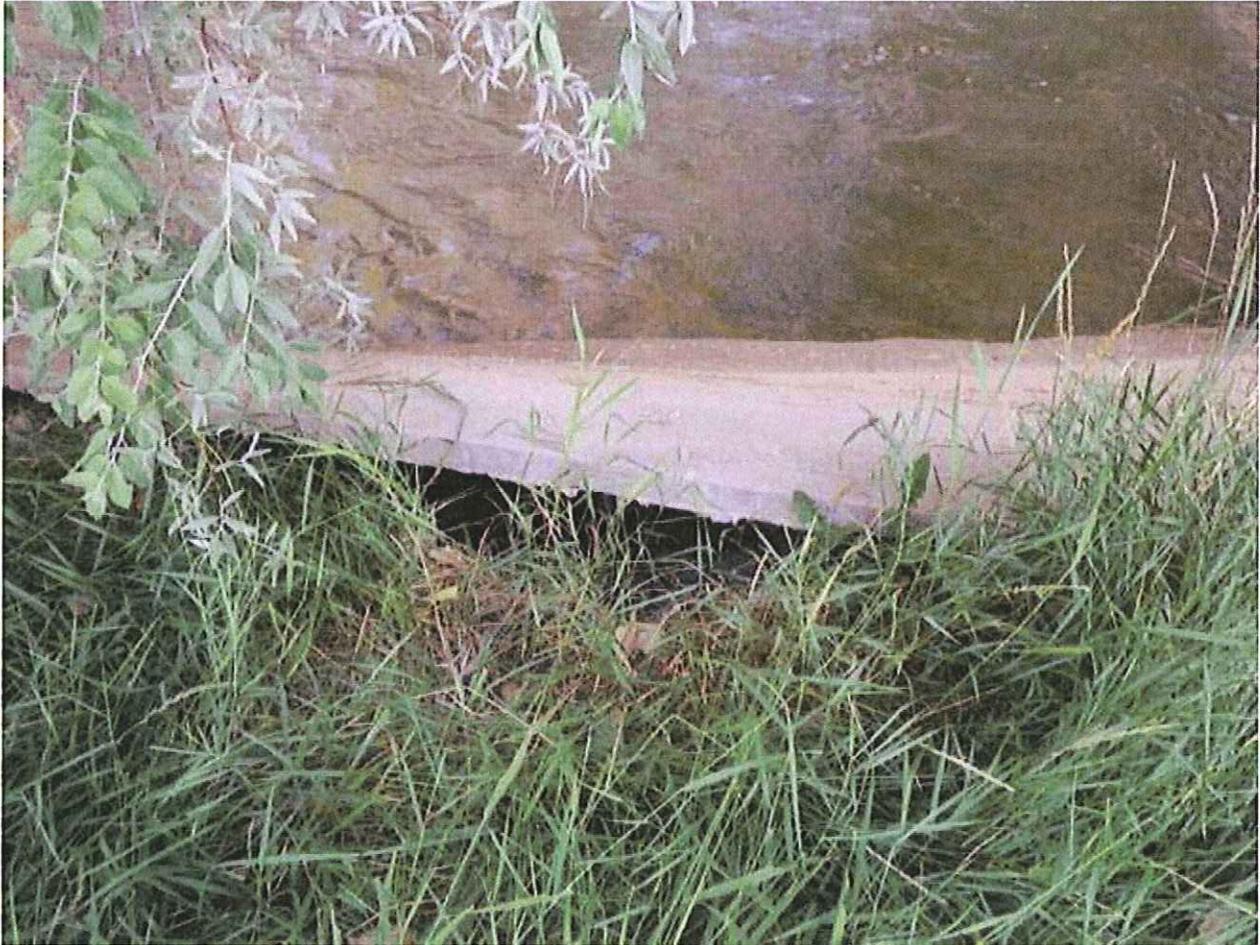
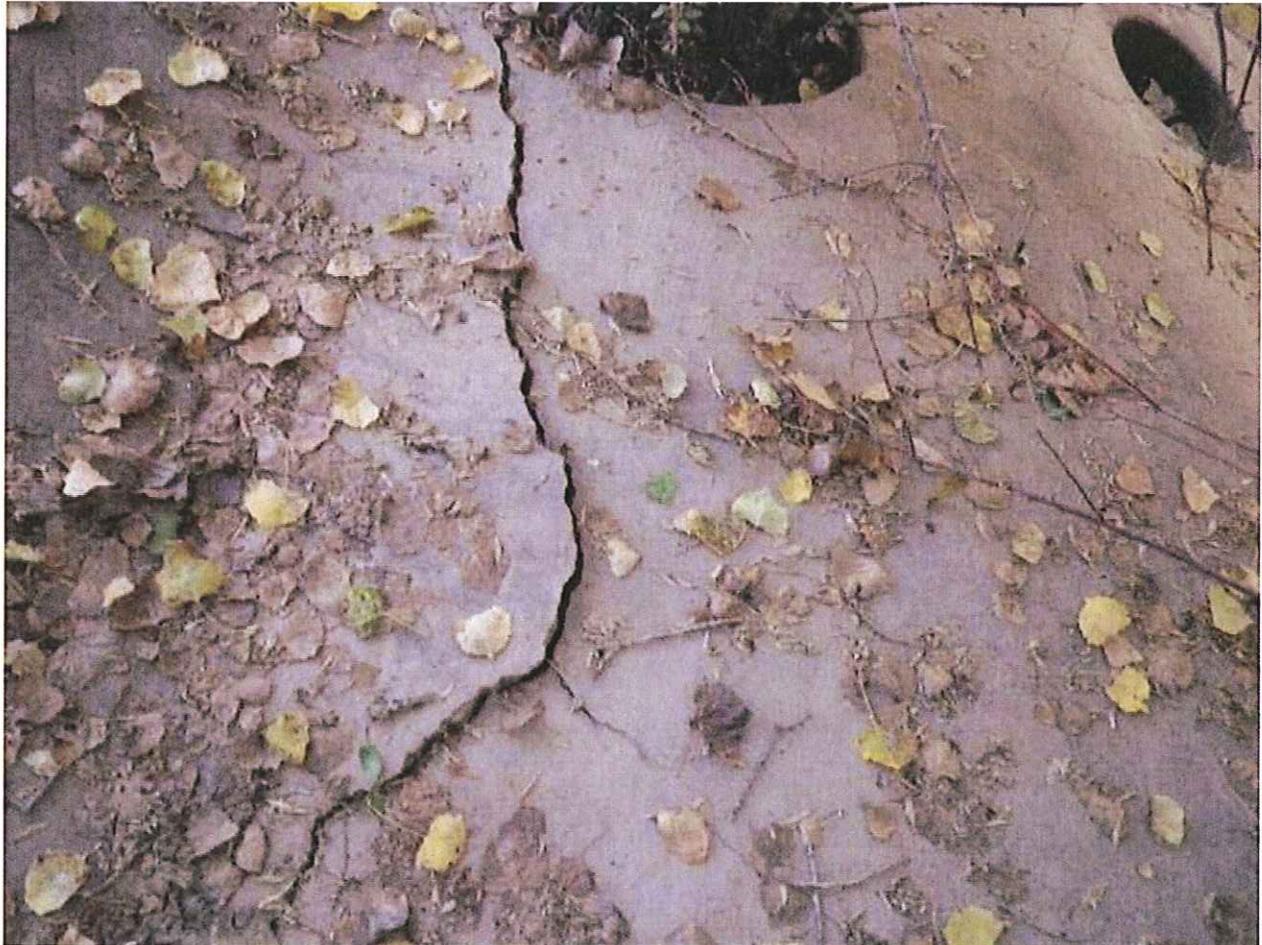
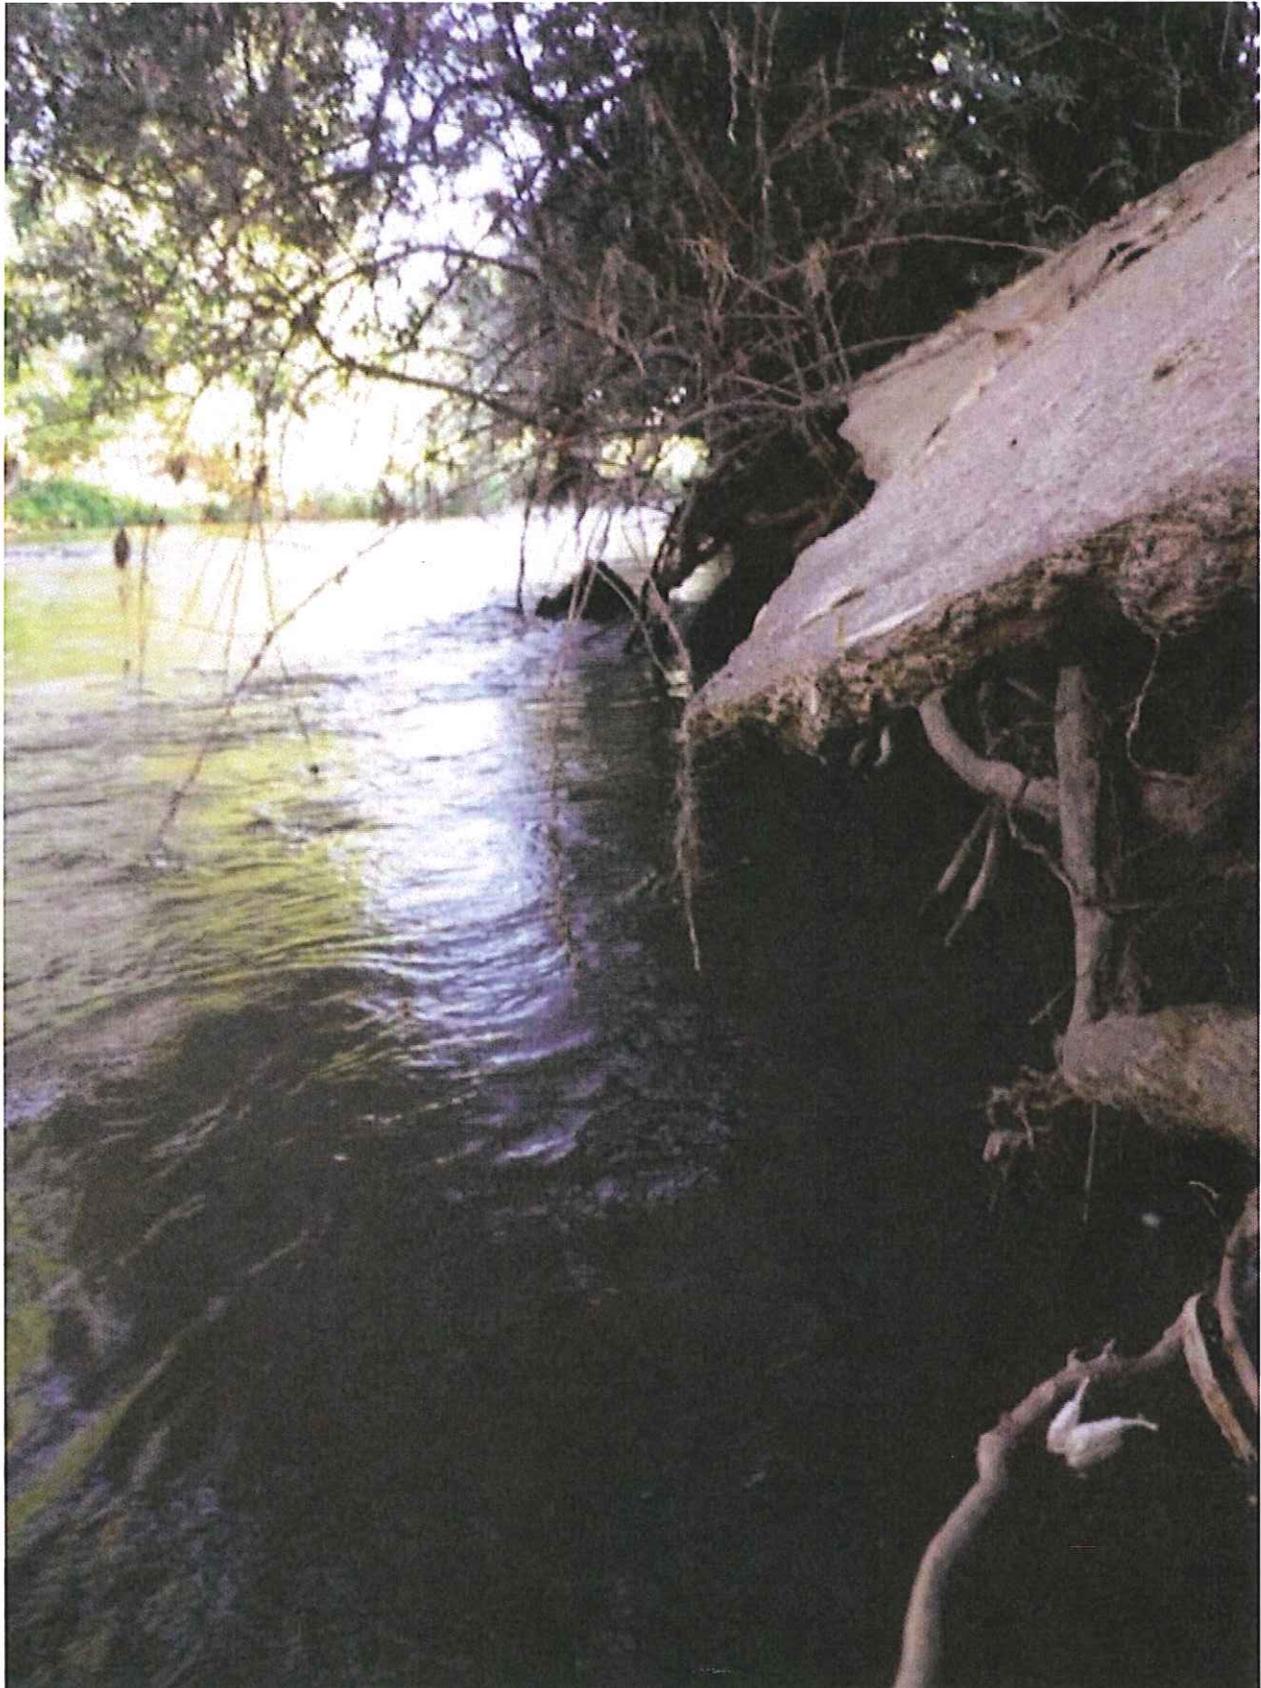
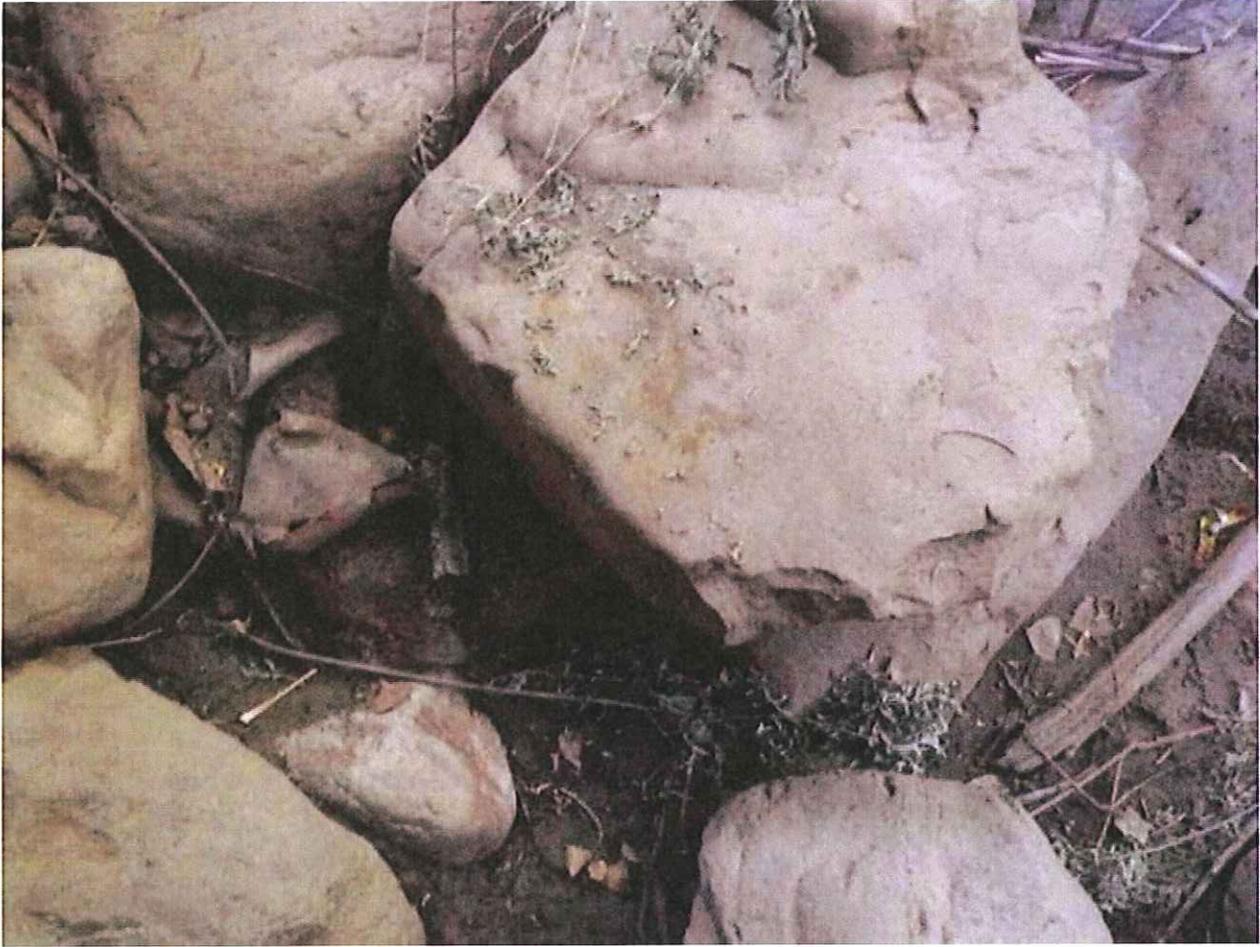
Flood Assessment Point:	#7-Concrete Revetment at Les Schwab Tire
GPS Coordinates:	8-16-11 Point 26
Direction to Assessment Point:	On left bank approximately 450 ft upstream of the Riverdale Rd. Bridge on the bike path.
Project Priority:	High Moderate Low X
Description of Issue:	There is 15'x50' concrete slab poured on the bank, ostensibly done for bank protection. The concrete slab is undercut and failing. The exposed slab may be causing adverse hydraulics exacerbating bank erosion and may create a safety hazard. There is insufficient toe stability.
Structures:	Bank protection, sculpture
Geomorphic Description:	This concrete slab is not constructed properly for bank protection. Generally, flexible rip-rap is preferable to a concrete slab due to its ability to conform to the changing river bank.
Habitat Considerations:	Degraded Riparian habitat, source of sediment
Flood Damage Repair	<ul style="list-style-type: none"> • \$5,000-\$10,000

Measures:	<ul style="list-style-type: none"> • Option 1 (Flood Damage Replacement Project) <ul style="list-style-type: none"> ○ Remove concrete ○ Stabilize Toe ○ Biostabilize bank ○ \$35,000-\$64,000
Photographs:	<ul style="list-style-type: none"> • IMG0175 • IMG0176 • IMG0177

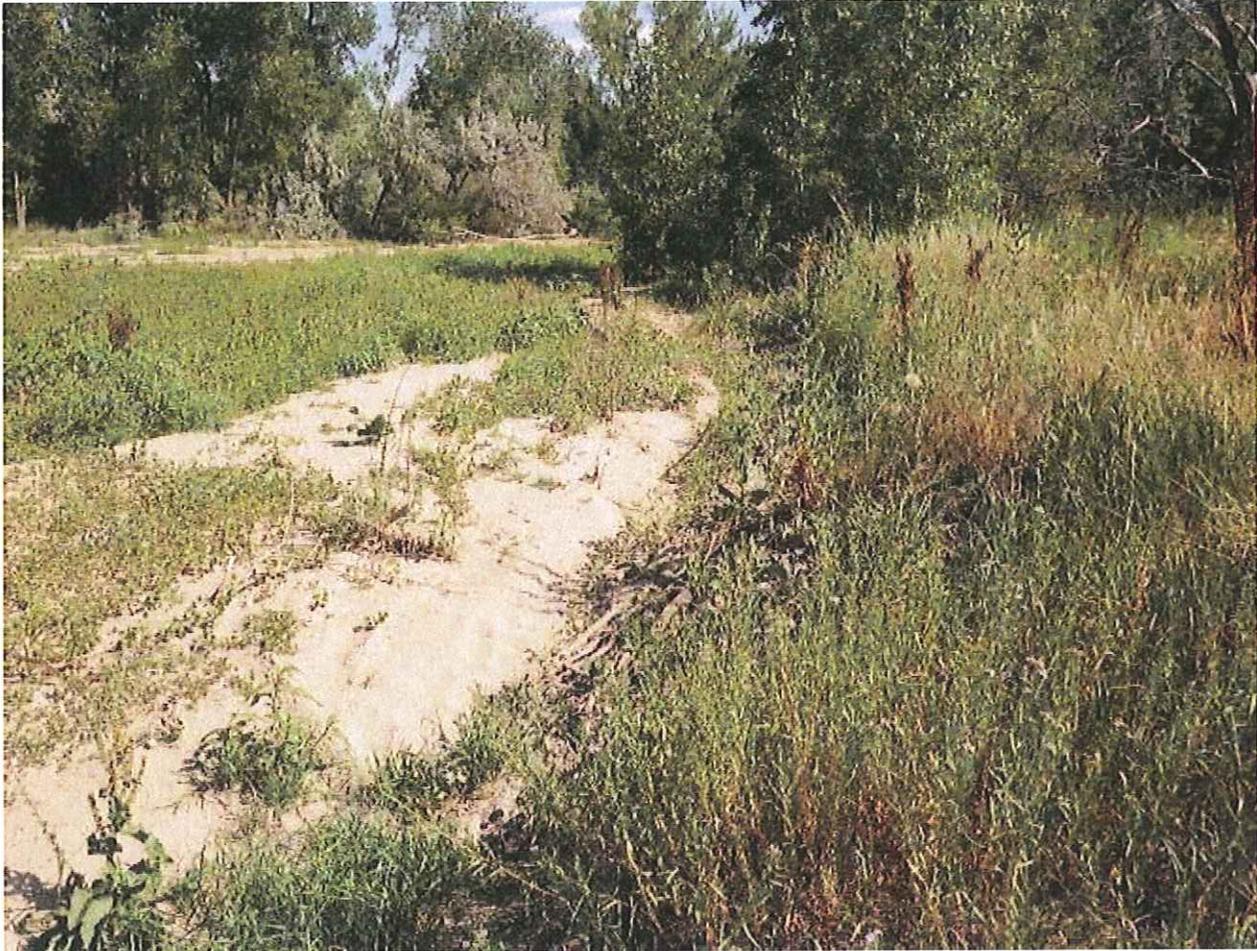
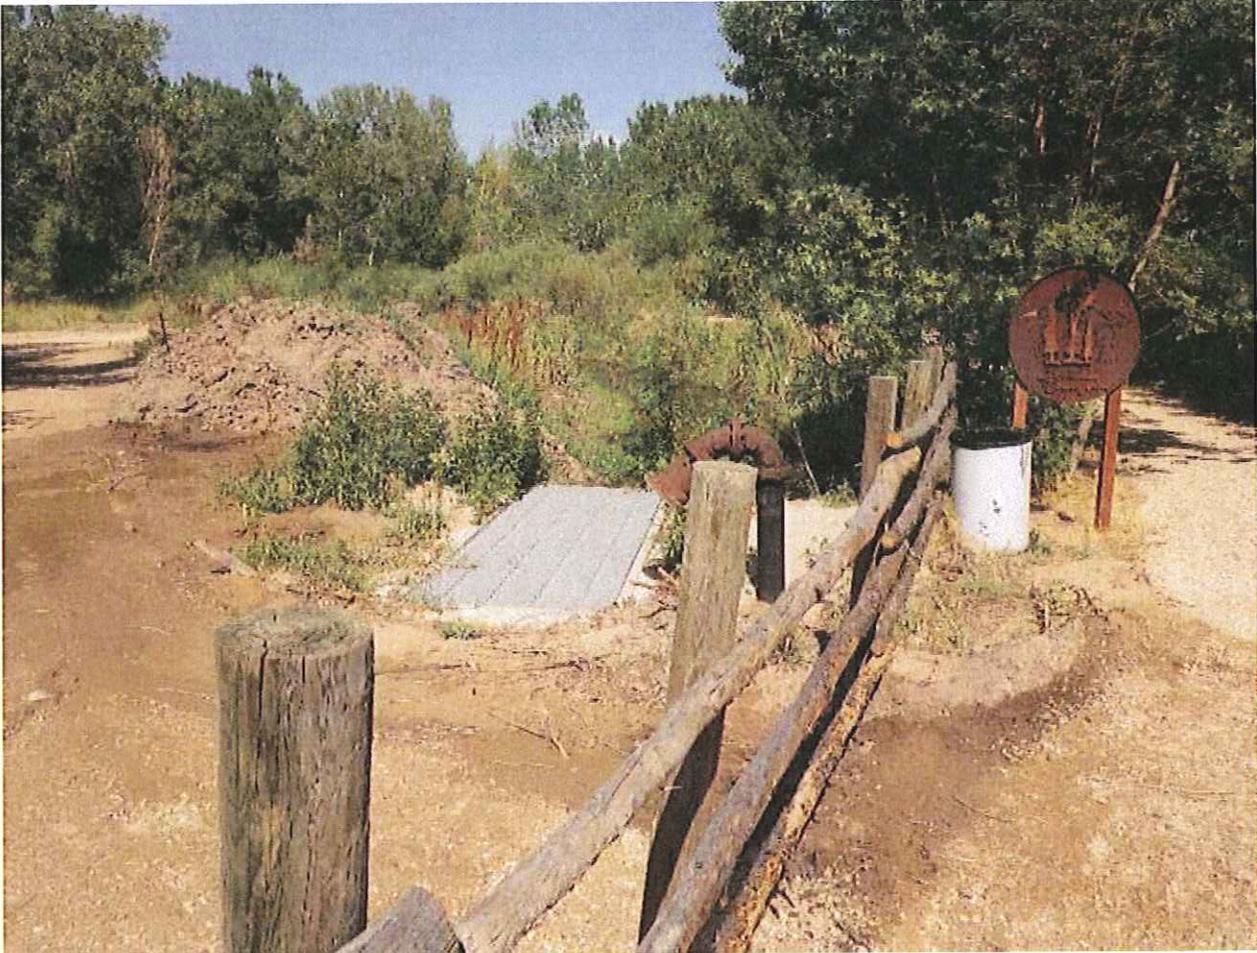
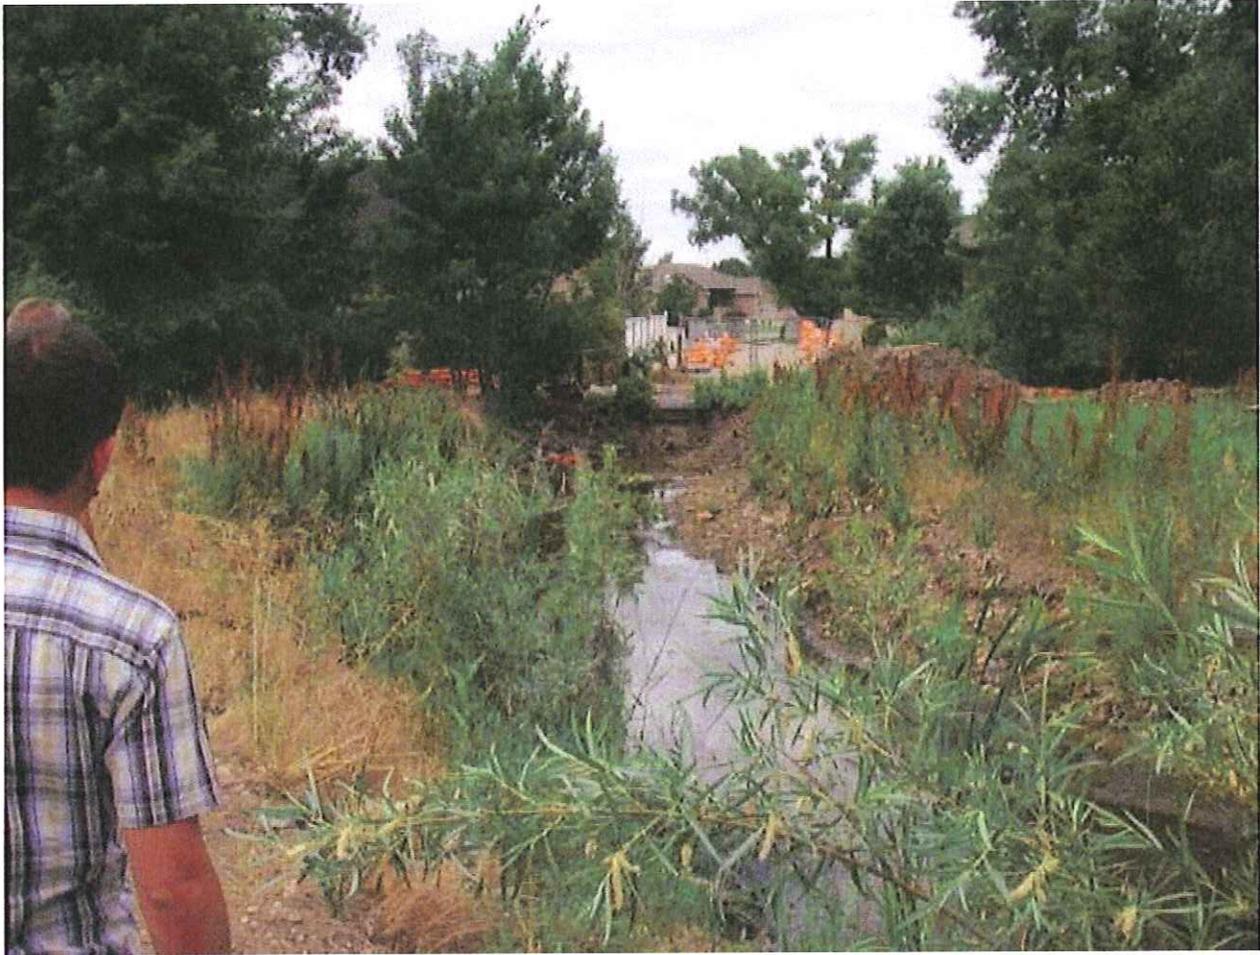
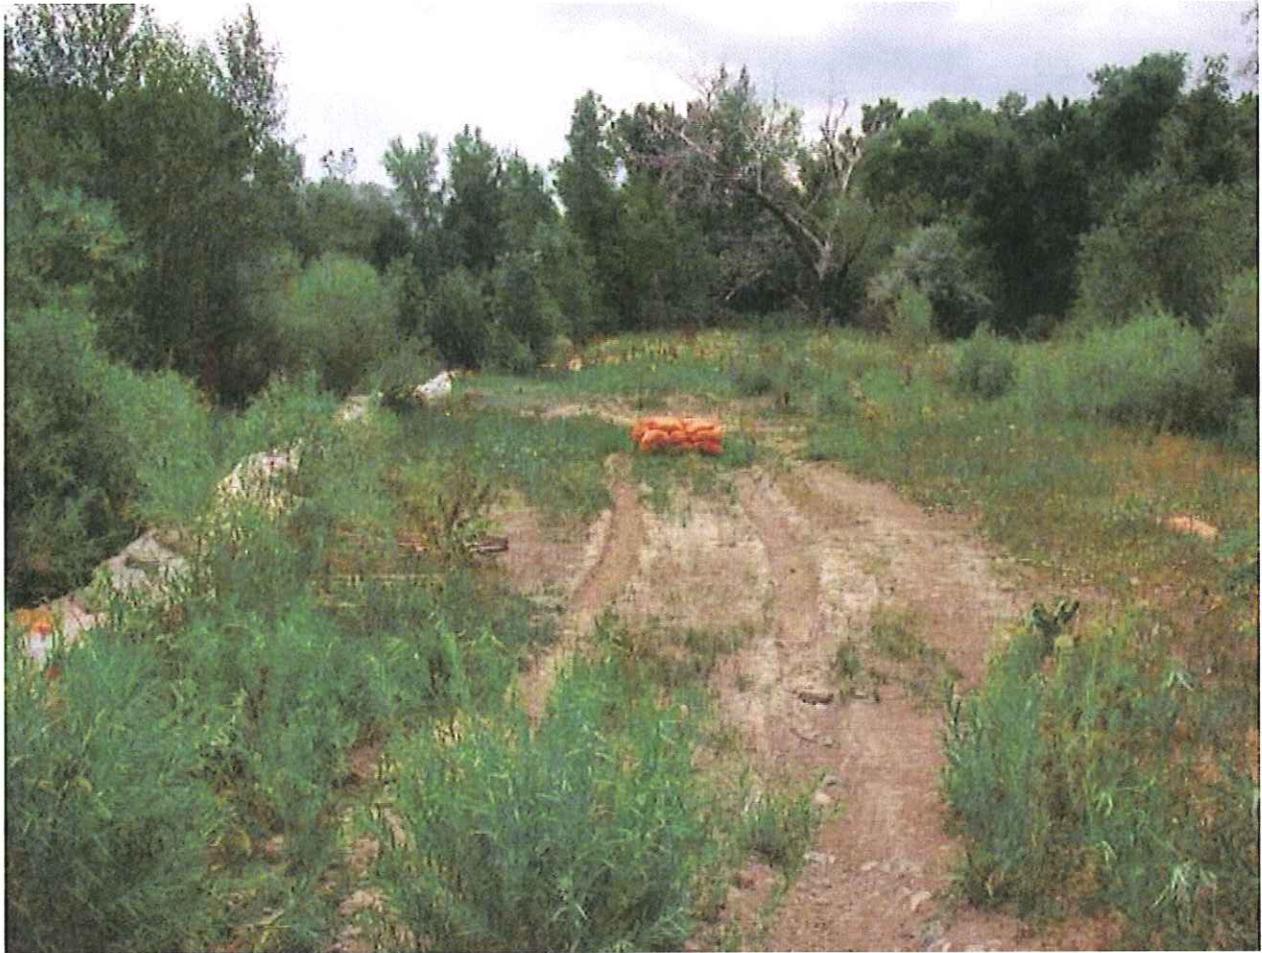
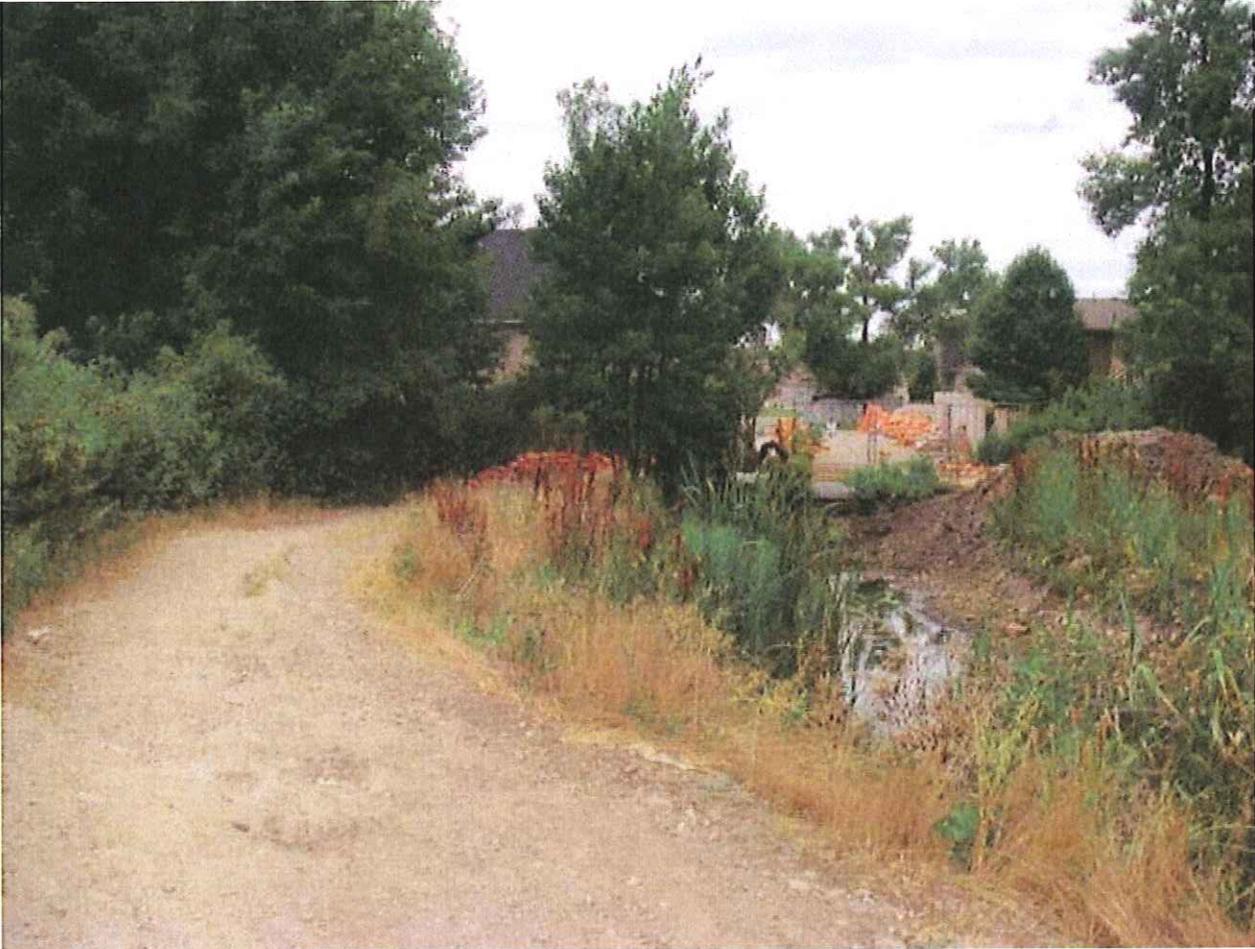
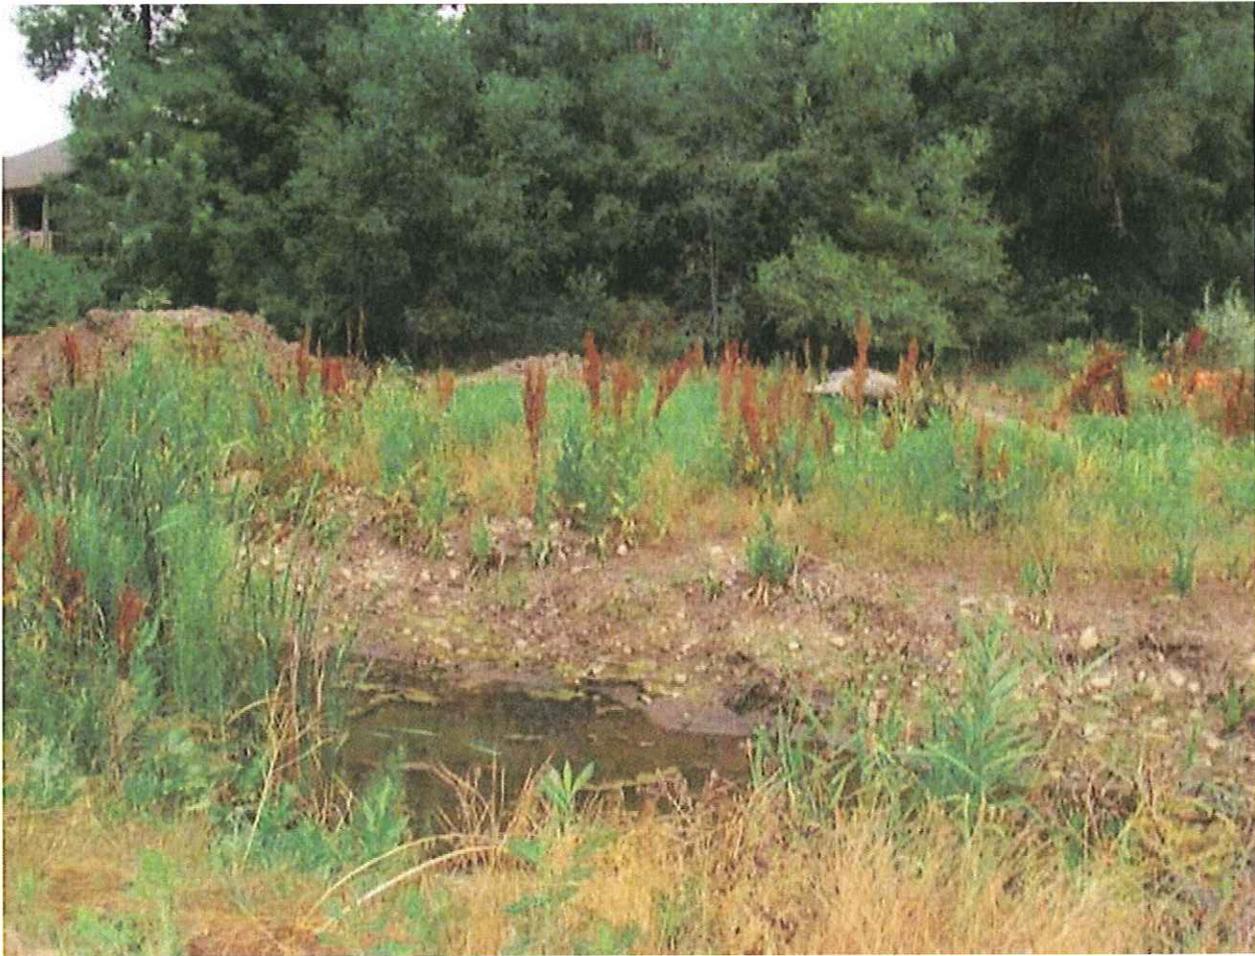
Flood Assessment Point:	#9 & #13-Creekside Trailhead Path Erosion @ River Glen Subdivision
GPS Coordinates:	8-16-11 Point 39, 40, 41, 42
Direction to Assessment Point:	At the junction of the Creekside trail and the Weber River Pathway. Approximately 1000ft on the bike path upstream from north trail head.
Project Priority:	High Moderate Low X
Description of Damage:	The path that leads from the River Bend Subdivision was completely eroded by overbank flooding. This path was reconstructed immediately after the 2011 flood event. 275 ft of split rail fence destroyed, 275 ft path destroyed. There are also issues with the stormwater conveyance at this location. There is a drainage channel that discharges at the west end of the Creekside trail. During high flow events this structure backs up, causing flooding in the River Bend subdivision.
Structures:	Path, Fence, stormwater return channel, homes.
Geomorphic Description:	<p>This portion of the Weber River Floodplain has historically been very active. Historic aerial photos from prior to 1971 show that the active channel of the Weber River flowed through this area. The historic channel passed directly across the junction of the two paths, continued northwest directly through what is now Wildcat Storage and the trailhead facility. The construction of I-15 and Parker Drive has encroached on the active channel at this point, forcing the river east, into its current, channelized location. The river overbanks approximately 500 ft south of the trail junction on the Pathway. FEMA mapping indicates that the trail junction is in ZONE AE and the majority of the Creekside Trail is in the 500 year floodplain. During 2011 runoff this area was inundated by a 10-year flood, indicating that the FEMA information May need updating.</p> <p><u><i>It's important to note that the DFIRM identifies most of this area as 100-year and 500-year floodplain. This was a ten year event; this area should be remapped.</i></u></p> <p>Also we may want to separate this into two damage sites.</p>

Habitat Considerations:	None
Flood Damage Repair:	<ul style="list-style-type: none"> • \$5,000-\$15,000

<p>Measures:</p>	<ul style="list-style-type: none"> • Option 1(Flood Damage Replacement) <ul style="list-style-type: none"> ○ Repair path ○ Repair fence ○ Biostabilize left bank at location of overbank. ○ \$30,000-\$64,000 • Option 2 (Flood Mitigation Project) <ul style="list-style-type: none"> ○ Rebuild path to handle overbank flows ○ Remove fence to facilitate overbank flows ○ Create overbank flow path between Weber Parkway and Riverbend Subdivision ○ Reconstruct Weber Pathway to have boardwalk to allow overbank flows ○ Biostabilze overbank area ○ Construct return flow channel upstream of North trailhead and downstream of trail junction. ○ Build offset levee along property lines ○ Install pump station at trailhead to pump stormwater against floodflow head, discharge downstream in Weber River. ○ \$250,000-\$500,000
<p>Photographs:</p>	<ul style="list-style-type: none"> • IMG0192 Trailhead • IMG0193 Looking upstream flood channel • IMG0195 Bank failure at overbank area • IMG0196 Looking downstream at overbank area, flood flow path.

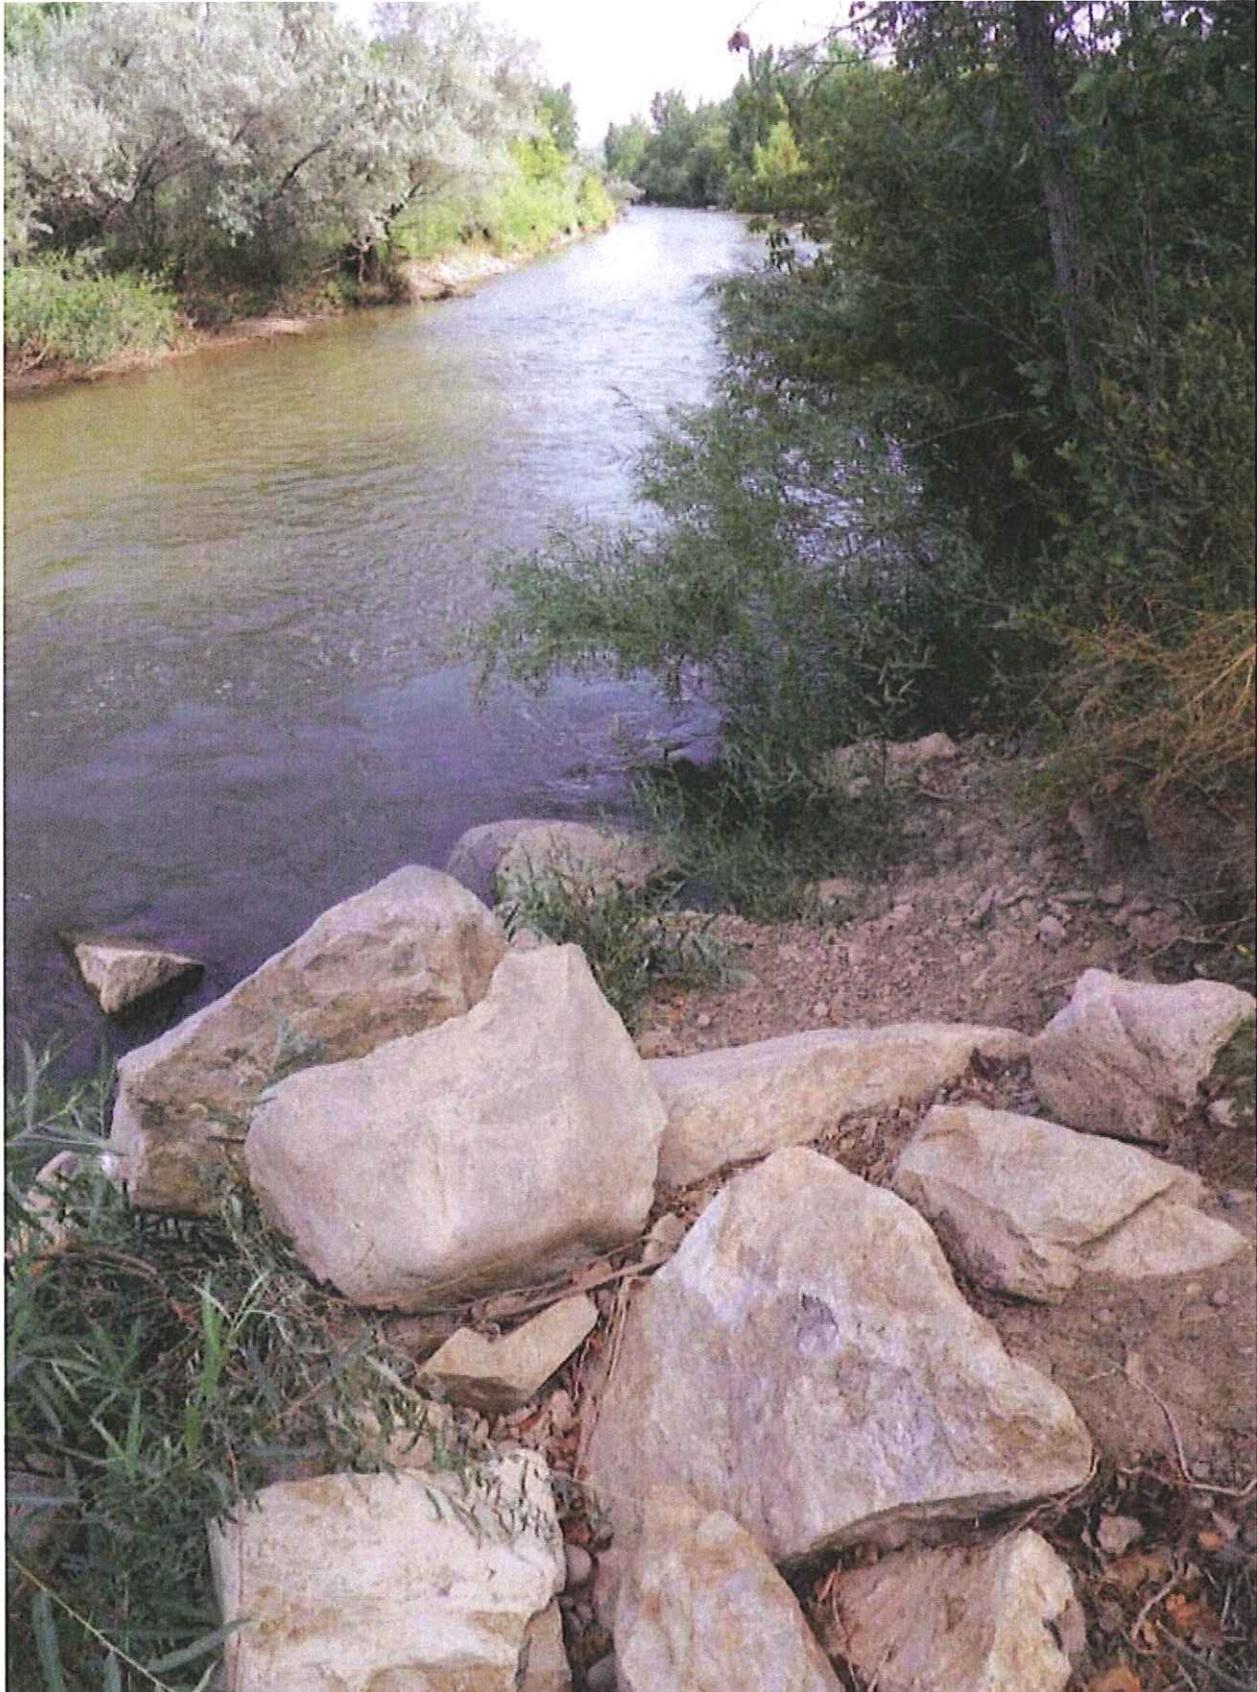
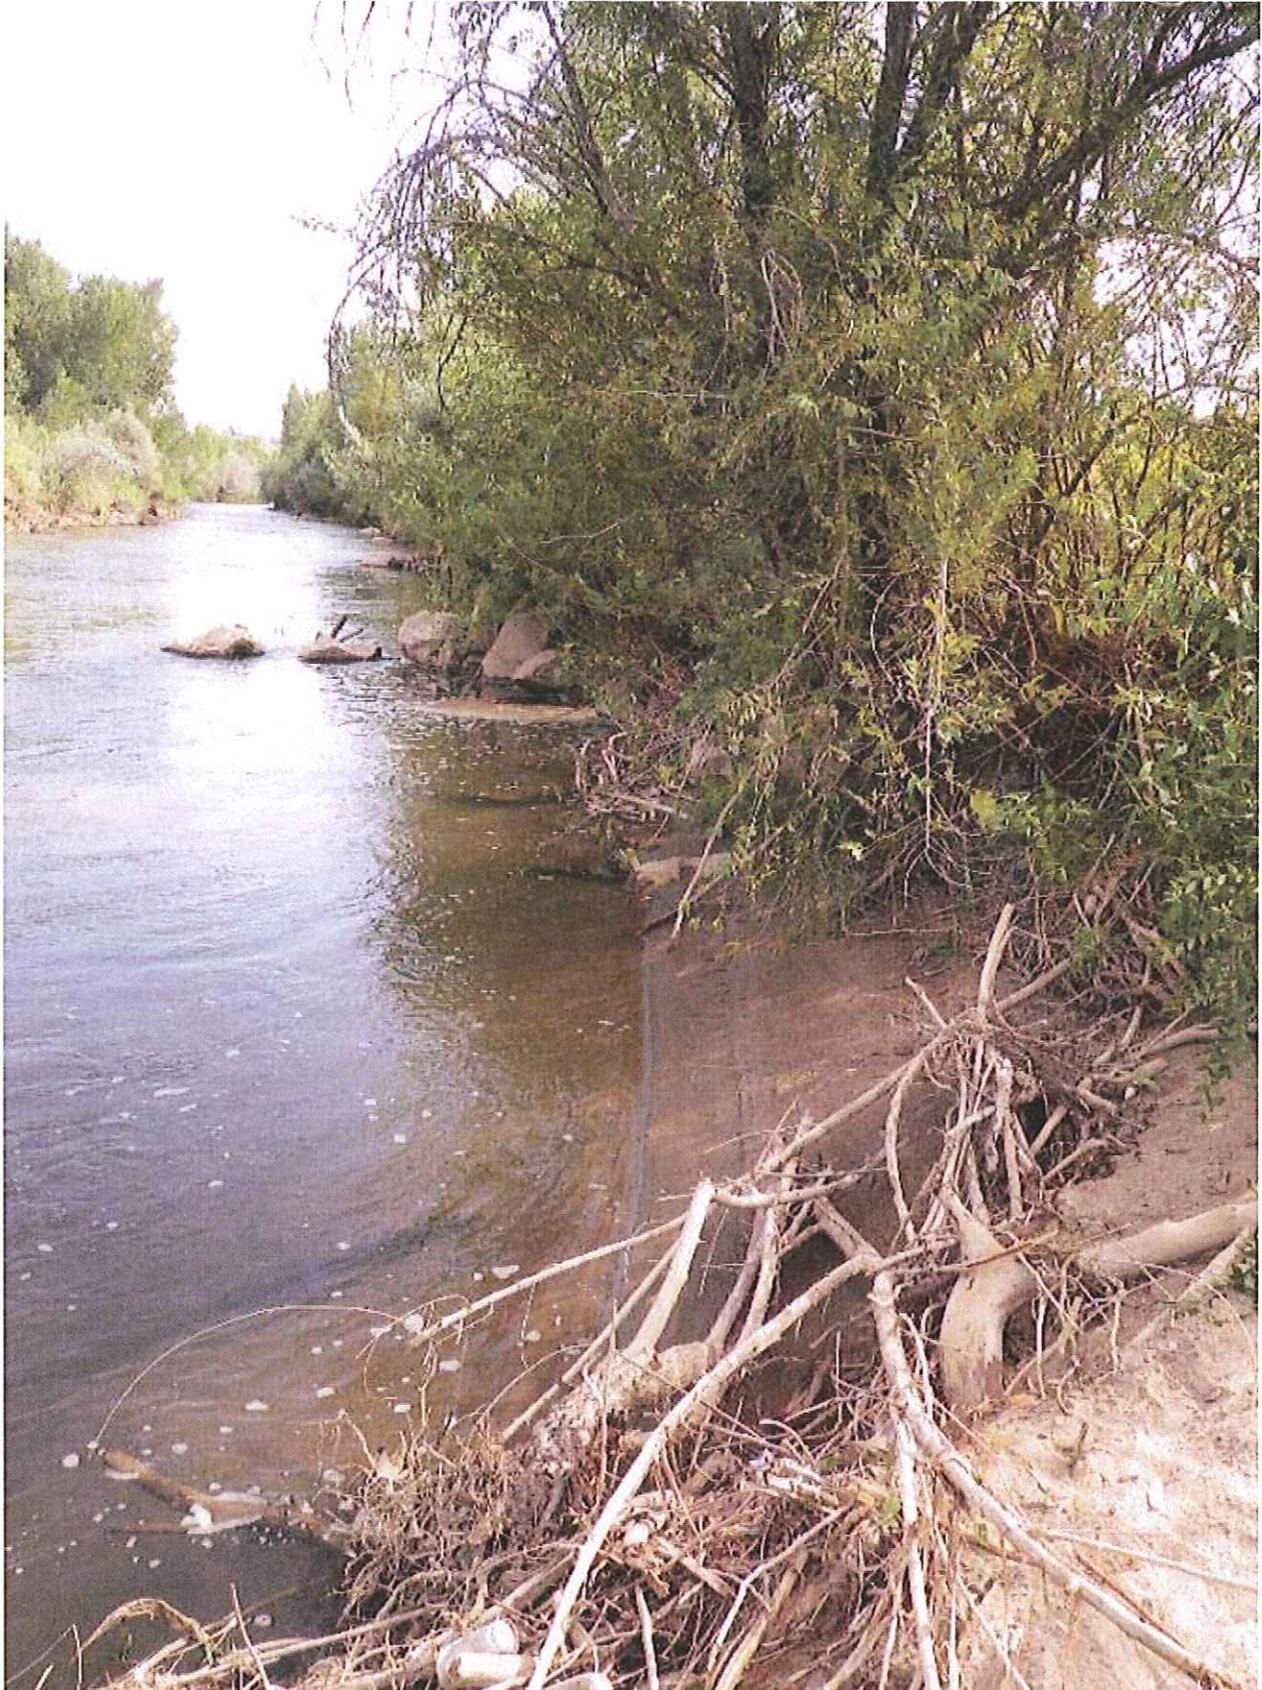
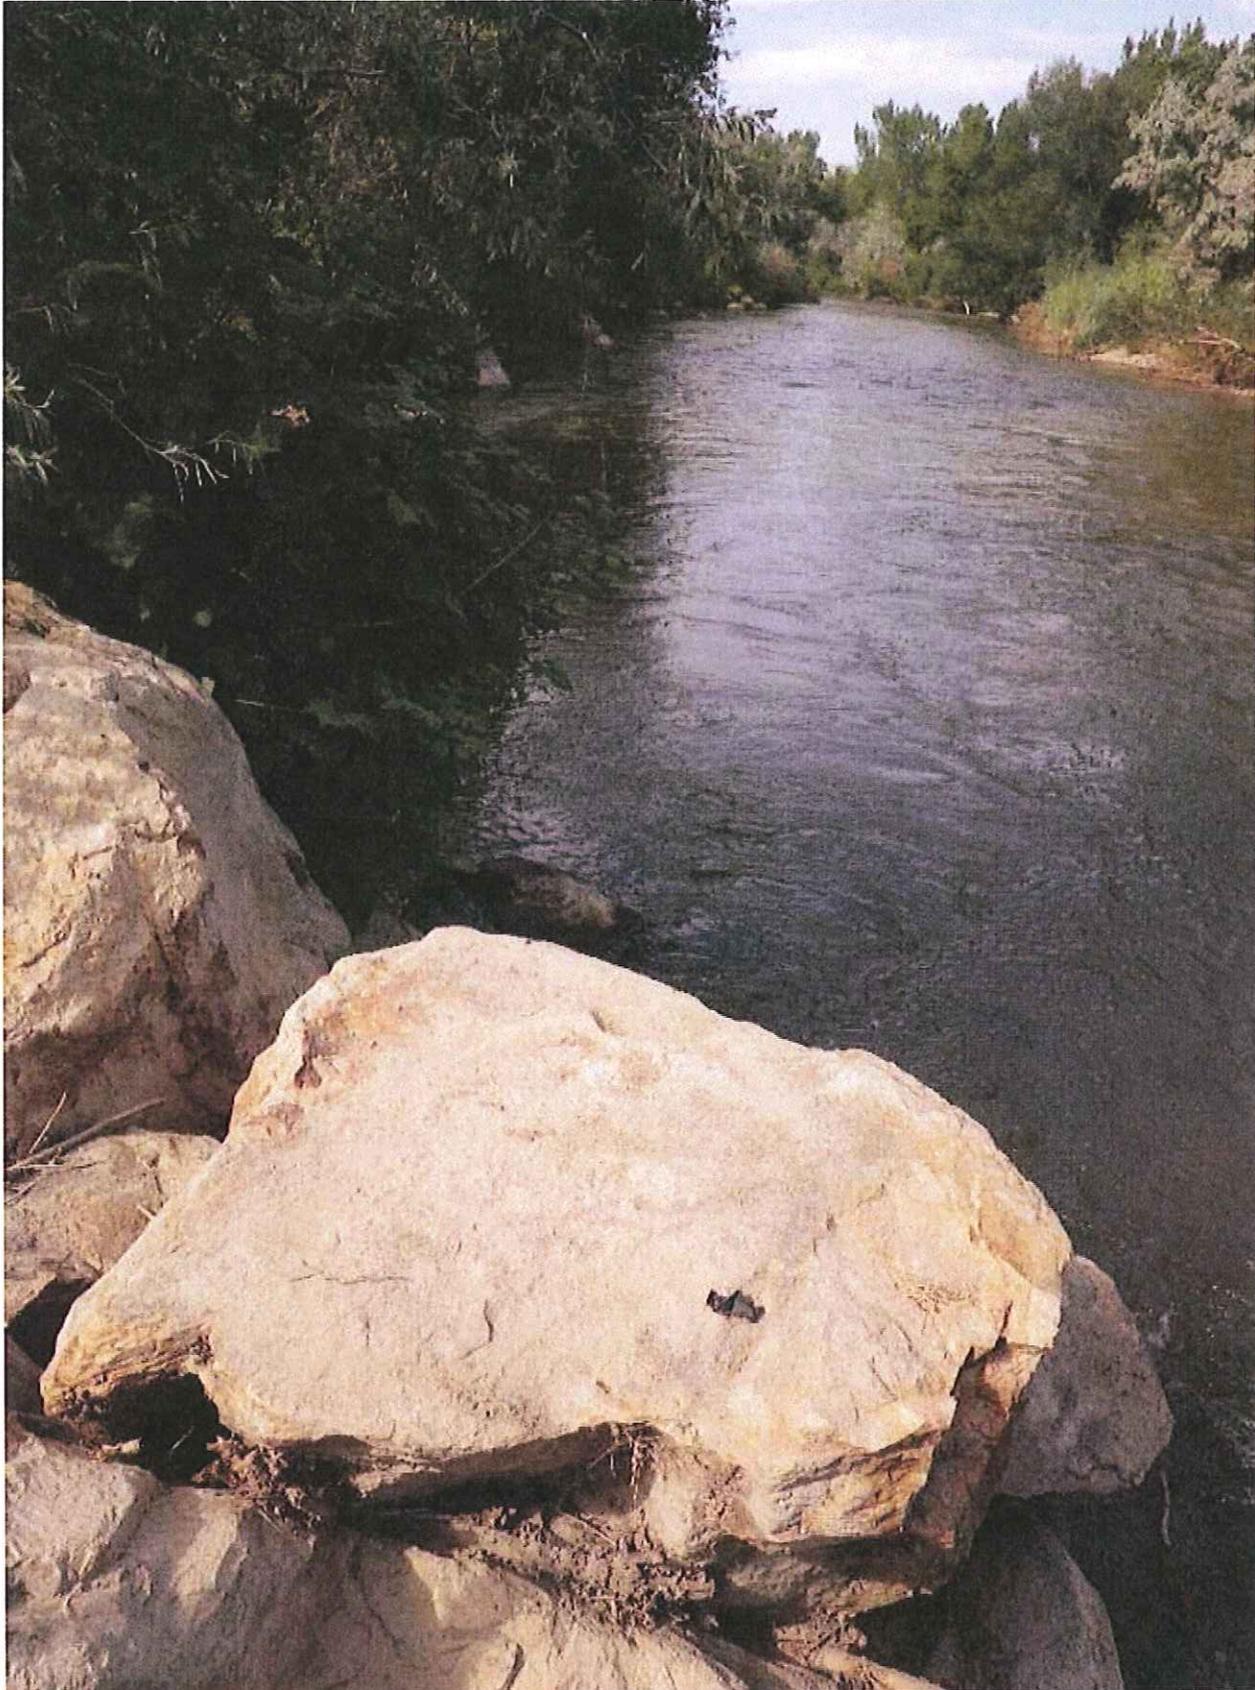
Flood Assessment Point:	#10-Failed Bank Stabilization
GPS Coordinates:	8-16-11 Points 46
Direction to Assessment Point:	This specific location is at the Junction of the Hunter Creek Trail and the Weber Parkway See also Failed J-Hooks Point 50 (8-16-11)
Project Priority:	High Moderate Low X
Description of Damage:	Non systemically planned constructed J-hooks and localized erosion
Structures:	J-hooks, Path
Geomorphic Description:	Similar to other location along the Weber River, these structure were placed to prevent bank erosion and the subsequent migration of the river channel. Installed in the 1980s or early 1990, these structures may have been intended to reduce shear stress on the bank by forcing the flow towards the centerline of the channel. Many of these structures were designed without consideration of systemic response. Other stabilization methods may be more appropriate for this location

Habitat Considerations:	j-hooks cause erosion which contributes to non-point source sediment pollution.
Flood Damage Repair:	<ul style="list-style-type: none"> • \$20,000-\$40,000
Measures:	<ul style="list-style-type: none"> • Option 1 (Flood Damage Replacement Project) <ul style="list-style-type: none"> ○ Remove J-hook structures ○ Use boulders for toe protection/Stabilization ○ Biostabilize bank ○ Toe Stability ○ \$35,000 - \$64,000
Photographs:	<ul style="list-style-type: none"> • IMGP0203 • IMGP0205 • IMGP0206
