RIVERDALE CITY COUNCIL AGENDA-AMENDED
CIVIC CENTER - 4600 S. WEBER RIVER DR.
TUESDAY – MARCH 6, 2012

Riverdale City 2011 Flood Damage Assessment

October 13, 2011

Prepared For:
Riverdale City, Utah
Public Works department
4600 South Weber River Drive
Riverdale City, Utah 84405

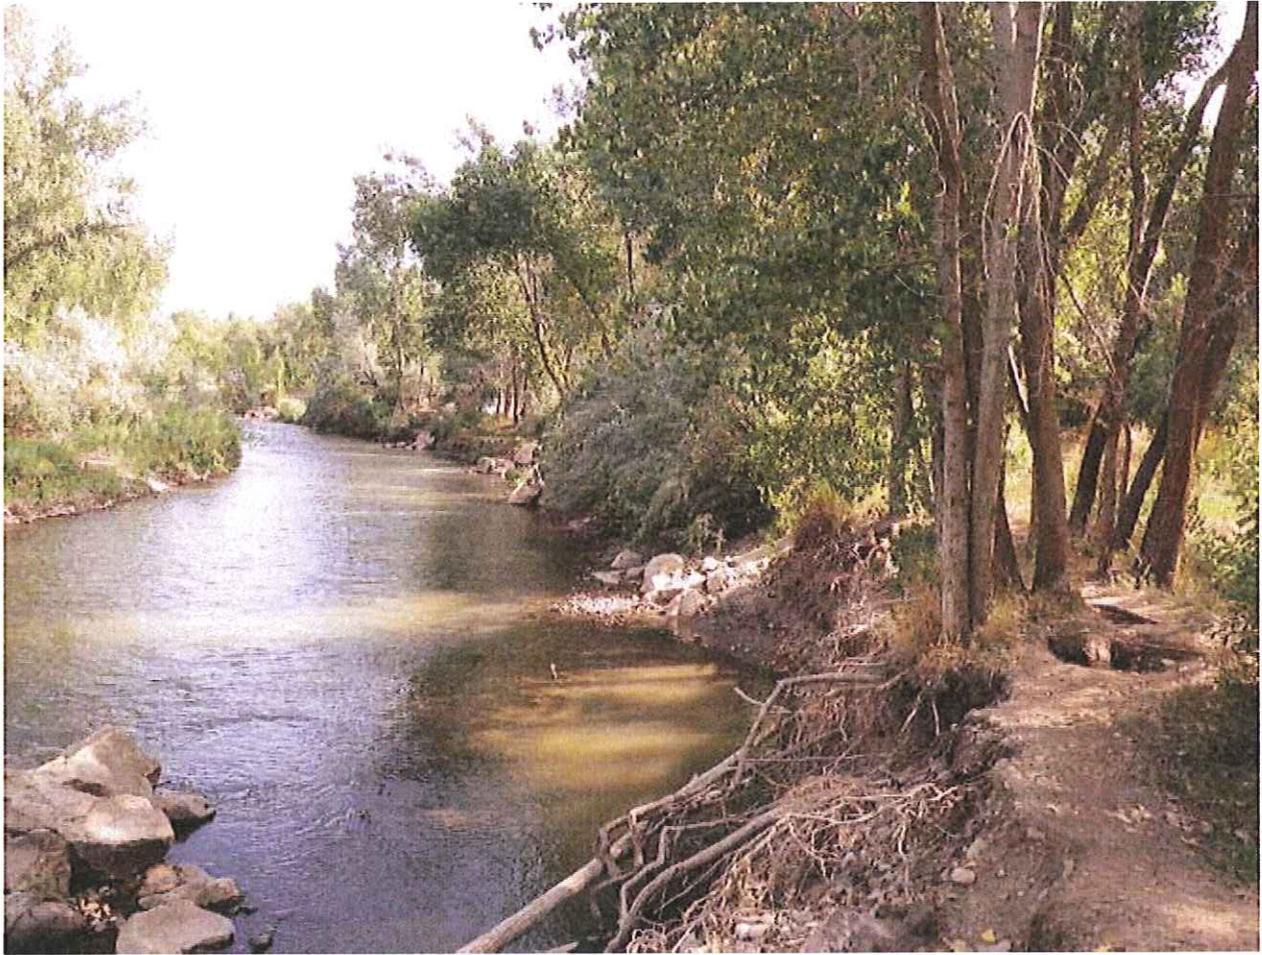
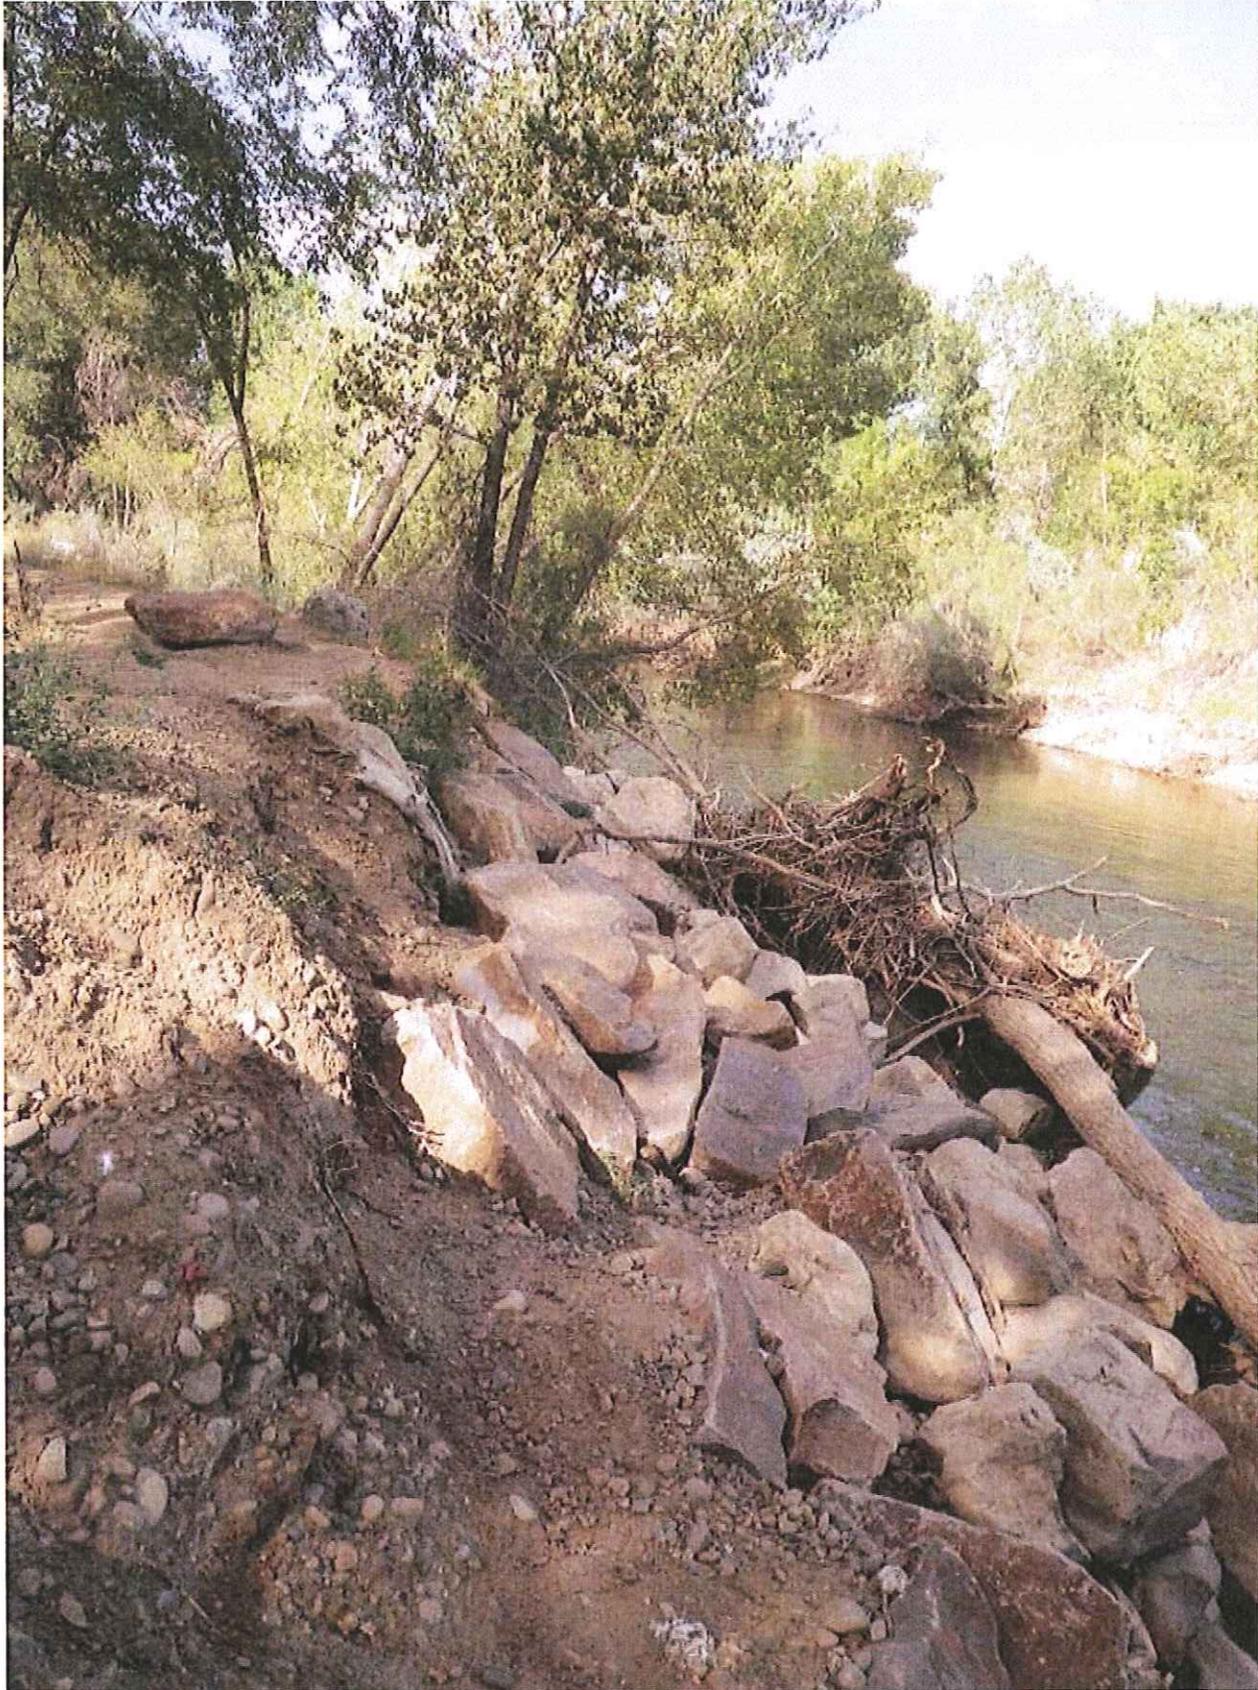
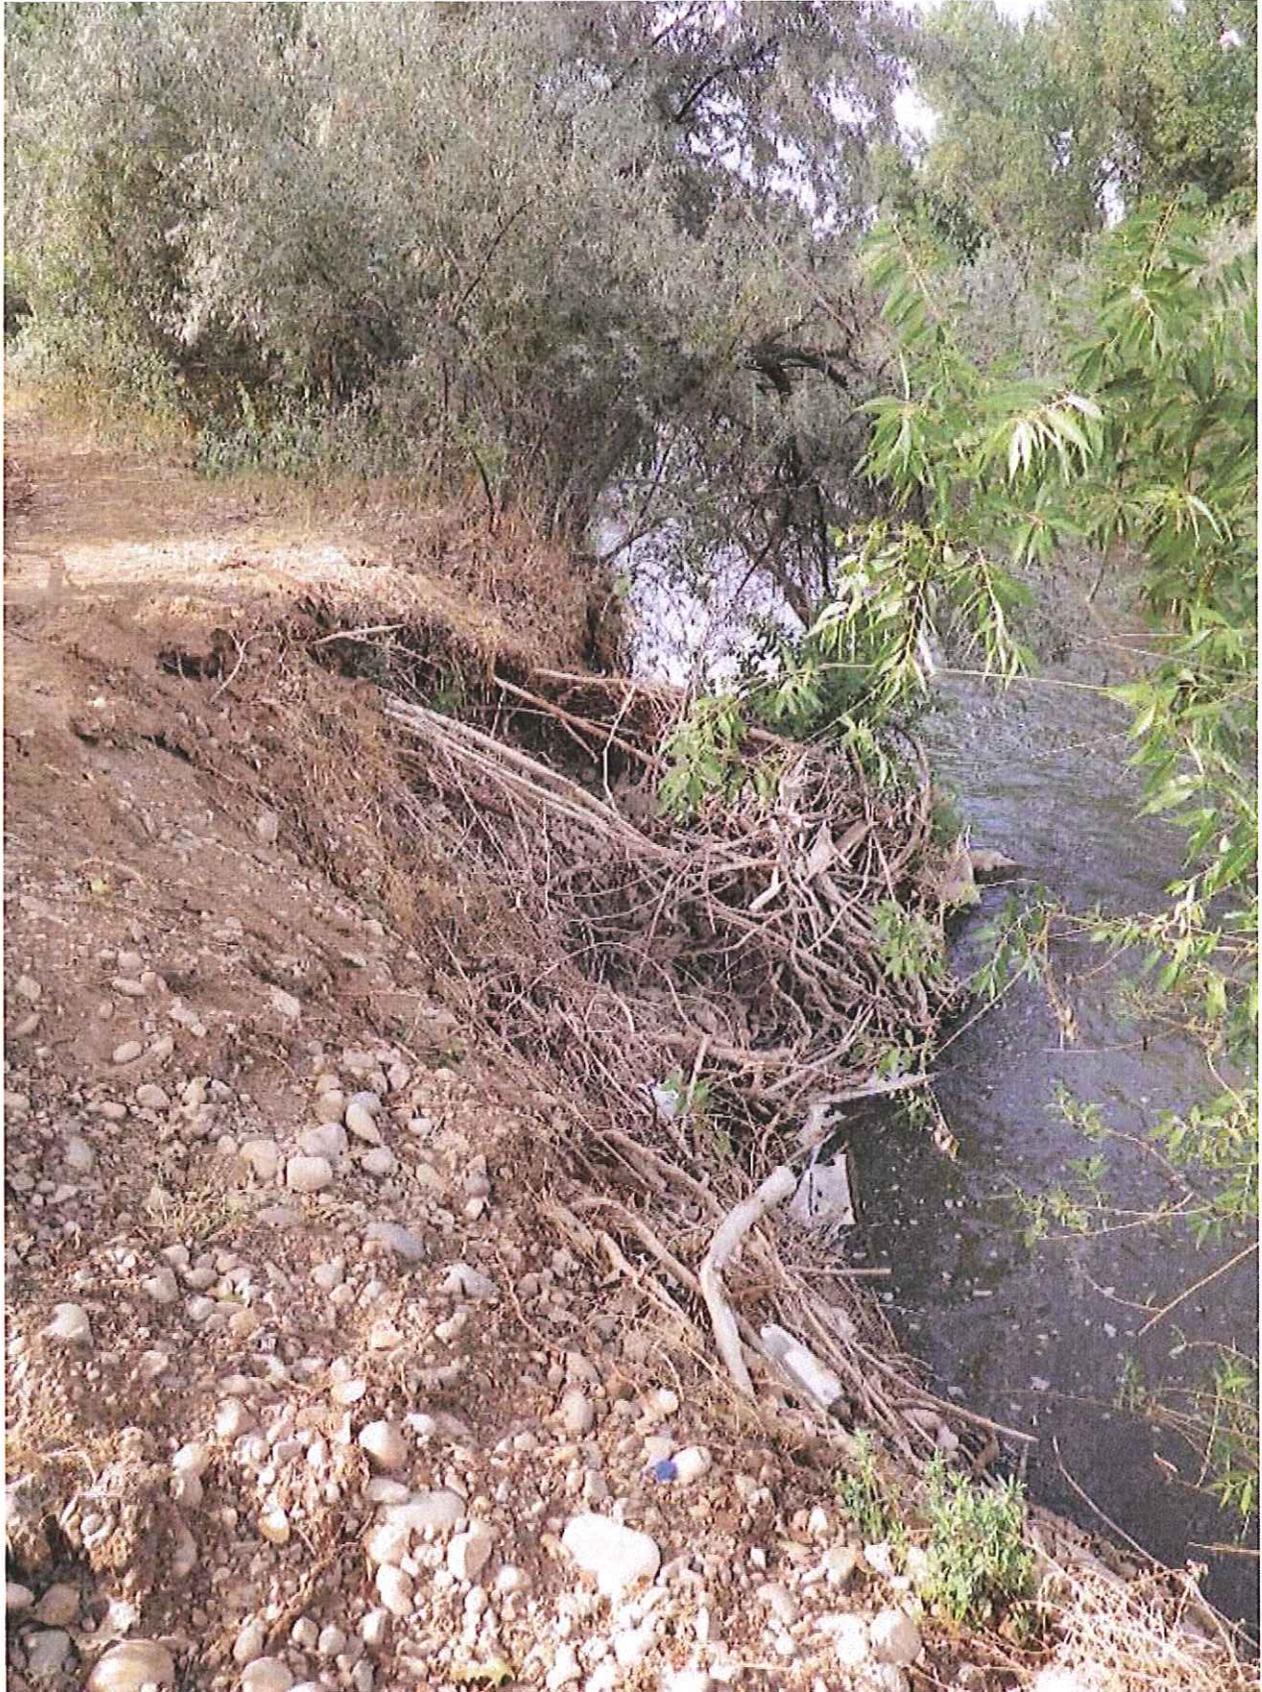
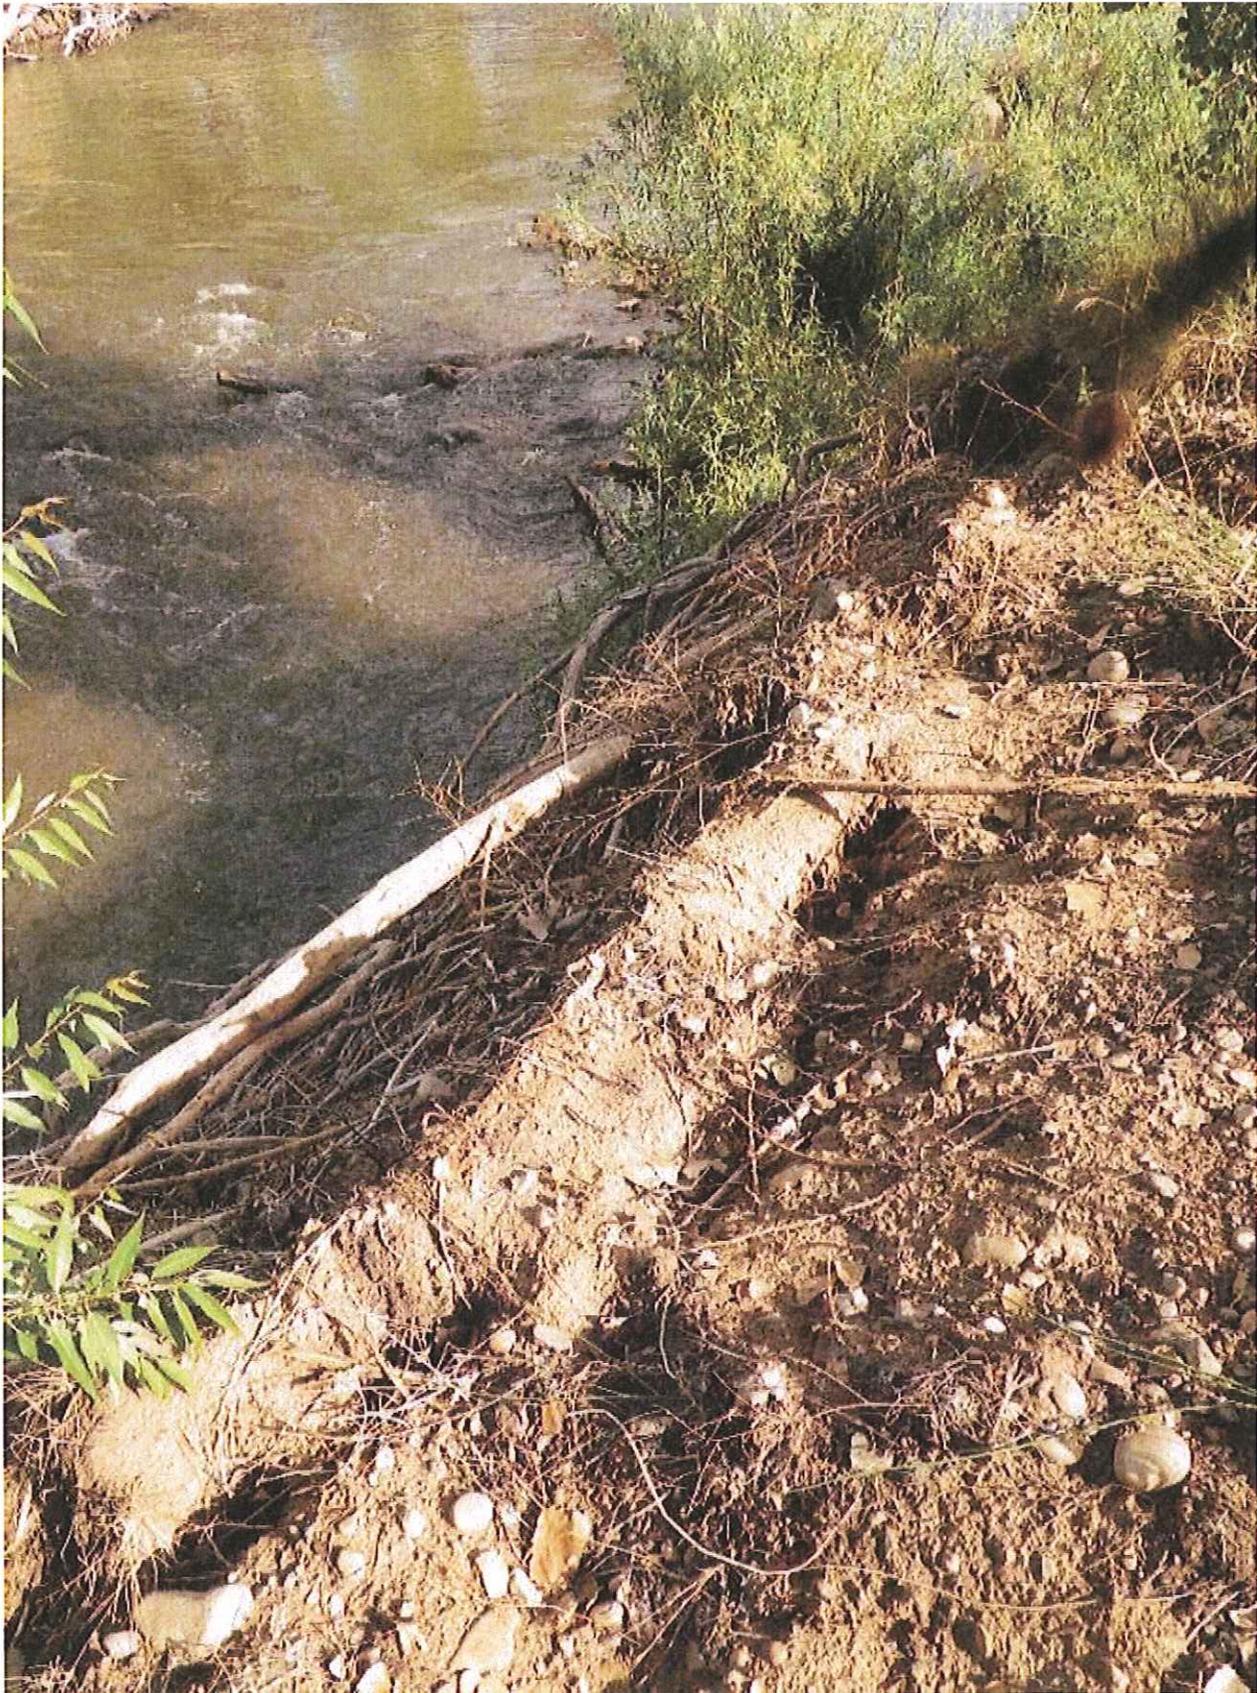
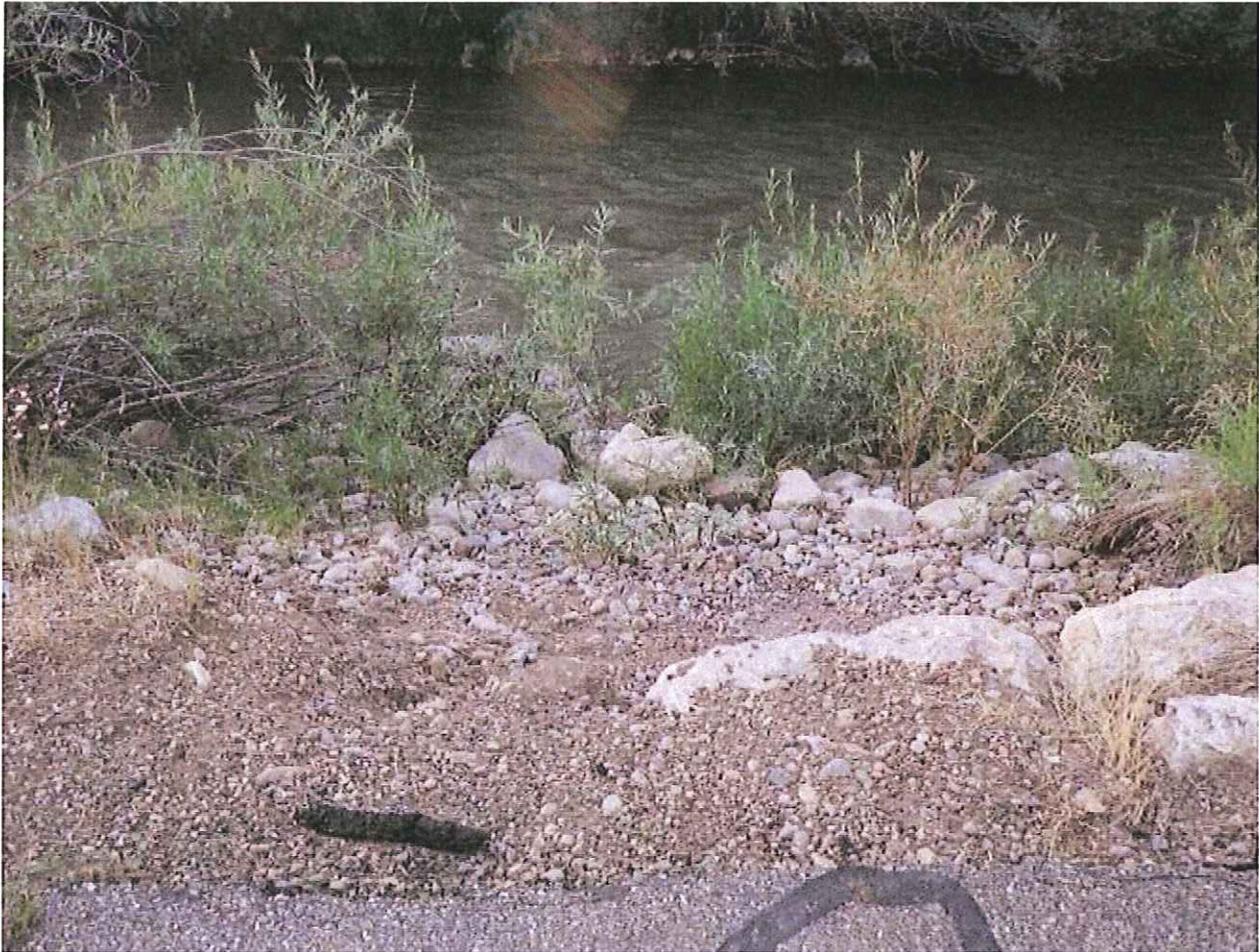
Photographs:	<ul style="list-style-type: none"> • IMG0211

Flood Assessment Point:	#11-Failed Bank Stabilization
GPS Coordinates:	8-16-11 Points 50, 51
Direction to Assessment Point:	Upstream end is approximately 330ft downstream of the Riverdale Kayak Park on the Pathway
Project Priority:	High Moderate Low X
Description of Damage:	Numerous failed J-hook structures, failed rip-rap and eroded banks and resulted bank failure is approximately 700' long and 10' high.
Structures:	Path, Homes, Land
Geomorphic Description:	These structures (rip-rap and J-hooks) were installed in response to the rivers channelized flow path to protect land and the Parkway. The residential areas to the west of this location were constructed in the late 1970s and early 1980s. Aerial photography from the 1950s shows that the location of the River Valley Subdivision was a historic flow path for the Weber River. Prior to the subdivision development the Weber Rivers geomorphically active floodplain was more than 1000ft wide. The historic photos also show a large oxbow flood channel located in the exact location of 4300 S (A.K.A. Oxbow Dr.) and River Valley Dr. Presently the River is constrained to a corridor that is 100 to 150 ft wide.

Habitat Considerations:	Source of non-point source sediment pollution.
Flood Damage Repair Measures:	<ul style="list-style-type: none"> • \$100,000-\$200,000 • Option 1-(Flood Damage Replacement) <ul style="list-style-type: none"> ○ 700 ft of bank stabilization ○ Remove J-Hooks and use boulders for toe protection ○ Import material to protect bank. ○ \$200,000-\$350,000 • Option 2-(Flood Improvement, Improved Project) <ul style="list-style-type: none"> ○ Remove upper bank boulders and riprap and place 150' D.S. to connect left bank levee (100' Long) ○ Improving D.S. flood overflow channel. ○ \$64,000 • Options 3-(Flood Mitigation Project) <ul style="list-style-type: none"> ○ Remove upper bank boulders and riprap and place 150' D.S. to connect left bank levee (100' Long) ○ Improving D.S. flood overflow channel. ○ Realign Bike Path away from River. ○ Biostabilize Left Bank ○ \$85,000-\$120,000
