RIVERDALE CITY COUNCIL AGENDA-AMENDED
CIVIC CENTER - 4600 S. WEBER RIVER DR.
TUESDAY – MARCH 6, 2012

Riverdale City 2011 Flood Damage Assessment

October 13, 2011

Prepared For:
Riverdale City, Utah
Public Works department
4600 South Weber River Drive
Riverdale City, Utah 84405

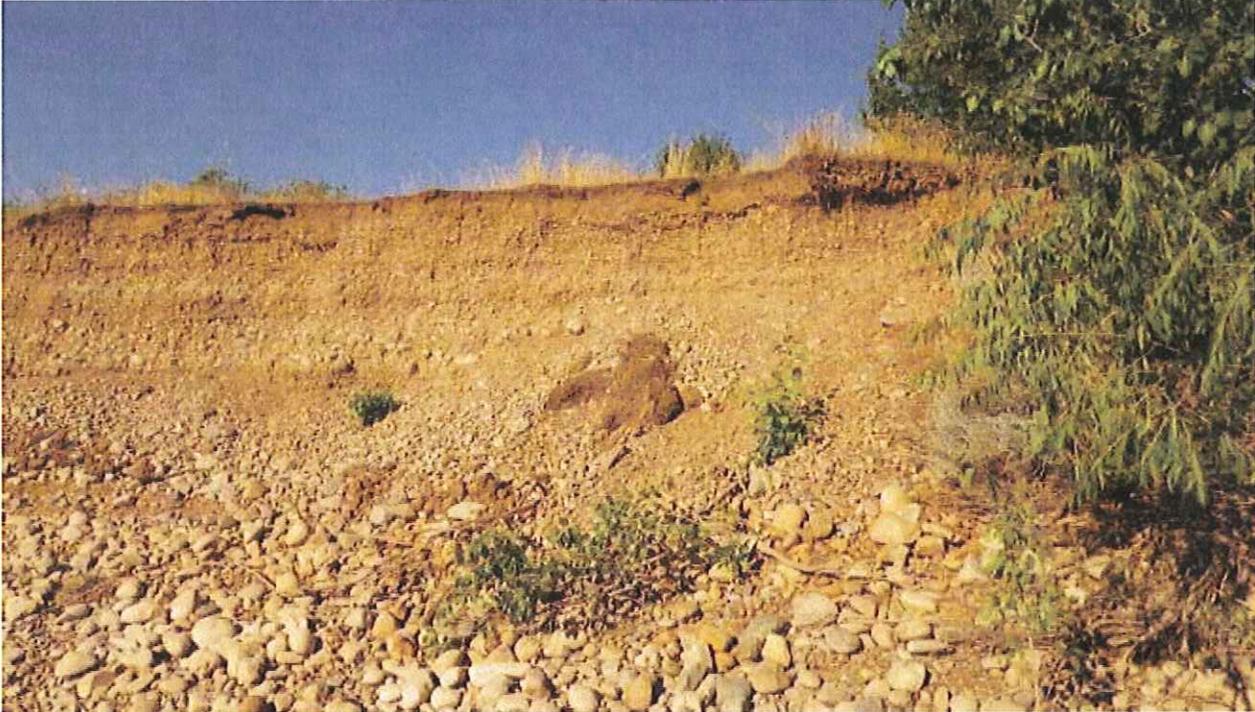
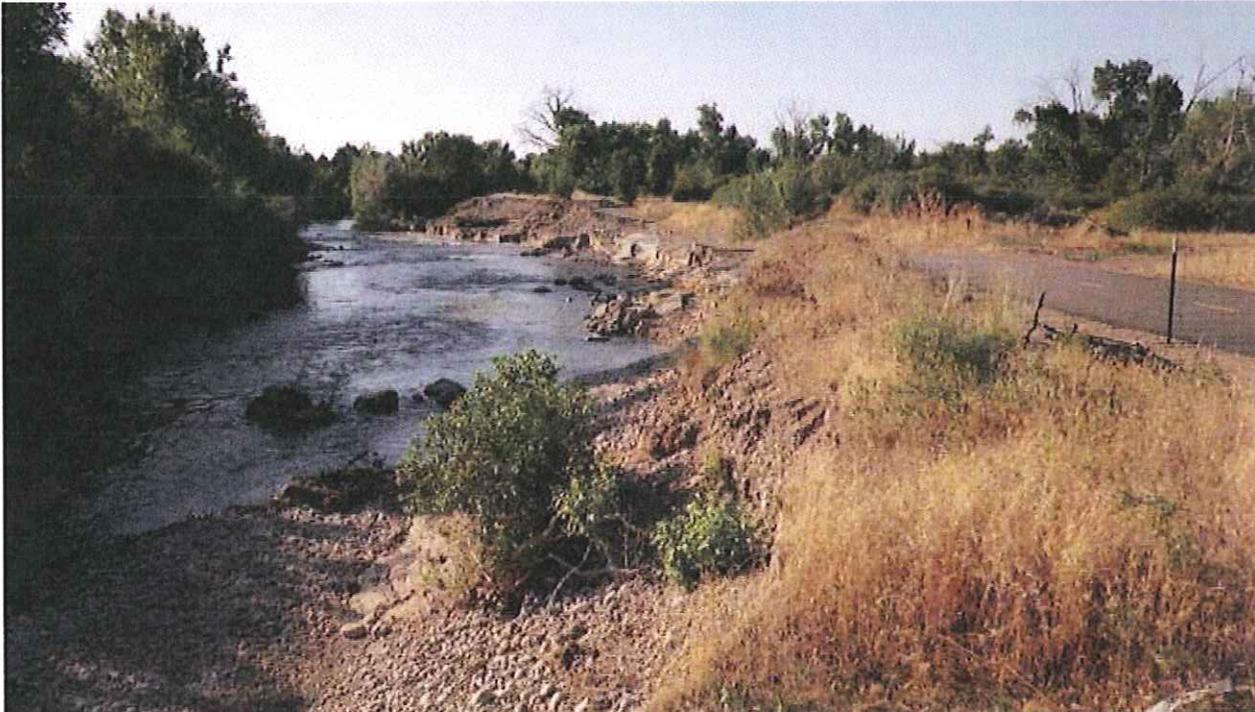
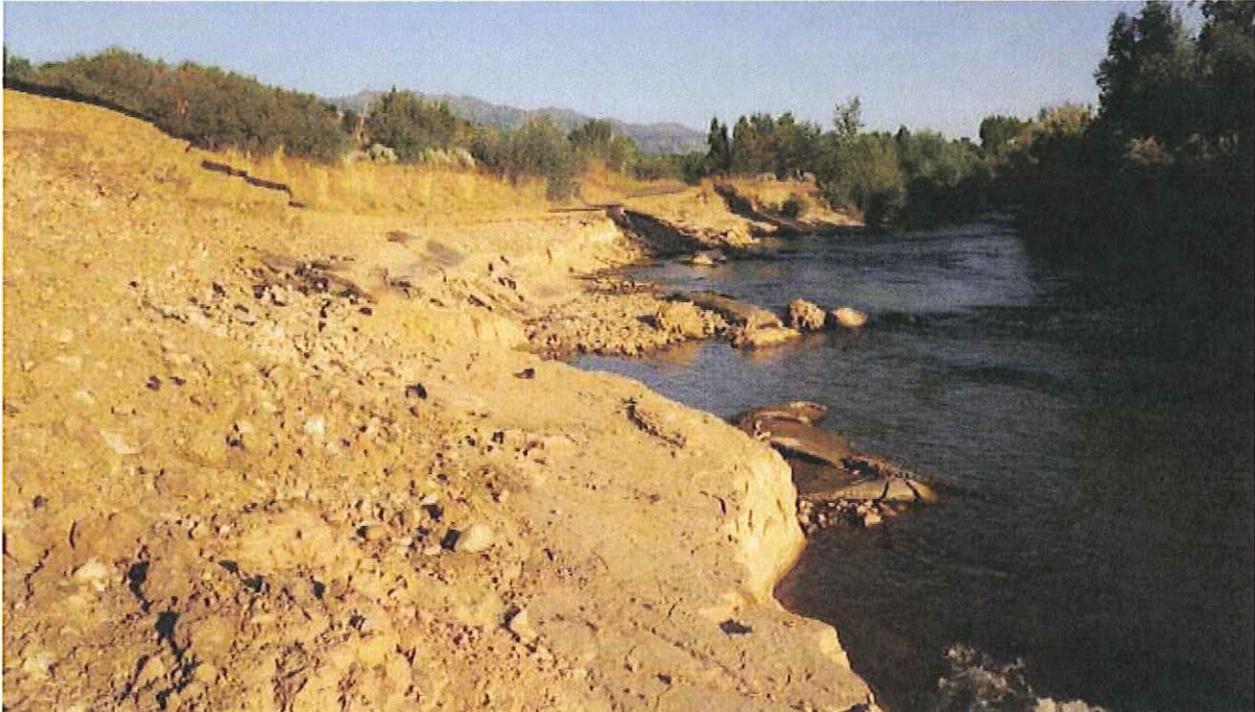
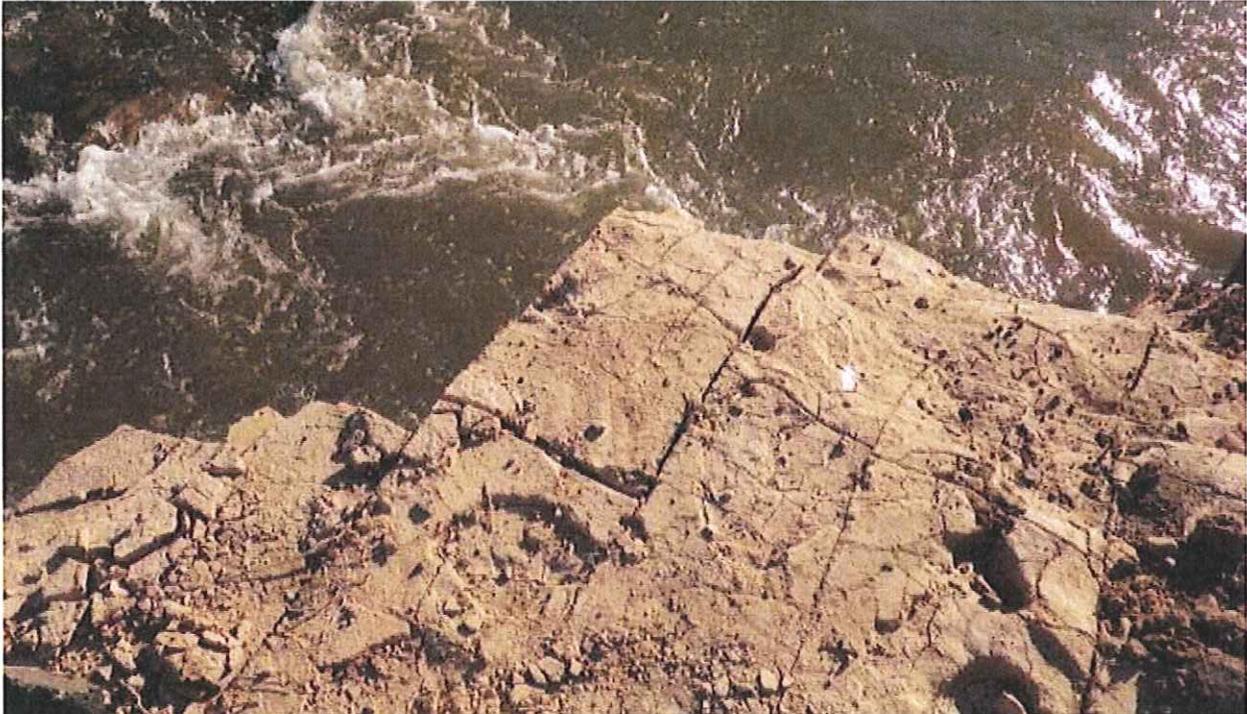
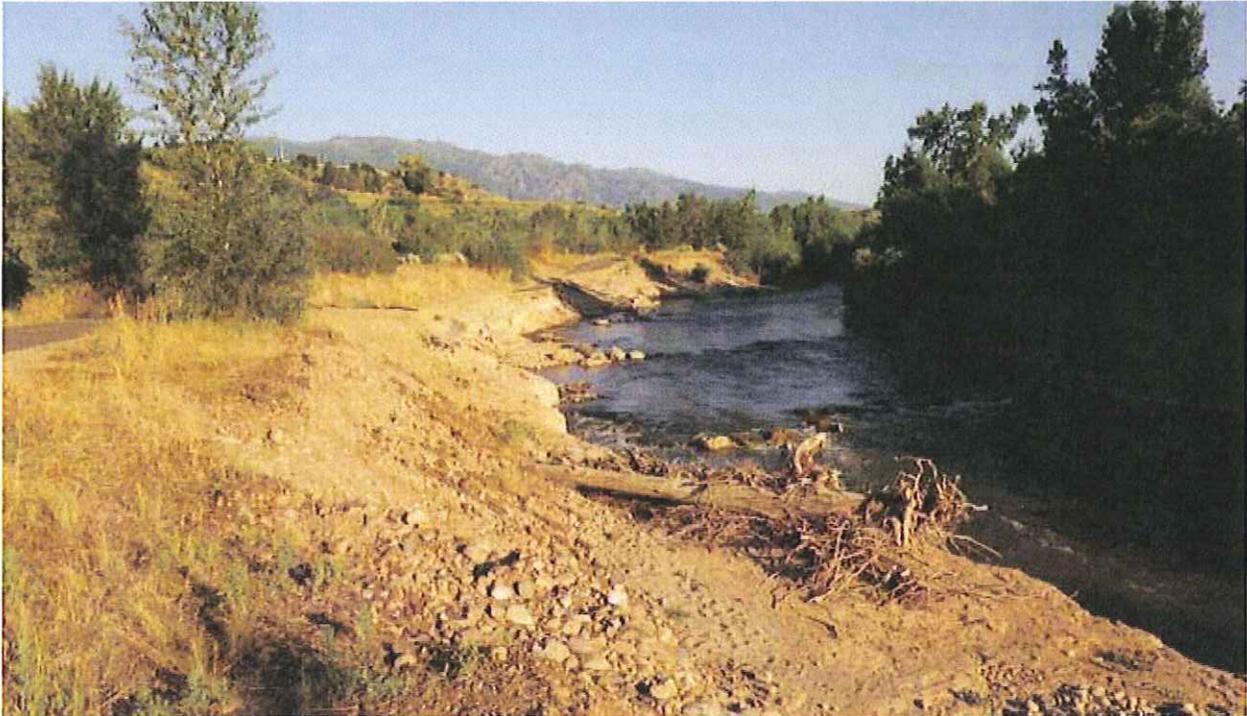
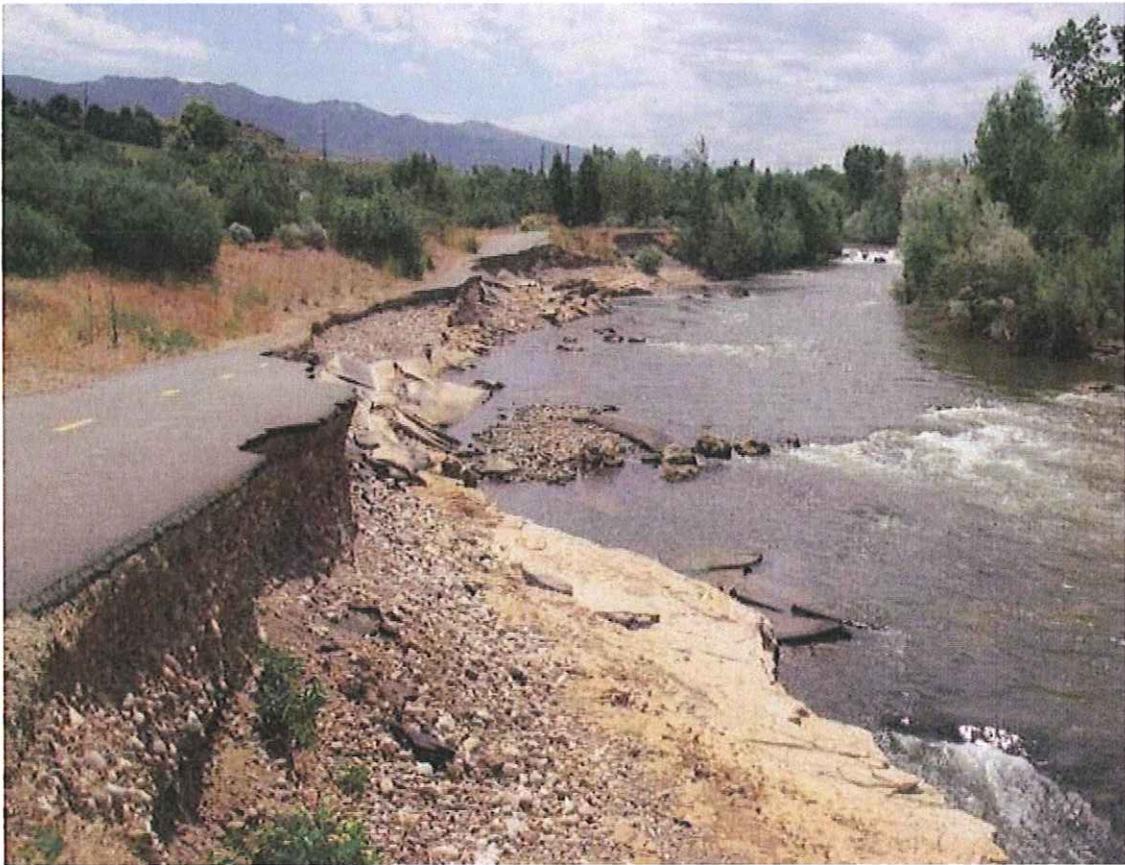
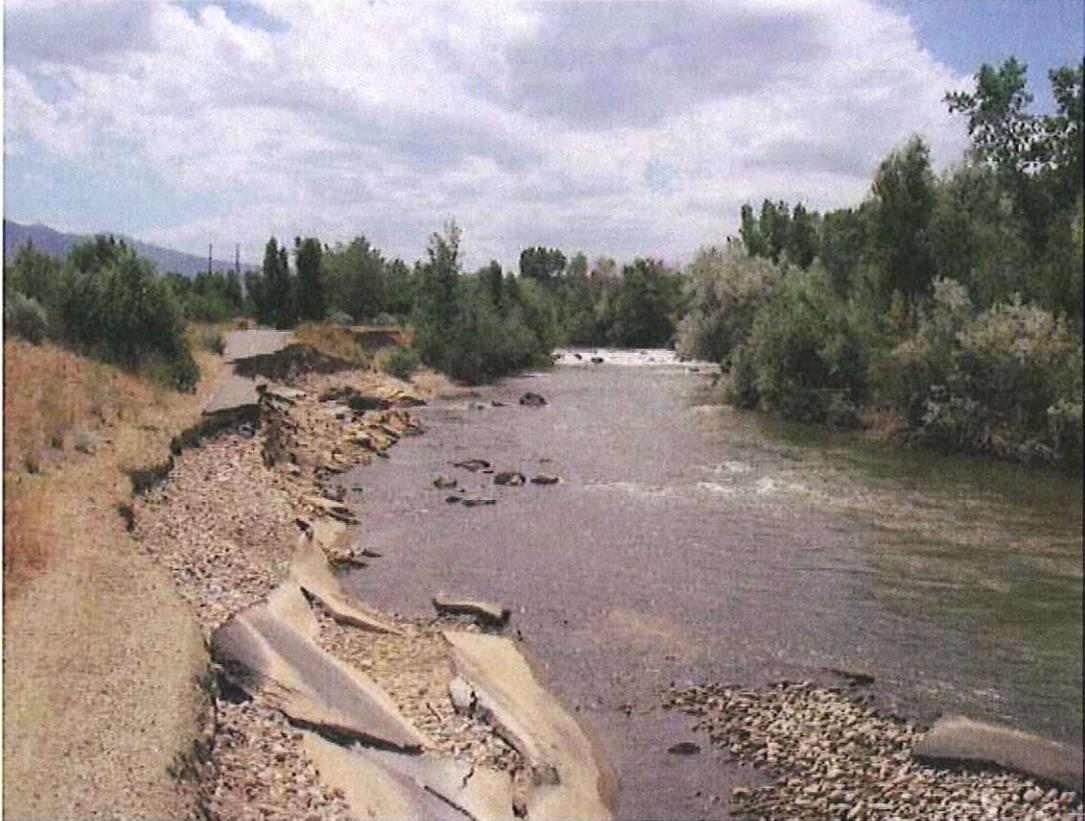
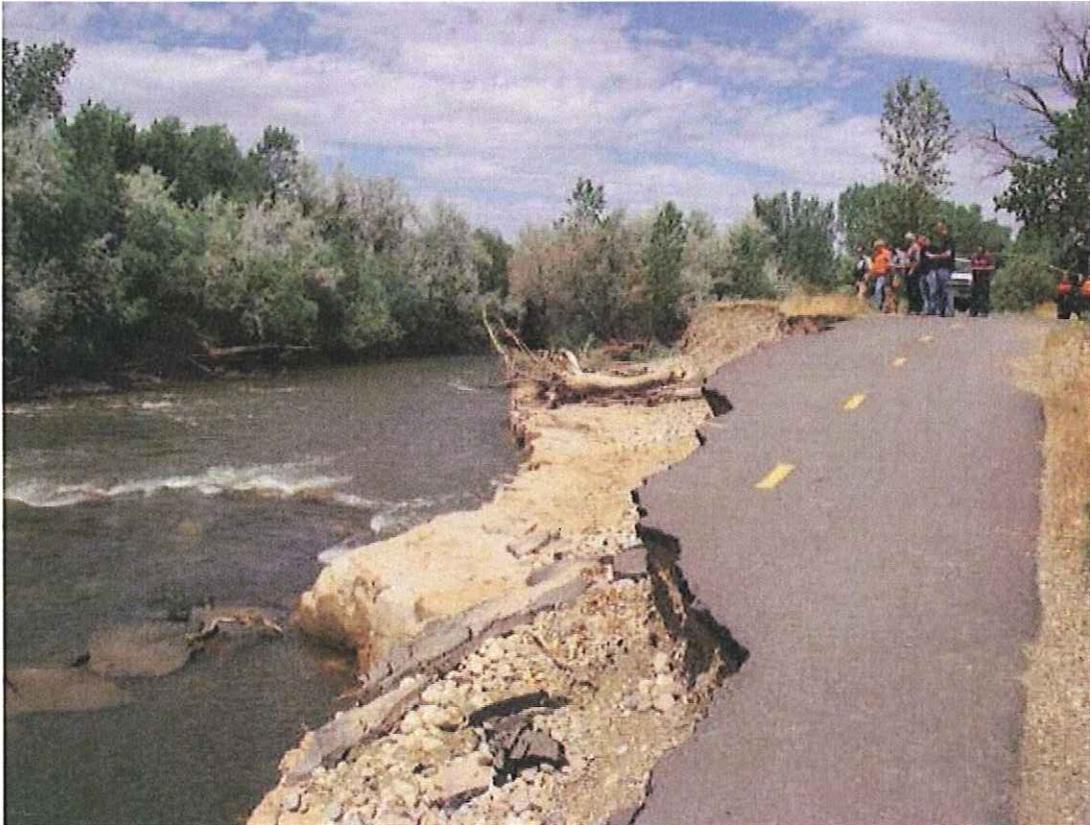
Flood Assessment Point:	#1-Weber River Parkway Collapse						
GPS Coordinates:	Waypoints RC-10 to 29						
Direction to Assessment Point:	Approximately 5260ft upstream from Weber River Dr. on bike path.						
Project Priority:	<table style="width: 100%; border: none;"> <tr> <td style="width: 33%;">High</td> <td style="width: 33%;">Moderate</td> <td style="width: 33%;">Low</td> </tr> <tr> <td style="text-align: center;">X</td> <td></td> <td></td> </tr> </table>	High	Moderate	Low	X		
High	Moderate	Low					
X							
Description of Issue:	Sever erosion of nearly 550 ft of bank resulting in collapse of 300' of asphalt pathway.						
Structures:	Bike Path						
Geomorphic Description:	<p>Aerial photographs from 1953, 1954, 1971, 1973, 1979, 1980, 1997, 2003, 2006, and 2009 were reviewed to understand the geomorphic evolution of this reach. This portion of the Weber River was channelized in the early 1970's for the construction of I-84. Prior to channelization this reach had meanders with a similar planform to the upstream DNR reach as it exists today. Aerial photography from 1953 shows that the reach length has been reduced by over 20% (7500 feet to 5800 ft). In addition to decreasing the length and a subsequent decrease in slope the construction of the highway also narrowed the effective floodplain of the river. Historic channel patterns are also evident in the 1953 photo. These patterns indicate that the Weber River may have had a meander belt width in excess of 1500ft. Aerial Photographs from 1999 and 2009 show that virtually all of the meanders have been eliminated through channelization and the riparian corridor is less than 150 ft wide. In addition to the channelization a water main crossing was placed just upstream of the failed bike path (RC-9) creating a large drop structure. The river has responded to these changes by cutting into the right bank as it attempts to adjust its flow path length. The river was cutting at this bank prior to the construction of the path in 2009. Between 1997 and 2006 the bank eroded a horizontal distance of approximately 55-60 ft. Some of this bank loss was reclaimed with the construction of the path in 2009. The 1971 photo shows a mid-channel bar formed immediately across the river from the area of the failed bike path. Portions of this bar were left unaltered during the construction of the highway. It is likely that during high flows this mid channel bar become inundated and provided extra conveyance. During the extended drought period that ended in 2008 riparian vegetation was established on this bar thus closing off any significant conveyance. The lack of overbank flooding and the establishment of mature riparian vegetation has effectively eliminated any overbank</p>

<p>conveyance through this reach. Additionally there is evidence of bank toe erosion throughout this reach, indicating that the river is down cutting. Evidence of overbank flooding at downstream end of bank failure. Large amounts of driftwood caught in overgrown understory may have decreased overbank conveyance.</p>
Habitat Considerations:	<p>Throughout this reach there is a lack of habitat diversity. Channelization has created uniform flow patterns and in portions the riparian vegetation is sparse. There is little evidence of deposition through this reach. Eroded bank material is likely transported through the reach and deposited downstream of Riverdale City.</p>
Flood Damage Repair	<ul style="list-style-type: none"> • \$250,000-\$350,000
Measures:	<ul style="list-style-type: none"> • Option 1 (Flood Damage Improved Project): <ul style="list-style-type: none"> ○ Reconstruct Bike path further northeast. ○ Biostabilize Bank ○ \$50,000-\$100,000 + Lands • Option 2 (Flood Damage Improved Project): <ul style="list-style-type: none"> ○ Reconstruct bike path in new alignment ○ Stabilize Toe ○ Lay river bank back at 3:1 and biostabilize ○ Thin out overgrown riparian vegetation on river left to open up flood conveyance channels. ○ \$200,000 to \$300,000 + Lands

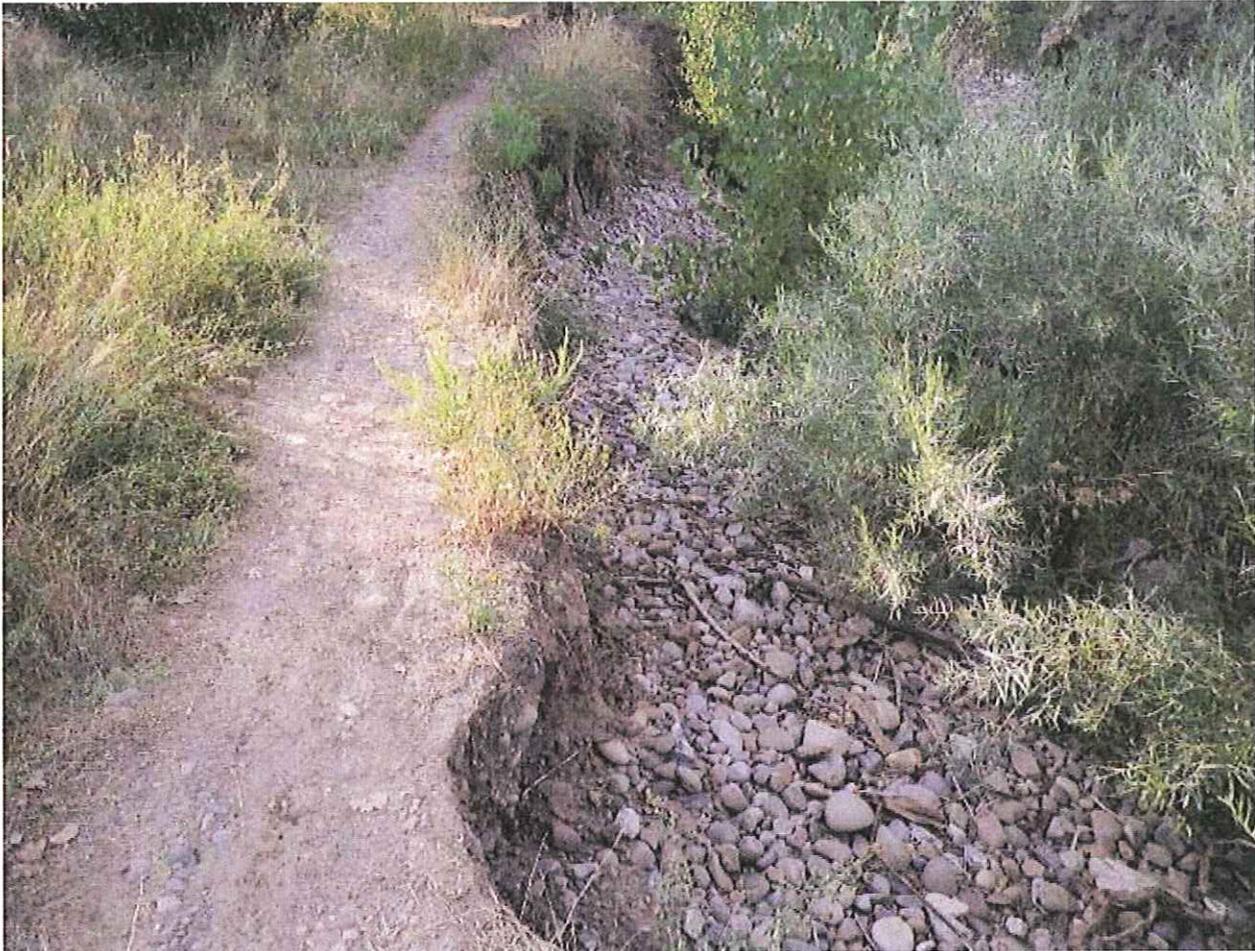
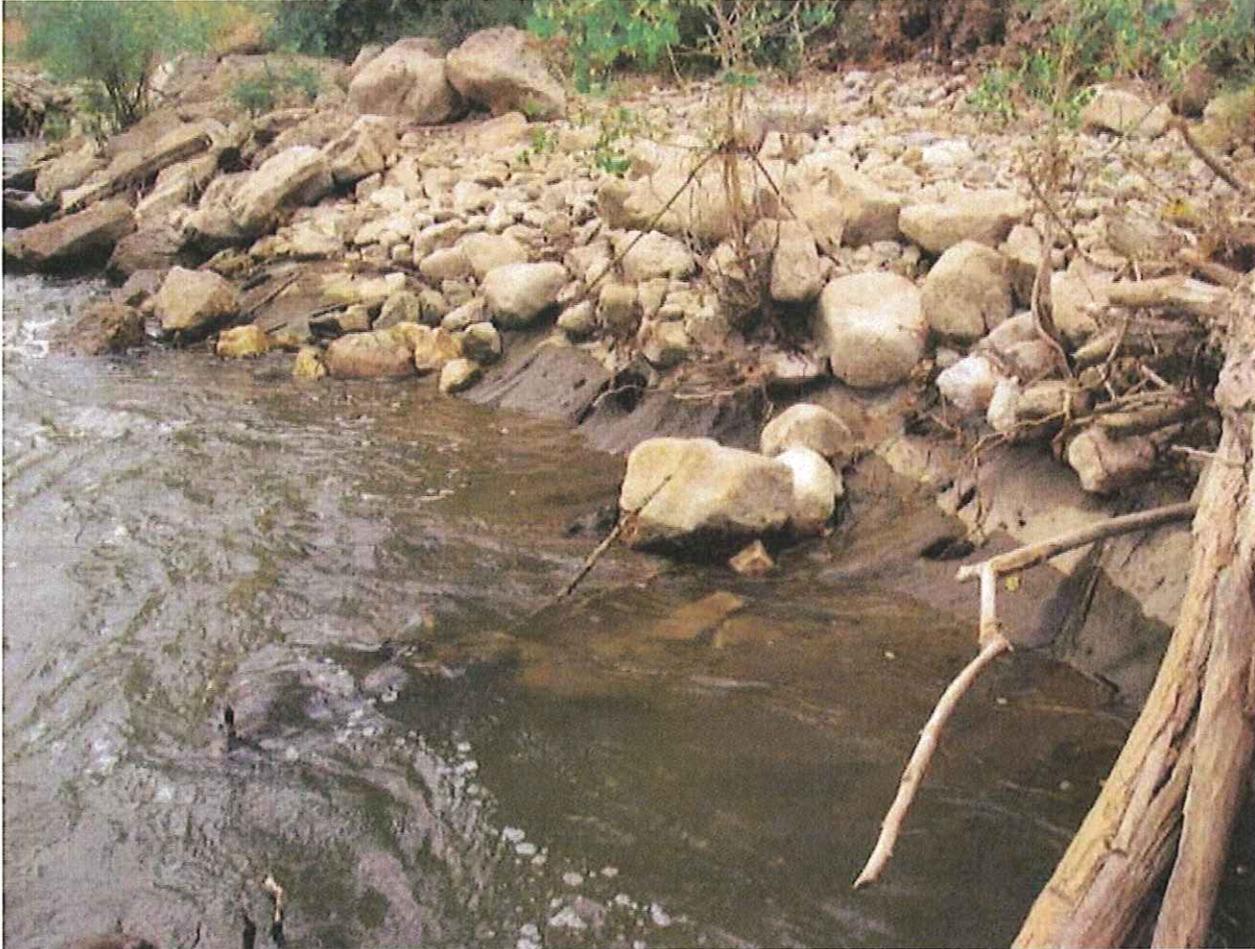
Photographs:	<ul style="list-style-type: none"> • IMGP0159 • IMGP0160 • IMGP0161 • IMGP 2796

Flood Assessment Point:	#4-Riverdale Play Park, Grade control and Riprap Failure
GPS Coordinates:	8-16-11: Pts 9 & 10
Direction to Assessment Point:	Approximately 600 ft downstream on the bike path from the South Weber River Dr. trailhead.
Project Priority:	High Moderate Low X
Description of Issue:	Grouted Riprap appears to be failing and as a result the whitewater wave no longer functions. Probing indicates 8’ deep hole upstream of the grouted grade control and an 8’ deep hole downstream of the structure. Design drawings indicate that the cutoff wall above the lower drop is only 5’ deep; it is likely that the grouted riprap has been undercut. Additionally the grouted grade control on the left bank between the two structures has also failed and there is significant erosion in the viewing area on the left bank at the lower drop. This erosion extend downstream over 350 ft. This is a High Priority project for a number of reasons: 1) the Riverdale Whitewater Park is a world class whitewater feature that brings tourism \$ into Riverdale, 2) <u>Potential significant entrapment hazard to boaters/swimmers (There is a popular rope swing just upstream of the lower structure)</u>

not uncommon for grouted grade control structures to be undercut. Additionally, the downstream hydraulics have caused significant bank erosion on the right bank of the river. General channel degradation is likely downstream of the grade control structure. Due to the excessive channel scour the structure no longer functions as designed.
Habitat Considerations:	This structure provides better fish passage than the upstream drop structures.
Flood Damage Repair:	<ul style="list-style-type: none"> • \$250,000-\$350,000
Measures:	<ul style="list-style-type: none"> • Option 1 (Flood Damage Lower Structure Improved Project) <ul style="list-style-type: none"> ○ Re-Grout riprap ○ Fill voids under structure with Flowable Fill ○ Replace Cutoff Wall (sheet pile) ○ Biostablize Left Bank ○ Repair downstream grade control ○ \$200,000-\$300,000 • Option 2- (Replace Lower Structure, Alternate Project) <ul style="list-style-type: none"> ○ Remove grouted rip-rip ○ Construct new structure out of large boulders embedded below scour depth ○ Install pre-cast “Wave Blocks” to create play wave ○ Install Sheet pile cutoff. ○ Protect viewing area with boulder and flagstone ○ \$350,000-\$650,000

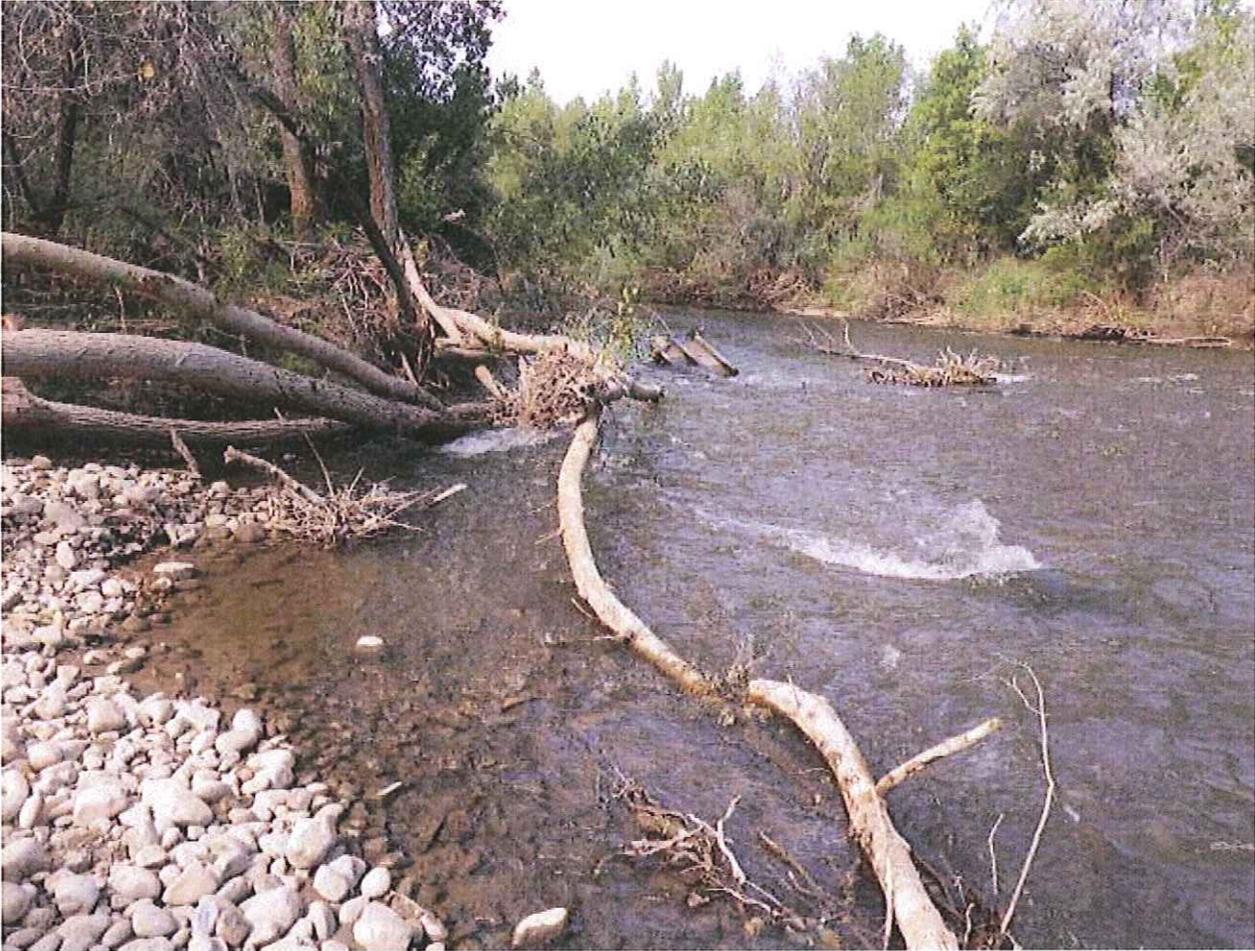
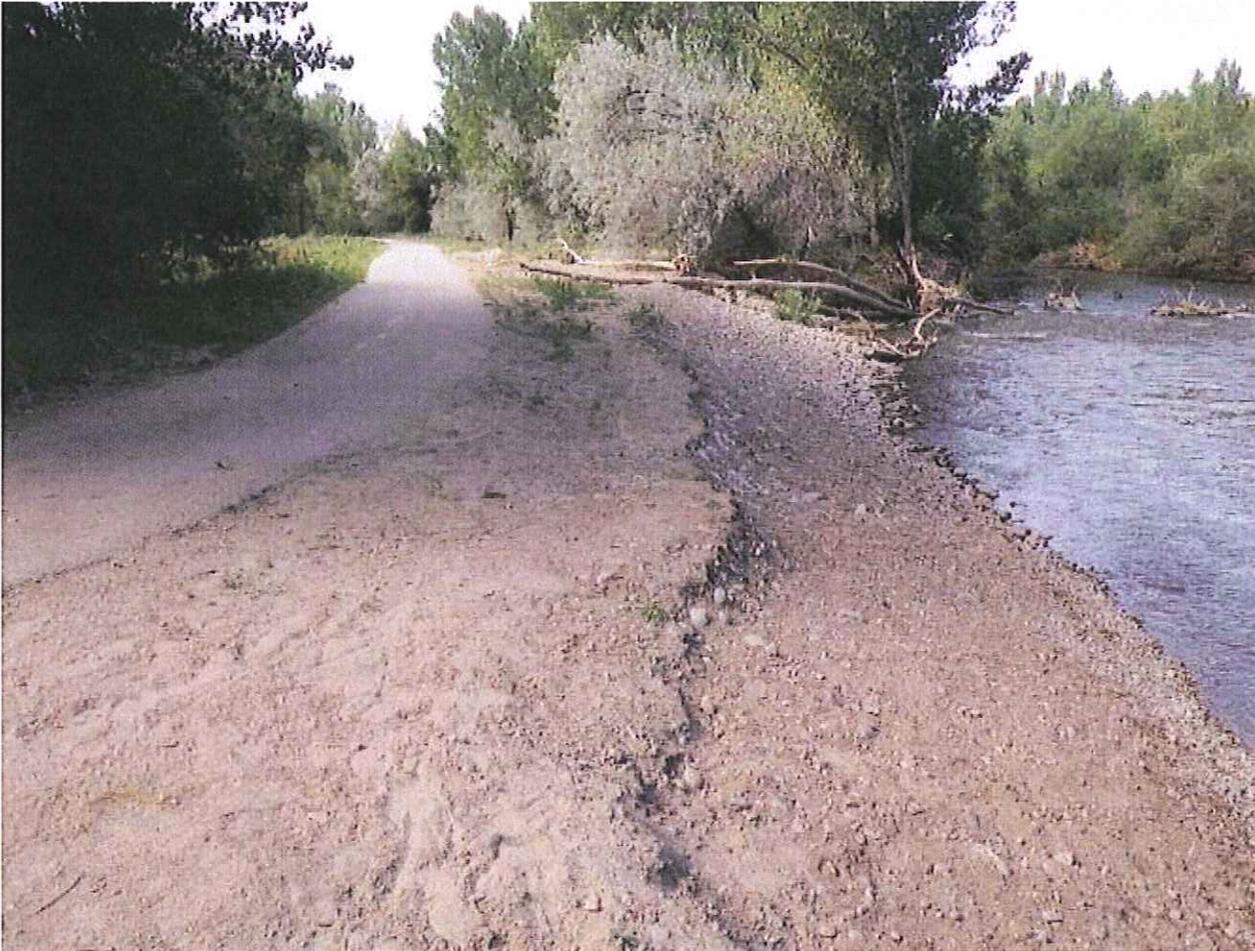
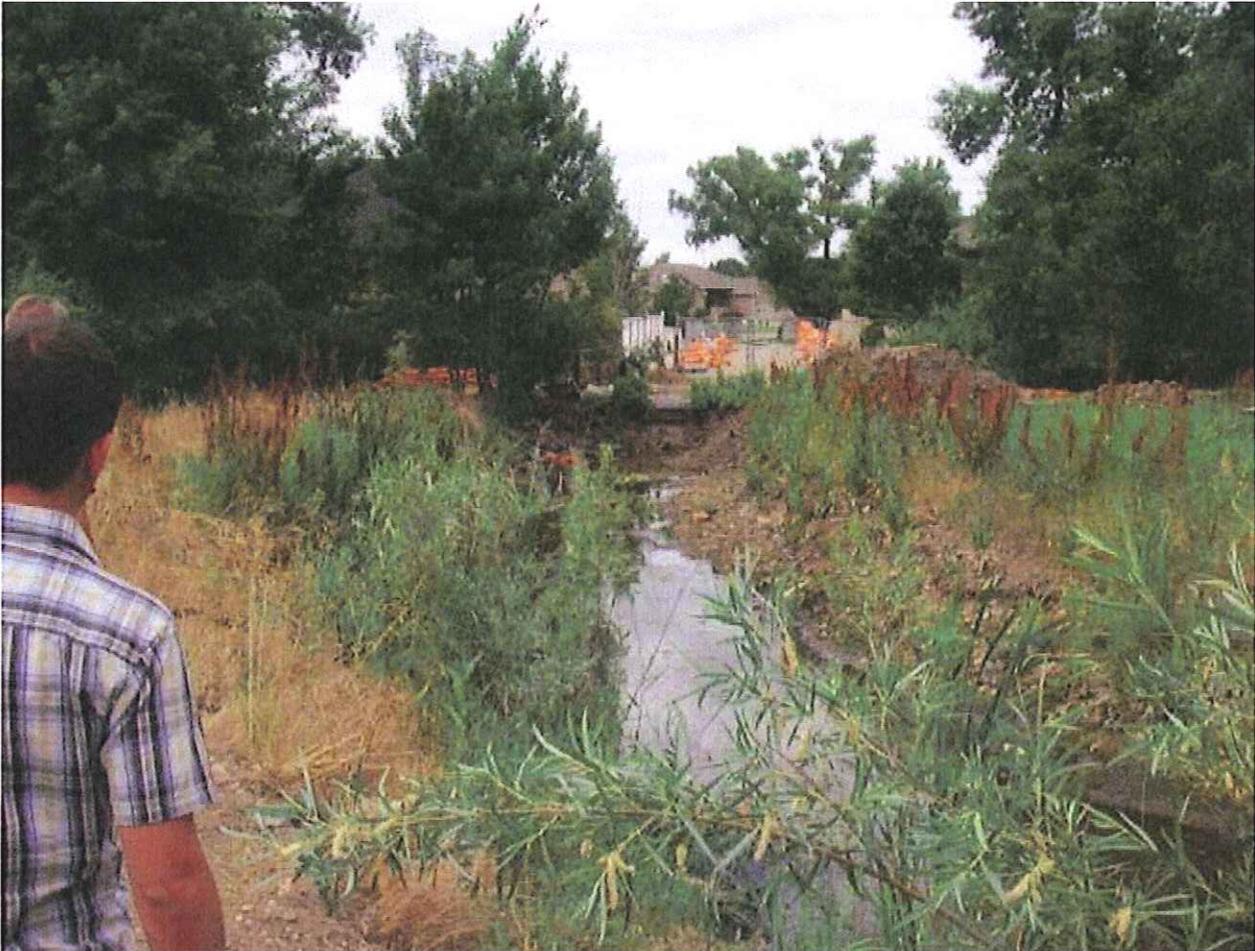
Flood Assessment Point:	#9 & #13-Creekside Trailhead Path Erosion @ River Glen Subdivision
GPS Coordinates:	8-16-11 Point 39, 40, 41, 42
Direction to Assessment Point:	At the junction of the Creekside trail and the Weber River Pathway. Approximately 1000ft on the bike path upstream from north trail head.
Project Priority:	High Moderate Low X
Description of Damage:	The path that leads from the River Bend Subdivision was completely eroded by overbank flooding. This path was reconstructed immediately after the 2011 flood event. 275 ft of split rail fence destroyed, 275 ft path destroyed. There are also issues with the stormwater conveyance at this location. There is a drainage channel that discharges at the west end of the Creekside trail. During high flow events this structure backs up, causing flooding in the River Bend subdivision.
Structures:	Path, Fence, stormwater return channel, homes.
Geomorphic Description:	<p>This portion of the Weber River Floodplain has historically been very active. Historic aerial photos from prior to 1971 show that the active channel of the Weber River flowed through this area. The historic channel passed directly across the junction of the two paths, continued northwest directly through what is now Wildcat Storage and the trailhead facility. The construction of I-15 and Parker Drive has encroached on the active channel at this point, forcing the river east, into its current, channelized location. The river overbanks approximately 500 ft south of the trail junction on the Pathway. FEMA mapping indicates that the trail junction is in ZONE AE and the majority of the Creekside Trail is in the 500 year floodplain. During 2011 runoff this area was inundated by a 10-year flood, indicating that the FEMA information May need updating.</p> <p><u><i>It's important to note that the DFIRM identifies most of this area as 100-year and 500-year floodplain. This was a ten year event; this area should be remapped.</i></u></p> <p>Also we may want to separate this into two damage sites.</p>

Habitat Considerations:	None
Flood Damage Repair:	<ul style="list-style-type: none"> • \$5,000-\$15,000

<p>Measures:</p>	<ul style="list-style-type: none"> • Option 1(Flood Damage Replacement) <ul style="list-style-type: none"> ○ Repair path ○ Repair fence ○ Biostabilize left bank at location of overbank. ○ \$30,000-\$64,000 • Option 2 (Flood Mitigation Project) <ul style="list-style-type: none"> ○ Rebuild path to handle overbank flows ○ Remove fence to facilitate overbank flows ○ Create overbank flow path between Weber Parkway and Riverbend Subdivision ○ Reconstruct Weber Pathway to have boardwalk to allow overbank flows ○ Biostabilze overbank area ○ Construct return flow channel upstream of North trailhead and downstream of trail junction. ○ Build offset levee along property lines ○ Install pump station at trailhead to pump stormwater against floodflow head, discharge downstream in Weber River. ○ \$250,000-\$500,000
<p>Photographs:</p>	<ul style="list-style-type: none"> • IMG0192 Trailhead • IMG0193 Looking upstream flood channel • IMG0195 Bank failure at overbank area • IMG0196 Looking downstream at overbank area, flood flow path.

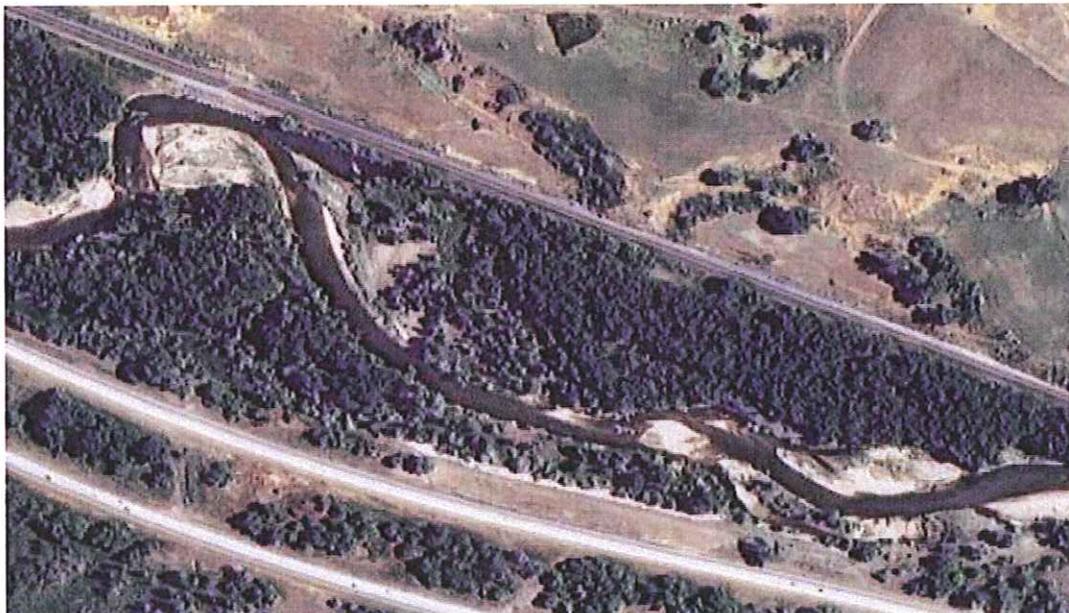
Figure 2-Active channel upstream of Riverdale City

The Weber River Valley where Riverdale City lies ranges from less than 3000 ft wide to over 6000 ft wide. Prior to human development the river was free to move across this entire valley in a dynamic process of aggradation and degradation. As the river deposits alluvium in one location, the bed aggrades, and the river is forced to flow in another direction. This result of this process is an ever changing meandering plan form and multiple channels. This action is most evident upstream of Riverdale City where large alluvial deposits and active bank erosion are particularly evident (Figure 1 and Figure 2). The reach upstream of Riverdale City is owned by the Utah Department of Natural Resources and has seen little urbanization when compared to Riverdale City. The river upstream has many cobble bars and changes its channel course every year.

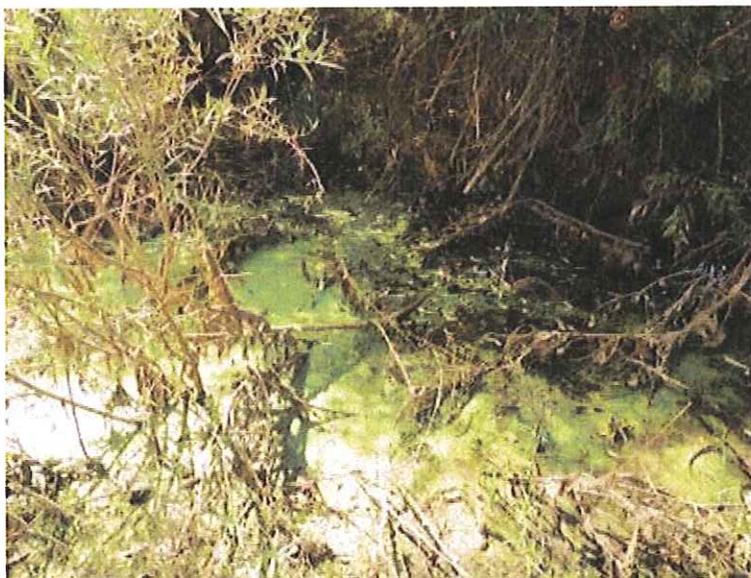
Figure 12-North Trailhead Wetland

The smallest and most downstream wetland is located adjacent to the North Trail Head. This wetland appears to be the associated with stormwater runoff from the adjacent area. This wetland drains under the Weber River Pathway just upstream of the Parker Rd. underpass. There is an abundance of algae and trash present in the wetland (Figure 12). This wetland may have insufficient flow to provide adequate oxygenation. The garbage should be removed and the mechanical drainage system should be inspected to ensure there is adequate flow through the wetland.

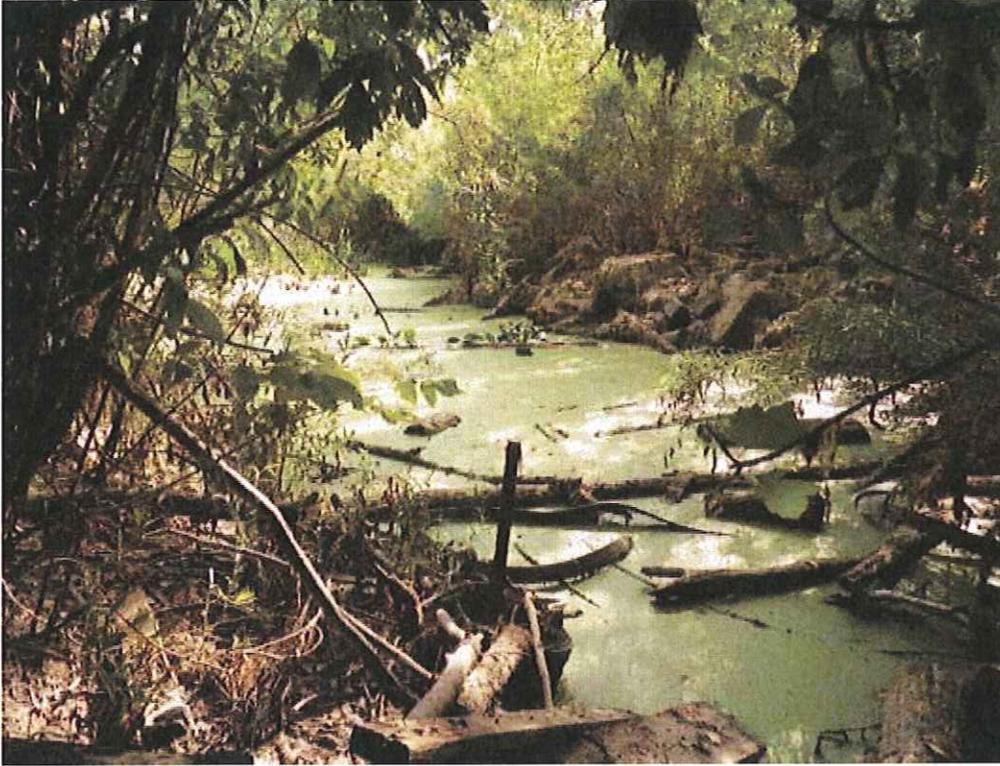
Figure 13-Oxbow wetland

The second emergent wetland is located approximately 550 ft upstream on the Parkway from the Great Salt Lake Brine Shrimp warehouse. This wetland appears to be a historic meander (or oxbow) that has been isolated from the river due to the trail construction (Figure 13). This wetland is completely covered with algae which reduces the amount of available oxygen. It is likely that this wetland is anoxic (lacking oxygen) below the surface. Additionally there is a substantial amount of concrete rubble dumped on the sides of the wetland. This concrete may have been placed there to protect the bank from erosion when this was an active channel. RiverRestoraion recommends reconnecting this wetland to the river with small culverts under the Parkway to improve its hydraulics as well as allow it to provide some level of backwater storage during flashy flood events. This wetland is unique within Riverdale City and has the potential to provide critical ecosystem functions as well as excellent educational (interpretive) opportunities. Removal of the concrete would also provide aesthetic benefits to the community.

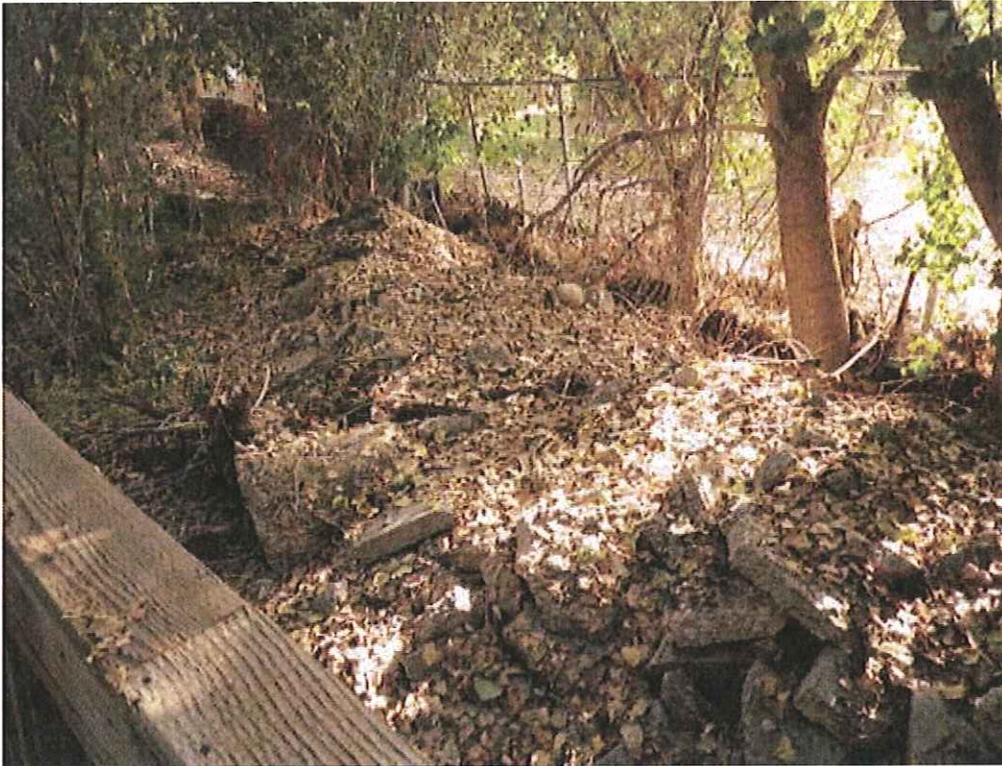
Figure 14-Brine Shrimp Wetland concrete fill

There is an additional non-emergent wetland adjacent to the Great Salt Lake Brine Shrimp warehouse. This wetland may be the result of backwater due to a tributary channel. There is a substantial amount of concrete rubble (Figure 14). The concrete may have been placed to protect the warehouse from flooding due to backwater. The concrete should be removed and potential flooding risk should be addressed with an offset levee as described in the previous section.
