RIVERDALE CITY COUNCIL AGENDA-AMENDED
CIVIC CENTER - 4600 S. WEBER RIVER DR.
TUESDAY – MARCH 6, 2012

Riverdale City 2011 Flood Damage Assessment

October 13, 2011

Prepared For:
Riverdale City, Utah
Public Works department
4600 South Weber River Drive
Riverdale City, Utah 84405

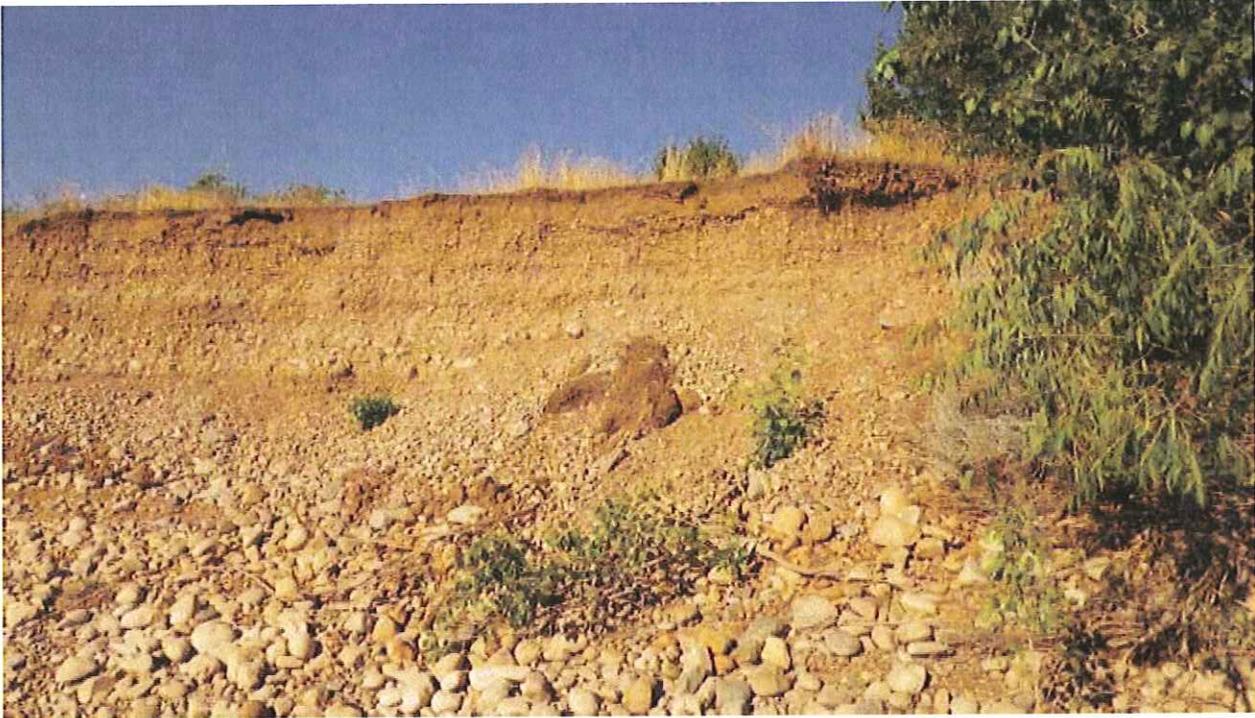
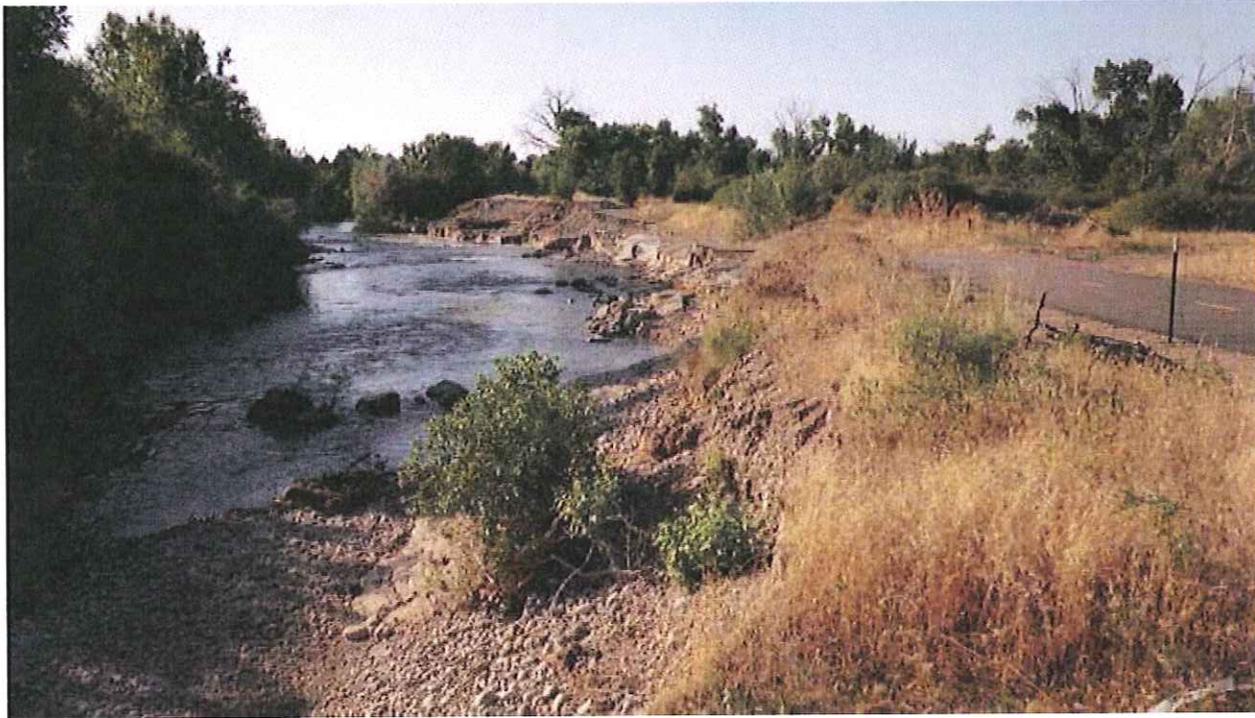
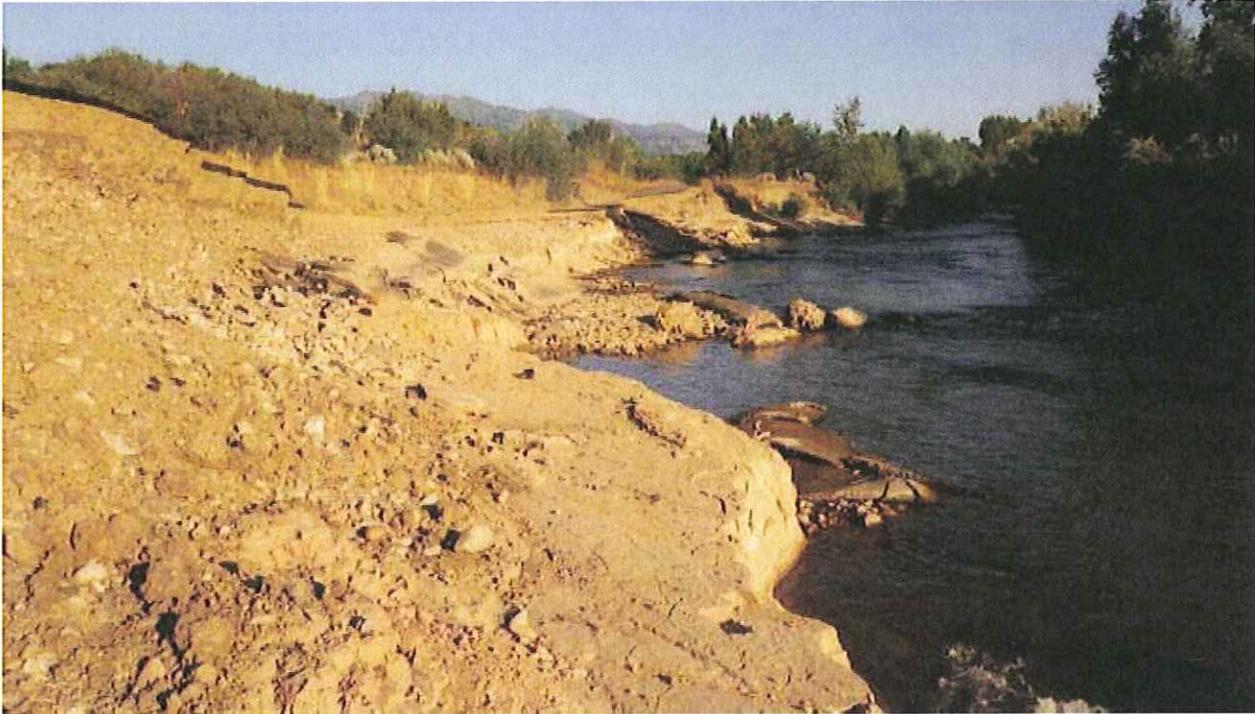
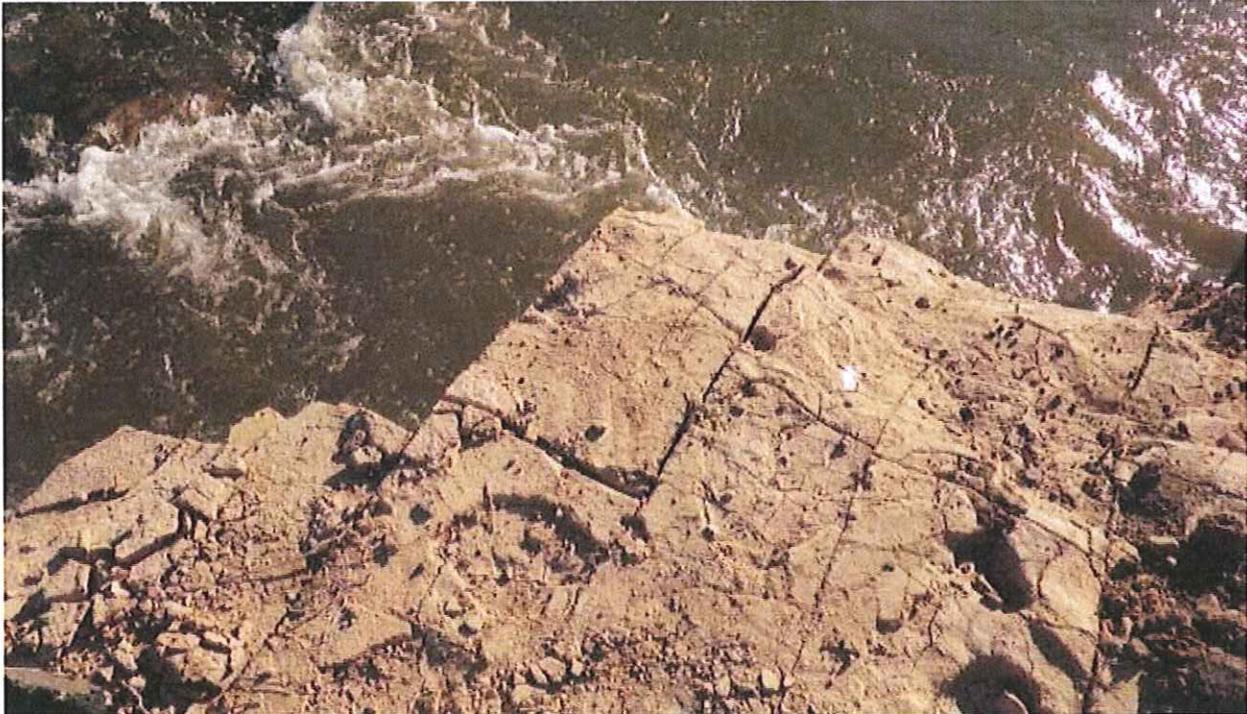
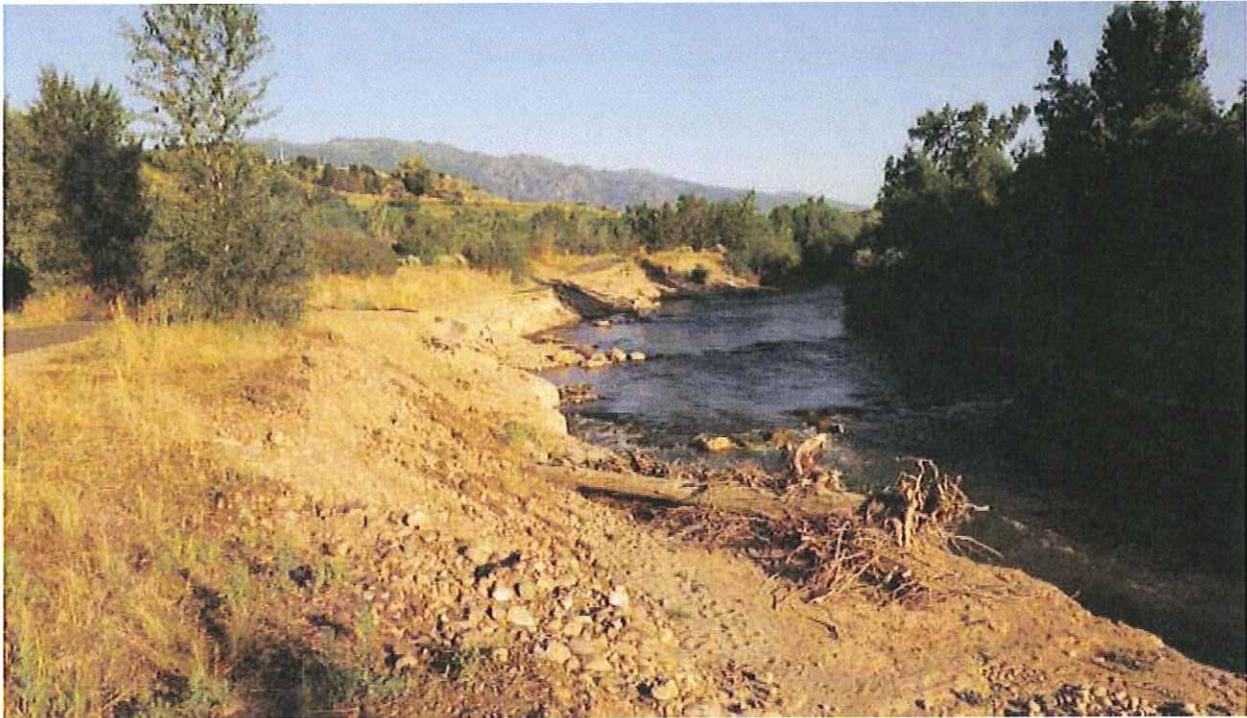
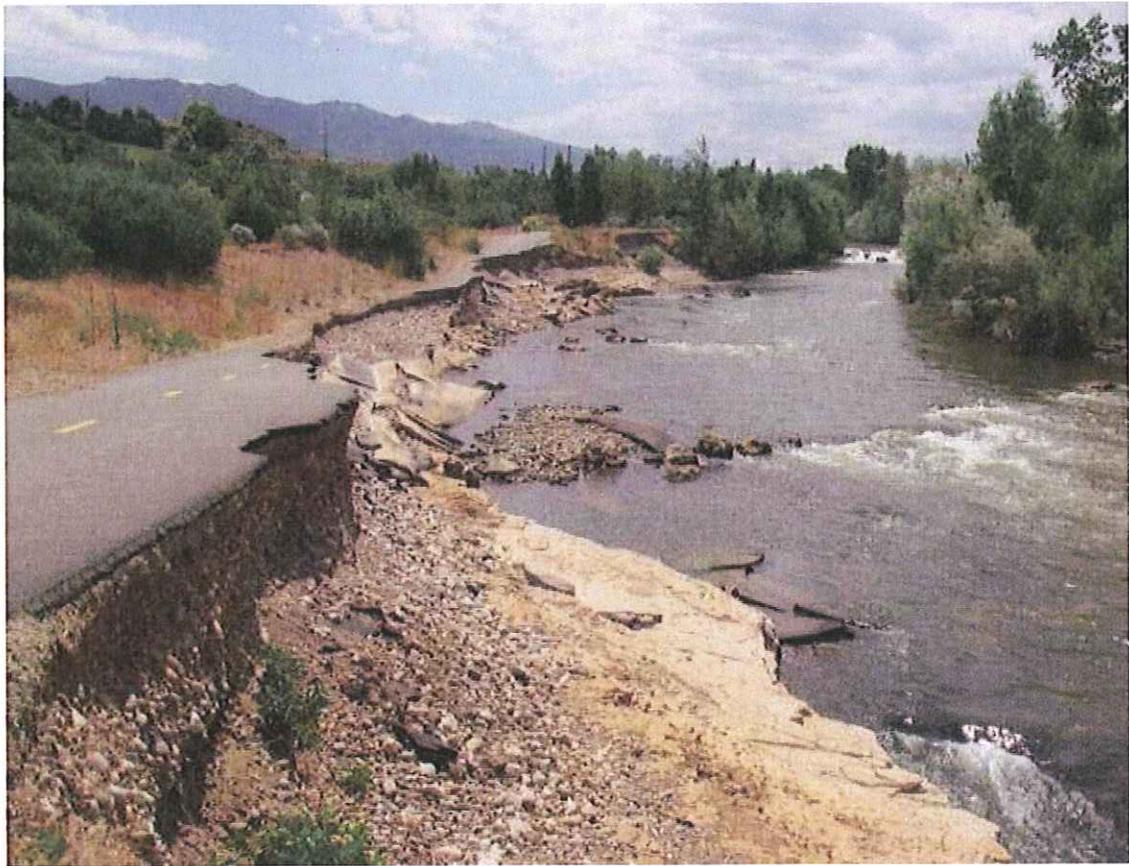
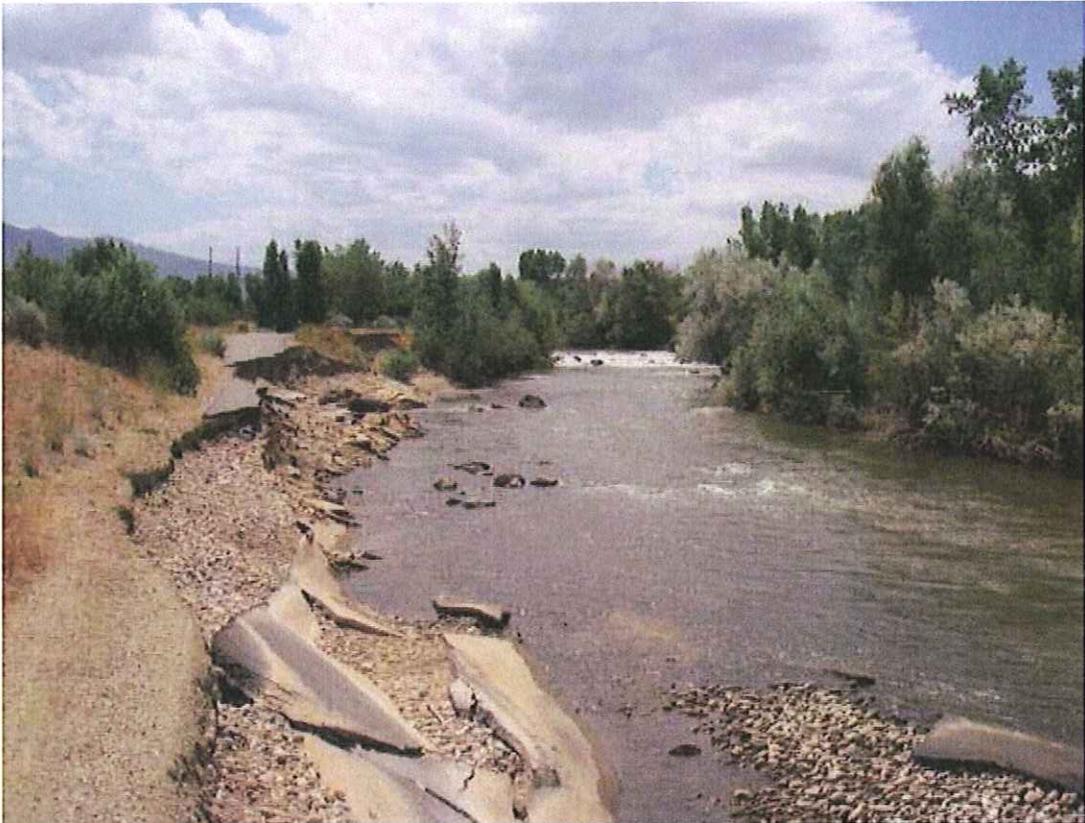
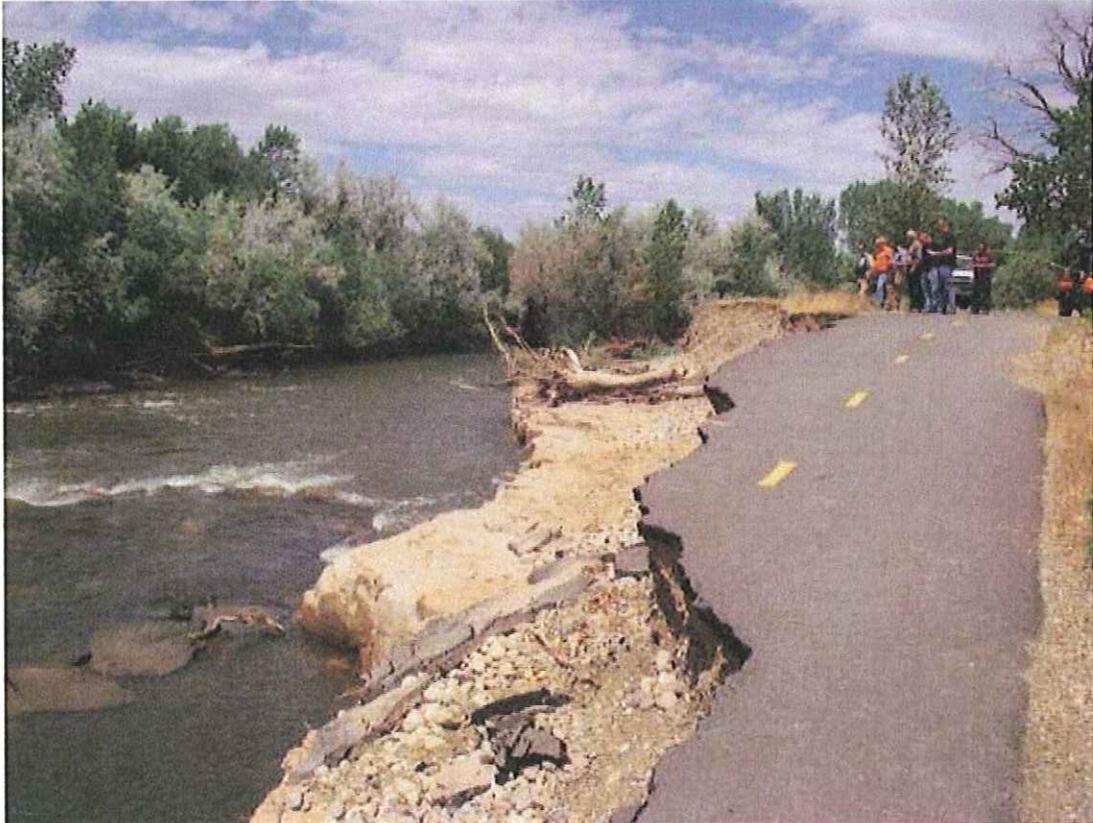
Flood Assessment Point:	#1-Weber River Parkway Collapse						
GPS Coordinates:	Waypoints RC-10 to 29						
Direction to Assessment Point:	Approximately 5260ft upstream from Weber River Dr. on bike path.						
Project Priority:	<table style="width: 100%; border: none;"> <tr> <td style="width: 33%;">High</td> <td style="width: 33%;">Moderate</td> <td style="width: 33%;">Low</td> </tr> <tr> <td style="text-align: center;">X</td> <td></td> <td></td> </tr> </table>	High	Moderate	Low	X		
High	Moderate	Low					
X							
Description of Issue:	Sever erosion of nearly 550 ft of bank resulting in collapse of 300' of asphalt pathway.						
Structures:	Bike Path						
Geomorphic Description:	<p>Aerial photographs from 1953, 1954, 1971, 1973, 1979, 1980, 1997, 2003, 2006, and 2009 were reviewed to understand the geomorphic evolution of this reach. This portion of the Weber River was channelized in the early 1970's for the construction of I-84. Prior to channelization this reach had meanders with a similar planform to the upstream DNR reach as it exists today. Aerial photography from 1953 shows that the reach length has been reduced by over 20% (7500 feet to 5800 ft). In addition to decreasing the length and a subsequent decrease in slope the construction of the highway also narrowed the effective floodplain of the river. Historic channel patterns are also evident in the 1953 photo. These patterns indicate that the Weber River may have had a meander belt width in excess of 1500ft. Aerial Photographs from 1999 and 2009 show that virtually all of the meanders have been eliminated through channelization and the riparian corridor is less than 150 ft wide. In addition to the channelization a water main crossing was placed just upstream of the failed bike path (RC-9) creating a large drop structure. The river has responded to these changes by cutting into the right bank as it attempts to adjust its flow path length. The river was cutting at this bank prior to the construction of the path in 2009. Between 1997 and 2006 the bank eroded a horizontal distance of approximately 55-60 ft. Some of this bank loss was reclaimed with the construction of the path in 2009. The 1971 photo shows a mid-channel bar formed immediately across the river from the area of the failed bike path. Portions of this bar were left unaltered during the construction of the highway. It is likely that during high flows this mid channel bar become inundated and provided extra conveyance. During the extended drought period that ended in 2008 riparian vegetation was established on this bar thus closing off any significant conveyance. The lack of overbank flooding and the establishment of mature riparian vegetation has effectively eliminated any overbank</p>

<p>conveyance through this reach. Additionally there is evidence of bank toe erosion throughout this reach, indicating that the river is down cutting. Evidence of overbank flooding at downstream end of bank failure. Large amounts of driftwood caught in overgrown understory may have decreased overbank conveyance.</p>
Habitat Considerations:	<p>Throughout this reach there is a lack of habitat diversity. Channelization has created uniform flow patterns and in portions the riparian vegetation is sparse. There is little evidence of deposition through this reach. Eroded bank material is likely transported through the reach and deposited downstream of Riverdale City.</p>
Flood Damage Repair	<ul style="list-style-type: none"> • \$250,000-\$350,000
Measures:	<ul style="list-style-type: none"> • Option 1 (Flood Damage Improved Project): <ul style="list-style-type: none"> ○ Reconstruct Bike path further northeast. ○ Biostabilize Bank ○ \$50,000-\$100,000 + Lands • Option 2 (Flood Damage Improved Project): <ul style="list-style-type: none"> ○ Reconstruct bike path in new alignment ○ Stabilize Toe ○ Lay river bank back at 3:1 and biostabilize ○ Thin out overgrown riparian vegetation on river left to open up flood conveyance channels. ○ \$200,000 to \$300,000 + Lands

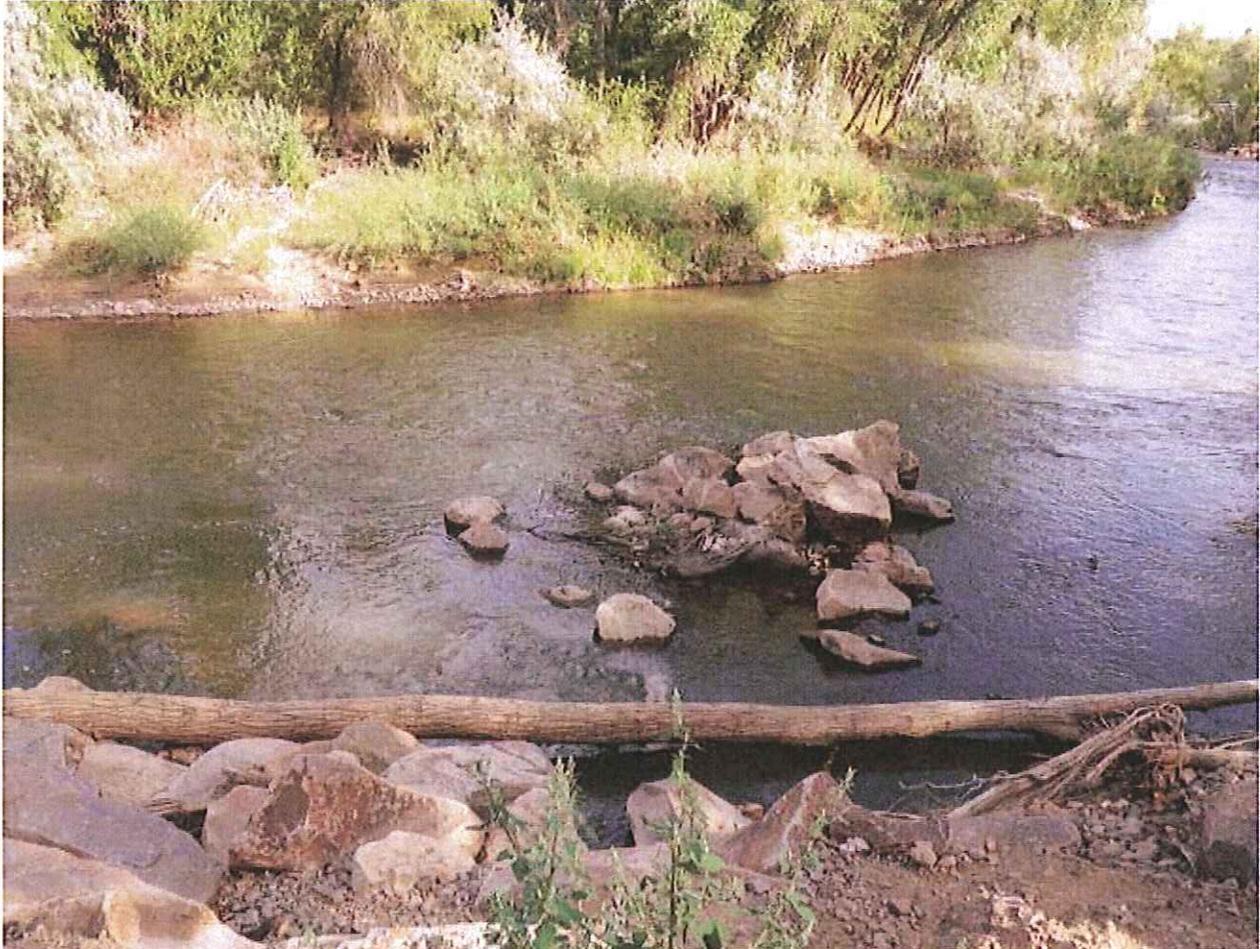
Flood Assessment Point:	#11-Failed Bank Stabilization
GPS Coordinates:	8-16-11 Points 50, 51
Direction to Assessment Point:	Upstream end is approximately 330ft downstream of the Riverdale Kayak Park on the Pathway
Project Priority:	High Moderate Low X
Description of Damage:	Numerous failed J-hook structures, failed rip-rap and eroded banks and resulted bank failure is approximately 700' long and 10' high.
Structures:	Path, Homes, Land
Geomorphic Description:	These structures (rip-rap and J-hooks) were installed in response to the rivers channelized flow path to protect land and the Parkway. The residential areas to the west of this location were constructed in the late 1970s and early 1980s. Aerial photography from the 1950s shows that the location of the River Valley Subdivision was a historic flow path for the Weber River. Prior to the subdivision development the Weber Rivers geomorphically active floodplain was more than 1000ft wide. The historic photos also show a large oxbow flood channel located in the exact location of 4300 S (A.K.A. Oxbow Dr.) and River Valley Dr. Presently the River is constrained to a corridor that is 100 to 150 ft wide.

Habitat Considerations:	Source of non-point source sediment pollution.
Flood Damage Repair Measures:	<ul style="list-style-type: none"> • \$100,000-\$200,000 • Option 1-(Flood Damage Replacement) <ul style="list-style-type: none"> ○ 700 ft of bank stabilization ○ Remove J-Hooks and use boulders for toe protection ○ Import material to protect bank. ○ \$200,000-\$350,000 • Option 2-(Flood Improvement, Improved Project) <ul style="list-style-type: none"> ○ Remove upper bank boulders and riprap and place 150' D.S. to connect left bank levee (100' Long) ○ Improving D.S. flood overflow channel. ○ \$64,000 • Options 3-(Flood Mitigation Project) <ul style="list-style-type: none"> ○ Remove upper bank boulders and riprap and place 150' D.S. to connect left bank levee (100' Long) ○ Improving D.S. flood overflow channel. ○ Realign Bike Path away from River. ○ Biostabilize Left Bank ○ \$85,000-\$120,000
